# Memorandum

To	Bala Subramanian, Senior Project Manager, Sydney Water		
Copy to			
From	Gary Leonard	Tel	+61 2 9239 7100
Subject	Arboricultural Impact Assessment relating to the Vacluse Diamond Bay Wastewater Improvements Project	Job no.	21-28225-15

## **Arboricultural Impact Assessment relating to the Vacluse Diamond Bay Wastewater Improvements Project- Parsley Bay Reserve**

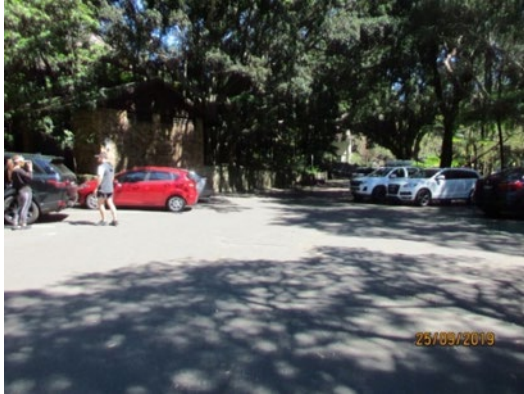
**Photo 1 Levelled area developed as carpark.**

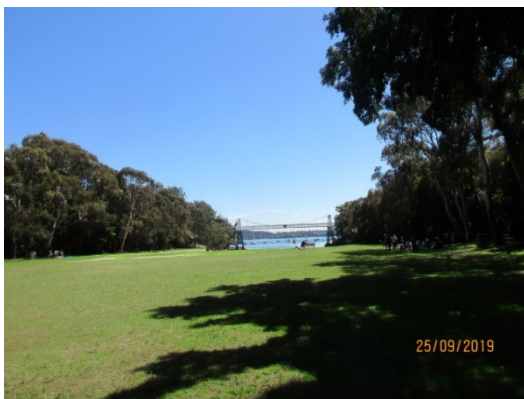
**Photo 2 Levelled area developed for recreation.**

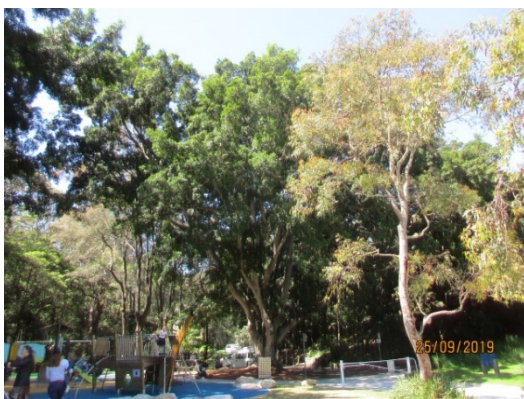
**Photo 3 View from playground. Entrance to Reserve right middle-ground; Tree 2 centre. Trees and vegetation on the site.**

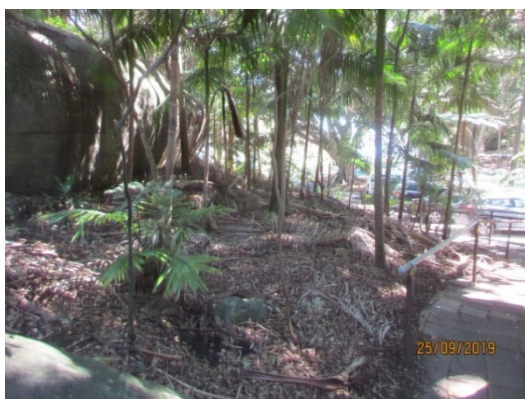
**Photo 4 Thicket of (probably planted) Bangalow Palms, west of the toilet block.**

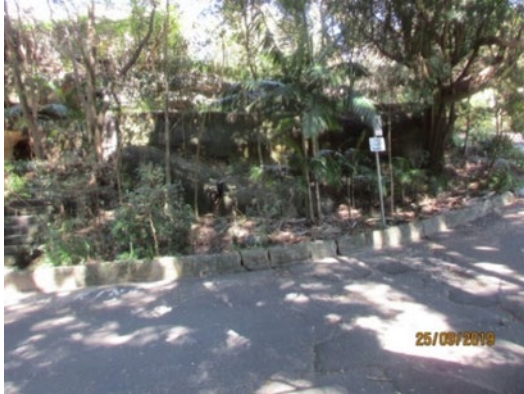
Although this survey did not include a botanical assessment, the occurrence of two threatened plant species was noted, because they occurred within an area adjacent to Tree 1, which is identified as an alternative site for the pump station. A sawn stump of Magenta Lilly Pilly (*Syzygium paniculatum*) with epicormic regrowth was recorded at the base of the retaining wall, to the northeast of Tree 1. A number of seedlings were recorded which were tentatively identified as *Syzygium paniculatum*, although the occurrence of *Syzygium smithii* and *Syzygium australe* seedlings in the same vegetation patch created uncertainty. A mature specimen of Sunshine Wattle (*Acacia terminalis* subsp. *terminalis*) was recorded near the Magenta Lilly Pilly stump. A more detailed ecological assessment of the site will be carried out in the future as part of the approvals process for the project.

**Photo 5 Planted and self-recruited vegetation to the west of the toilet block. Two threatened plant species were recorded in this patch.**

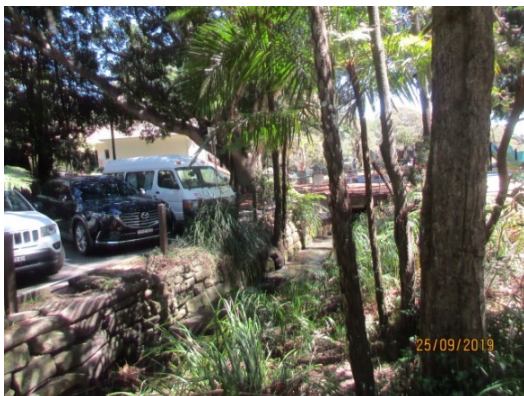
**Photo 6 Creek line vegetation, north of the toilet block.**

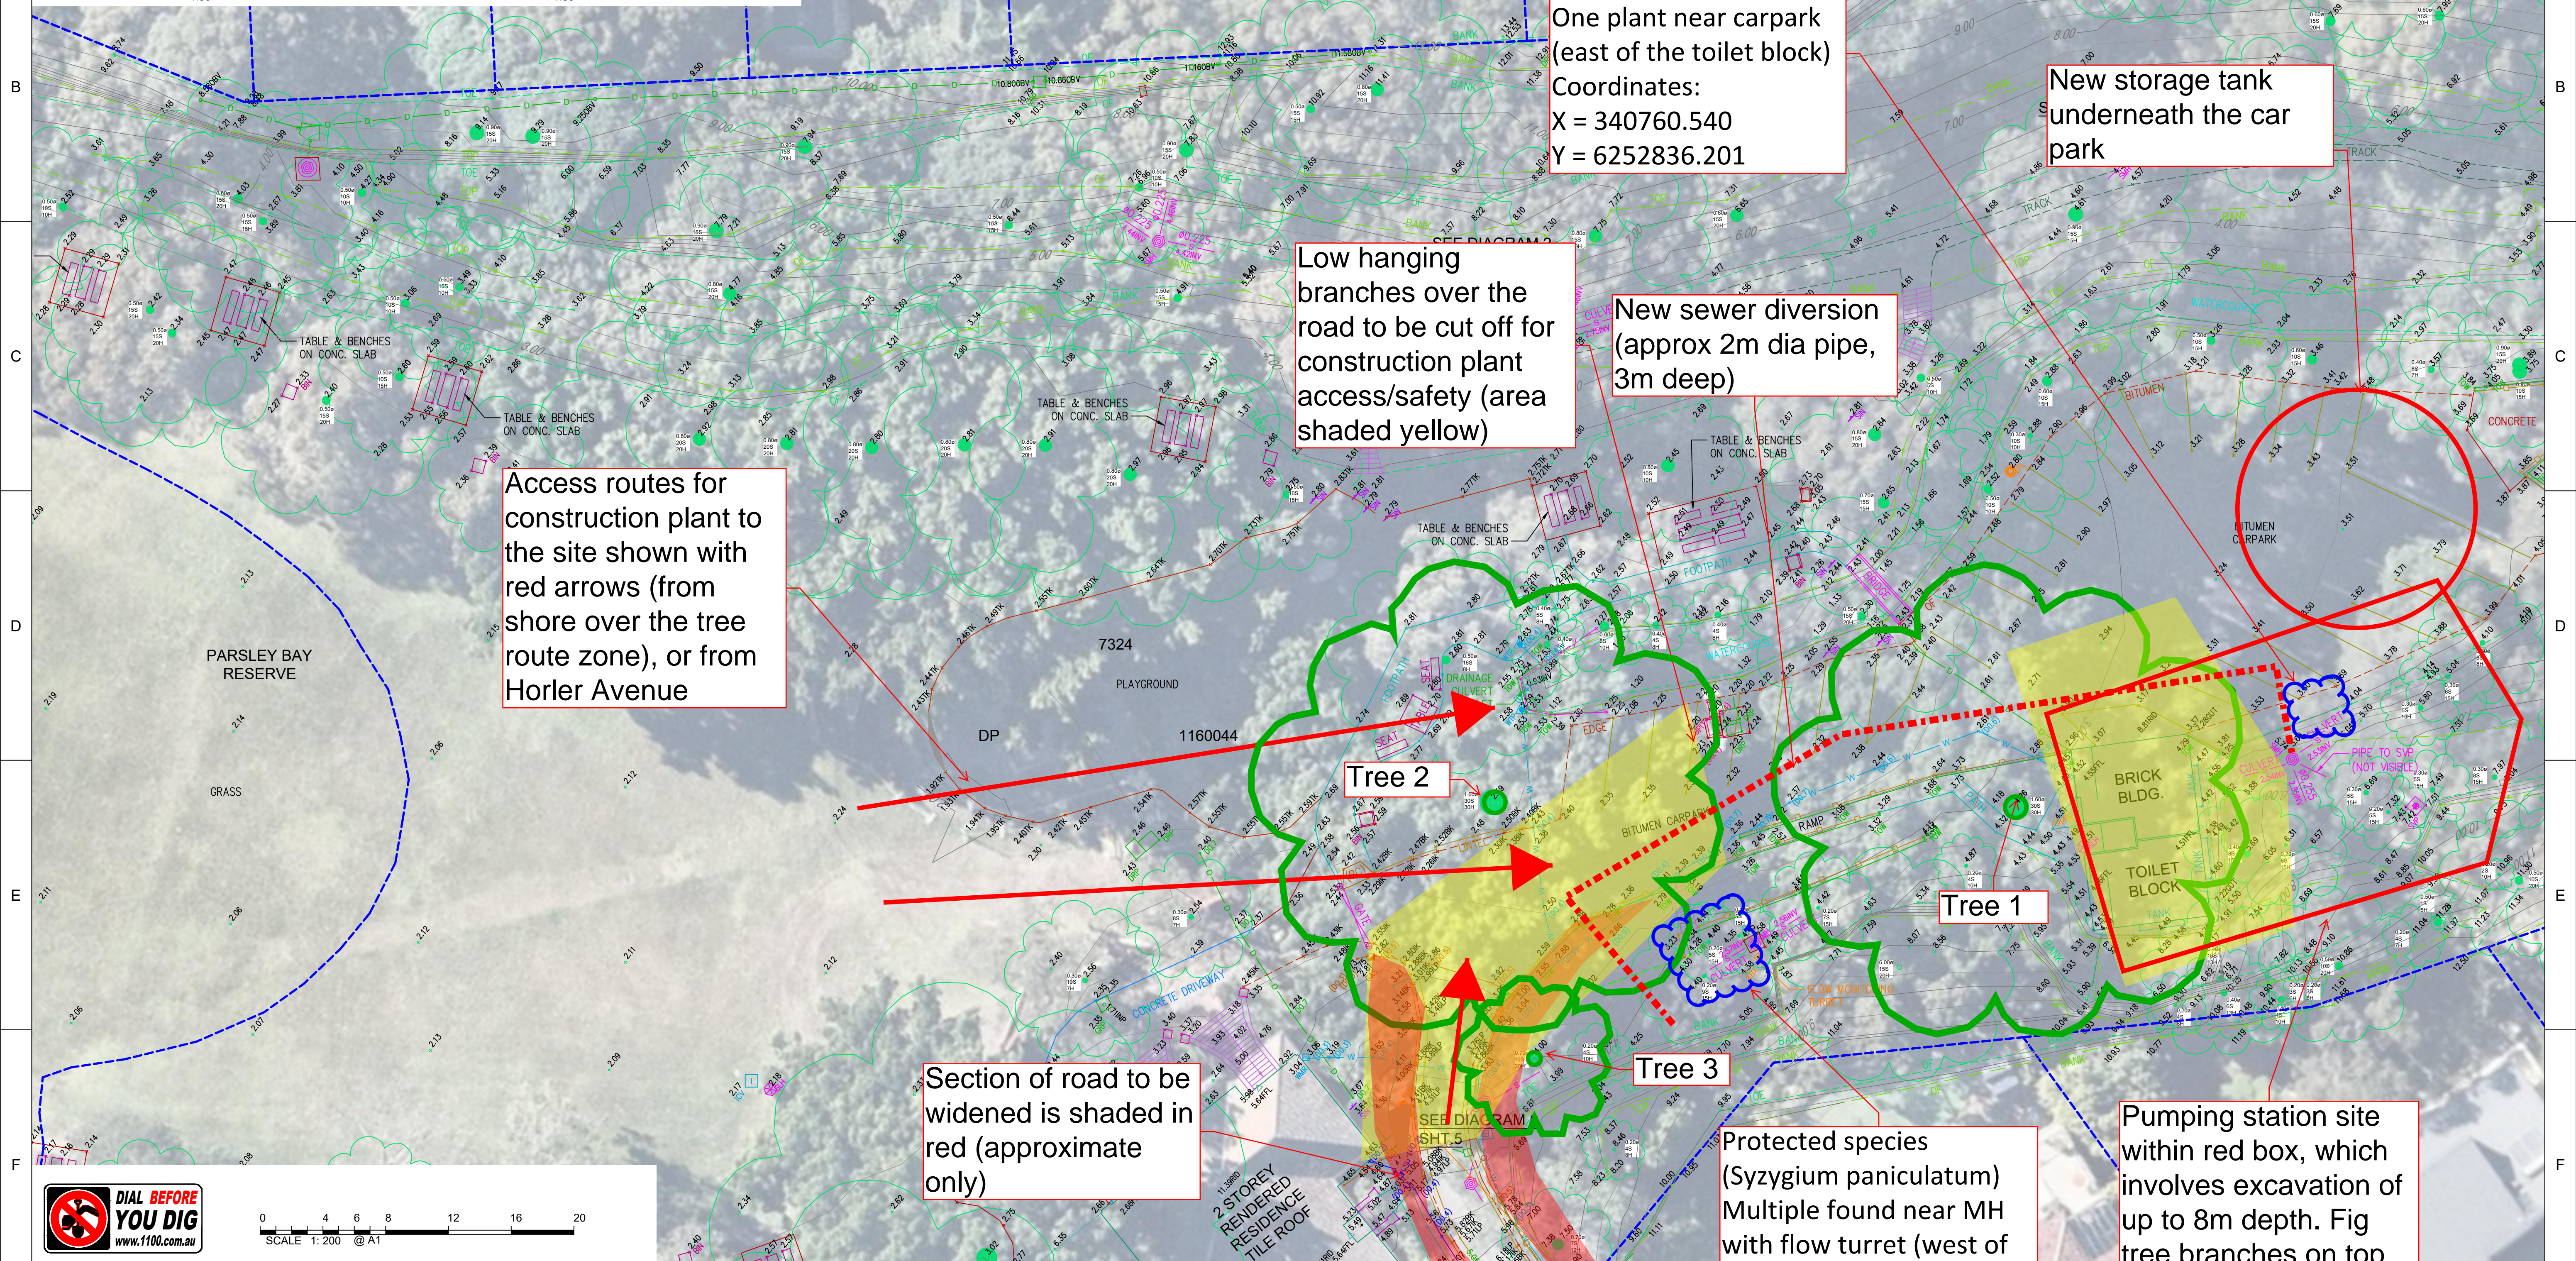
SHEET 3 OF 5	
DRAWING NUMBER	REV
11894101001	01

Protected species  
(*Syzygium paniculatum*)  
Multiple found near MH  
with flow turret (west of  
the toilet block)  
Coordinates:  
X = 340723.056  
Y = 6252854.907

Pumping station site within red box, which involves excavation of up to 8m depth. Fig tree branches on top of site to be cut off (shaded in yellow)

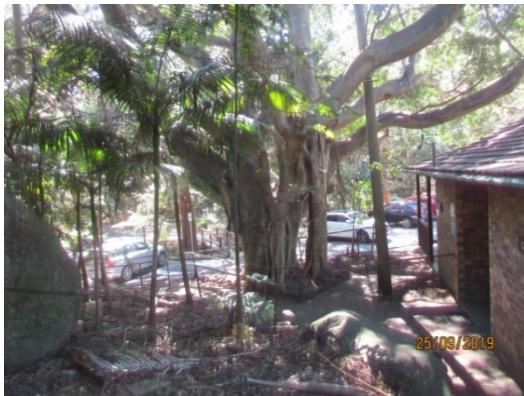
**Photo 7 View of aerial root column and lower platform. Note laterals extending over building.**

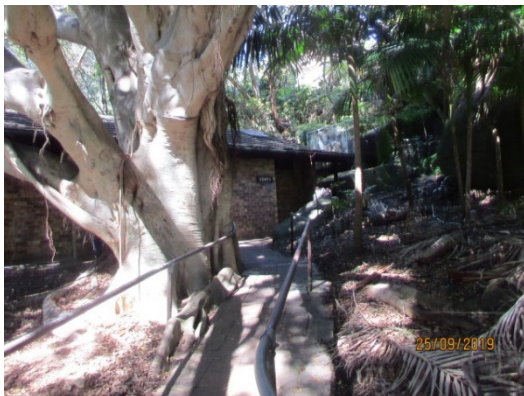
**Photo 8 Tree 1. Note growth of surface roots beneath path and into palm thicket.**

Although the theoretical TPZ of the tree would be 15 m (see Standards Australia 2009), it is apparent that there is a greater concentration of roots to the south-west of the aerial root column, where surface roots were recorded within a palm thicket and at the base of a sandstone platform. Roots survive in areas with adequate nutrients, moisture and air, therefore it is reasonable for a greater concentration of roots in the garden beds rather than towards and underneath the building. Some

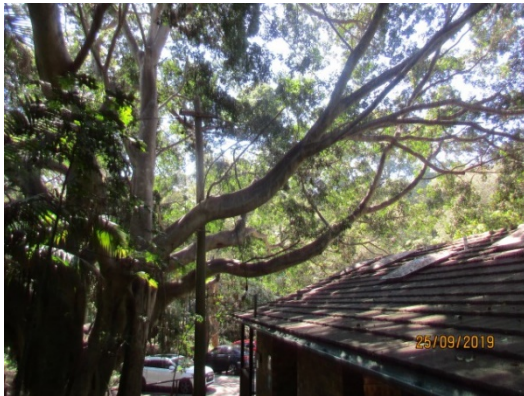
**Photo 9 Two laterals, extending in a north-easterly direction over the toilet block.**

The two laterals which extend from the platform over the toilet block will require removal, to provide machinery access during excavation and construction (Photo 9).

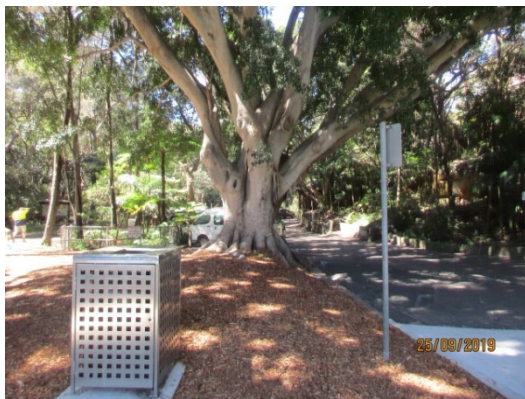
Tree 2 has good vigour and form, and no evidence of significant decay in wounds derived from previous lateral removal. The theoretical TPZ of Tree 2 is 15 m, although it is apparent that excavation for drains, underground surfaces, kerbs and sealed areas have removed some portions of the tree's root zone, and possibly concentrated most root growth towards less disturbed areas. Surface roots extend across the mulched bed and towards the creek line, as well as beneath the asphalt seal (Photo 11 and Photo 12). The canopy is low and spreading, with large laterals extending across the entrance to the carpark.

**Photo 10 Tree 2, showing location within mulched bed. Note laterals which extend over entrance to carpark.**

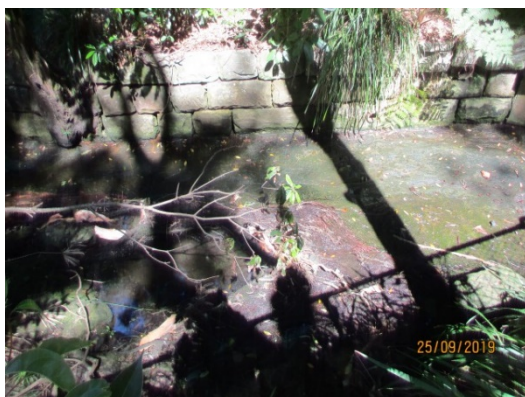
**Photo 11 Red-coloured roots in creek line adjacent and north of Tree 2 (centre, middle-ground) may have originated from Tree 2.**

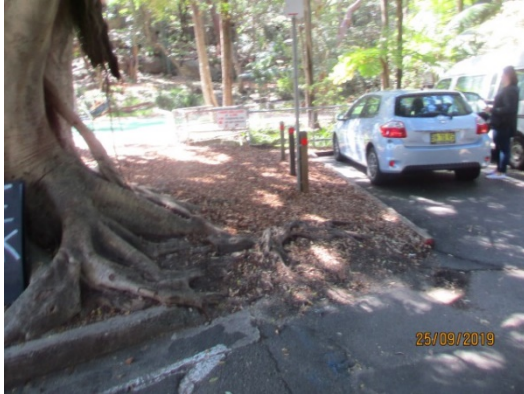
**Photo 12 Roots extending from Tree 2 beneath asphalt and into carpark.**

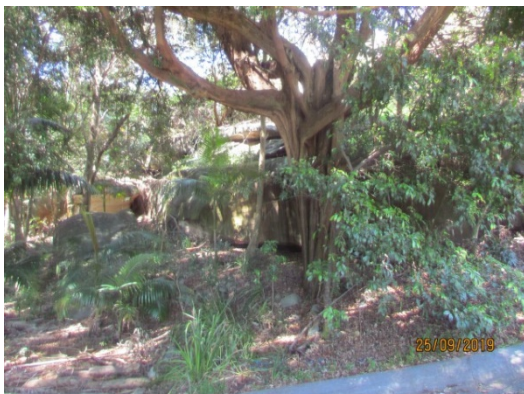
Tree 3 is mature and is in good condition and form (Photo 13). Some laterals have been previously removed back to the leader, although no evidence of significant decay was recorded in any of the wounds. The tree’s platform is partly suppressed to the north-east, with the result that there are long, low laterals to the south, extending across Horler Avenue at the entrance to the Reserve (Photo 14).

**Photo 13 Tree 3. Edge of Horler Avenue can be seen in foreground.**

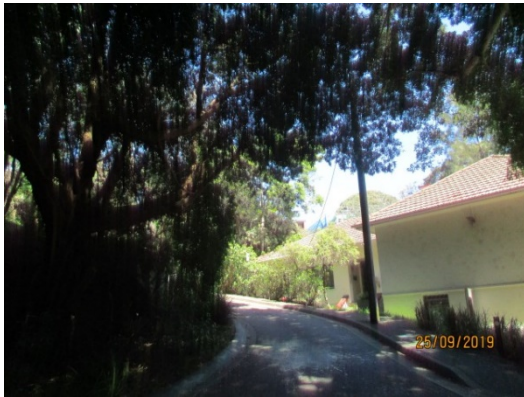
**Photo 14 Canopy of tree 3, extending over Horler Avenue.**

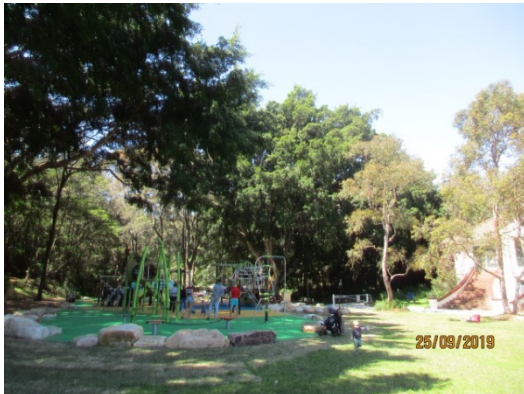
It is possible that the vehicular access from the bay to the excavation site will encroach on the TPZs of these trees (Photo 15).

**Photo 15** The access track for vehicles will pass near the two early-mature trees in right of picture (Trees 4 and 5). The TPZ surfaces of these trees should be adequately protected during the period of vehicular access.

It is possible that a proposed access road for heavy vehicles will encroach onto the northern portion of the TPZs of Trees 4 and 5. Vehicular movement over the TPZs would cause compaction and if sustained over a long period would result in necrosis to fine roots and supporting roots, mainly as a result of reduced available air in the rhizosphere. The tendency for compaction could be reduced if a protective cover is laid across the TPZ.

A proposed relocated sewer may, however cause complications, as it would likely encroach into the TPZs of Trees 4 and 5. Excavation into the TPZs of Trees 4 and 5 would result in loss of fine roots and possibly supporting roots, causing stress factors which are outlined in 5.1.

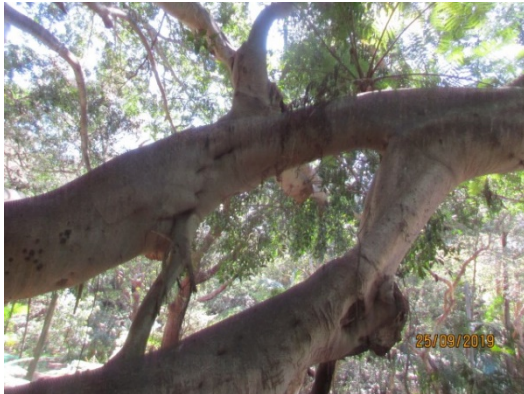
Removal of laterals is further complicated by branch grafting which has taken place, including within the laterals extending over the toilet block roof (Photo 16).

**Photo 16 Grafted laterals; Tree 1.**

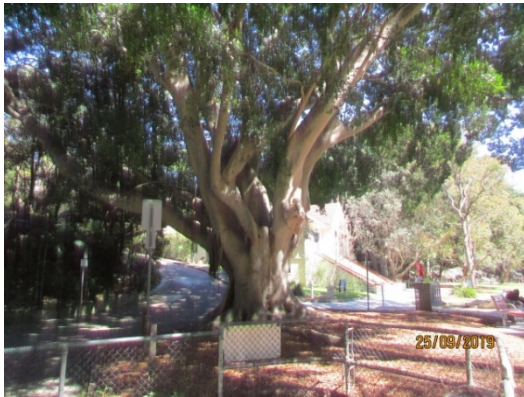
Excavation to the south and east of Tree 2 will occur within the tree's theoretical TPZ, potentially removing fine roots and supporting roots.

**Photo 17 Large lateral of Tree 2 over car-park entrance (left of picture).**

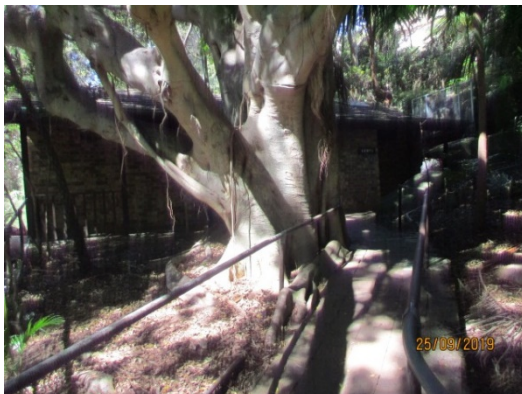
**Photo 18 Tree 1, surface roots over this area will require protection from damage and compaction by vehicles.**

- Appointment of a Project Arborist. The Project Arborist should co-operate with the site manager to determine the installation of adequate tree protection fencing. It is, however recognised that the siting of protection fencing according to Standards Australia (2009) will conflict to some extent with the need for vehicular and public access, therefore the Project Arborist will need to determine appropriate compromises, in order to ensure as much tree protection as is possible.
- Root zones located within or adjacent to works area or vehicular access should be protected by the application of either organic mulch, coarse gravel or geocells. The root protection should be installed prior to commencement of works and should not be removed until completion of all works. This measure applies to Trees 1, 2, 4 and 5 (Photo 16).
