Pre-Construction Road Dilapidation Report for Dapto NSW 2530

Prepared for Geosurv Locating Pty Ltd

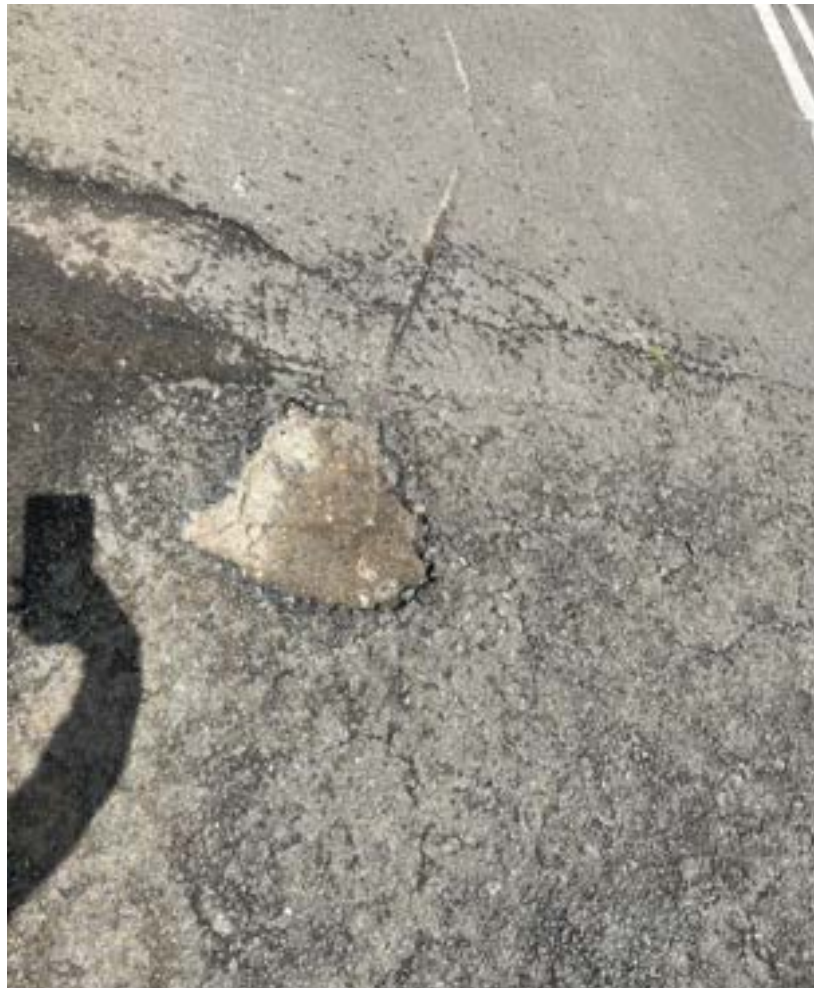
Photo 88

DEFECT/PHOTO NO.	LOCATION	LENGTH (mm)	WIDTH (max, mm)	COMMENTS
87	 	V	5 -10	Crocodile cracks in AC road surface
88		200	150	Delamination of AC road surface
89		V	5 -10	Various cracks near previously repaired section of AC road surface
90		2500	5 -10	Transverse crack in AC road surface
91		V	5 -15	Various cracks in AC road surface and ponding along edge of pavement
92		V	5 -15	Various cracks in AC road surface and ponding along edge of pavement
93		V	80	Various cracks and delamination near patching
94		V	10 -20	Meandering cracks in AC road surface
95		V	5 -10	Crocodile cracks in AC road surface
96		300	200	Delamination and pothole with crocodile crack in AC road surface
97		2000	150	Delamination with edge crack in AC road surface
98		300	200	Delamination and pothole with crocodile crack in AC road surface
99		250	100	Pothole
100		250	100	Pothole/delamination in AC road surface
101		3000	5 -10	Linear crack in AC road surface

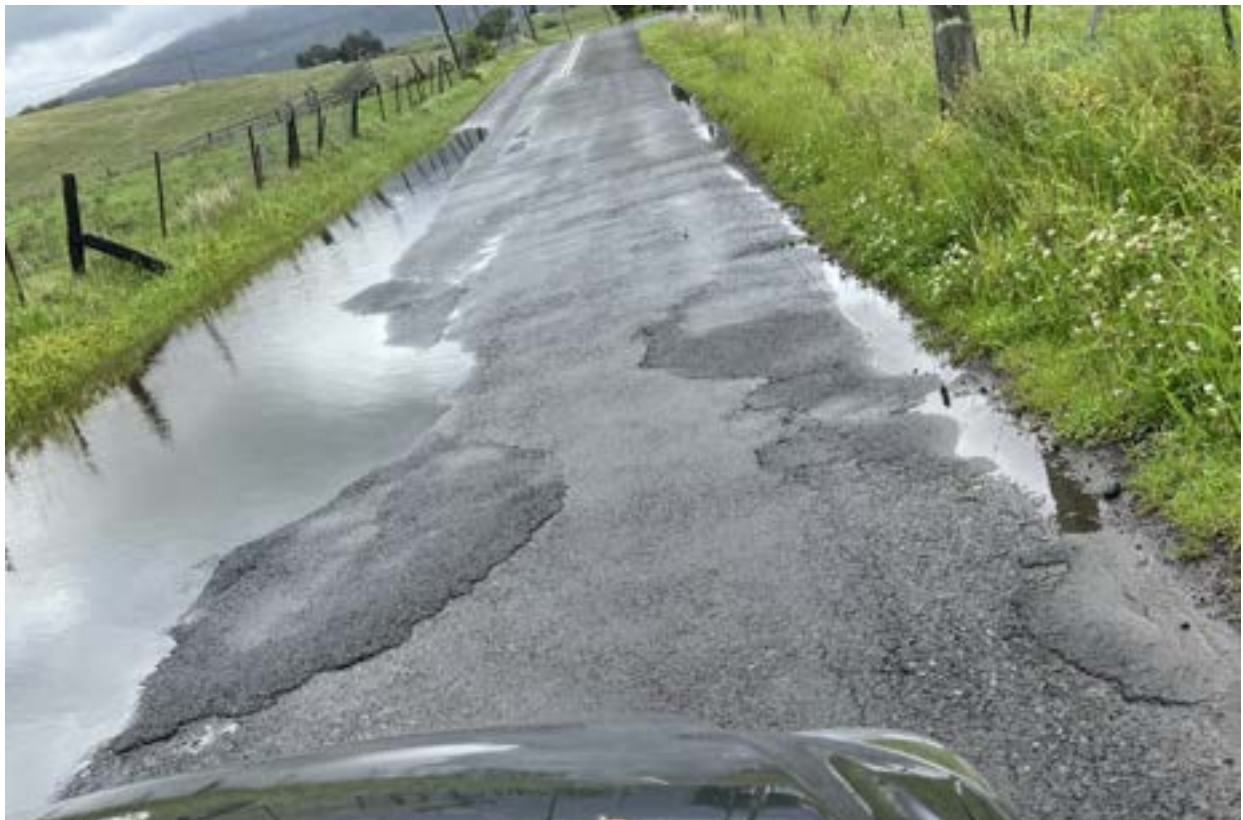
Photo 102

102		-	-	Evidence of ponding and patching
103		V	5 -10	Crocodile cracks in AC road surface and evidence of delamination
104		250	300	Delamination in AC road surface
105		300	150	Delamination with crocodile crack in AC road surface
106		150	100	Pothole with crocodile crack in AC road surface and evidence of patching
107		2000	150	Delamination in AC road surface
108		V	5 -10	Various cracks and evidence of patching and delamination in AC road surface
109		V	5 -15	Various cracks in AC road surface and previous patchwork
110		1000	100	Delamination and evidence of patching in AC road surface
111		V	5 -15	Various cracks and evidence of patching in AC road surface
112		V	5 -15	Various cracks and evidence of patching in AC road surface
