Review of Environmental Factors

**Maroubra Reservoir (WS0067) Dam safety works
and condition assessment.**

Sydney
WATER

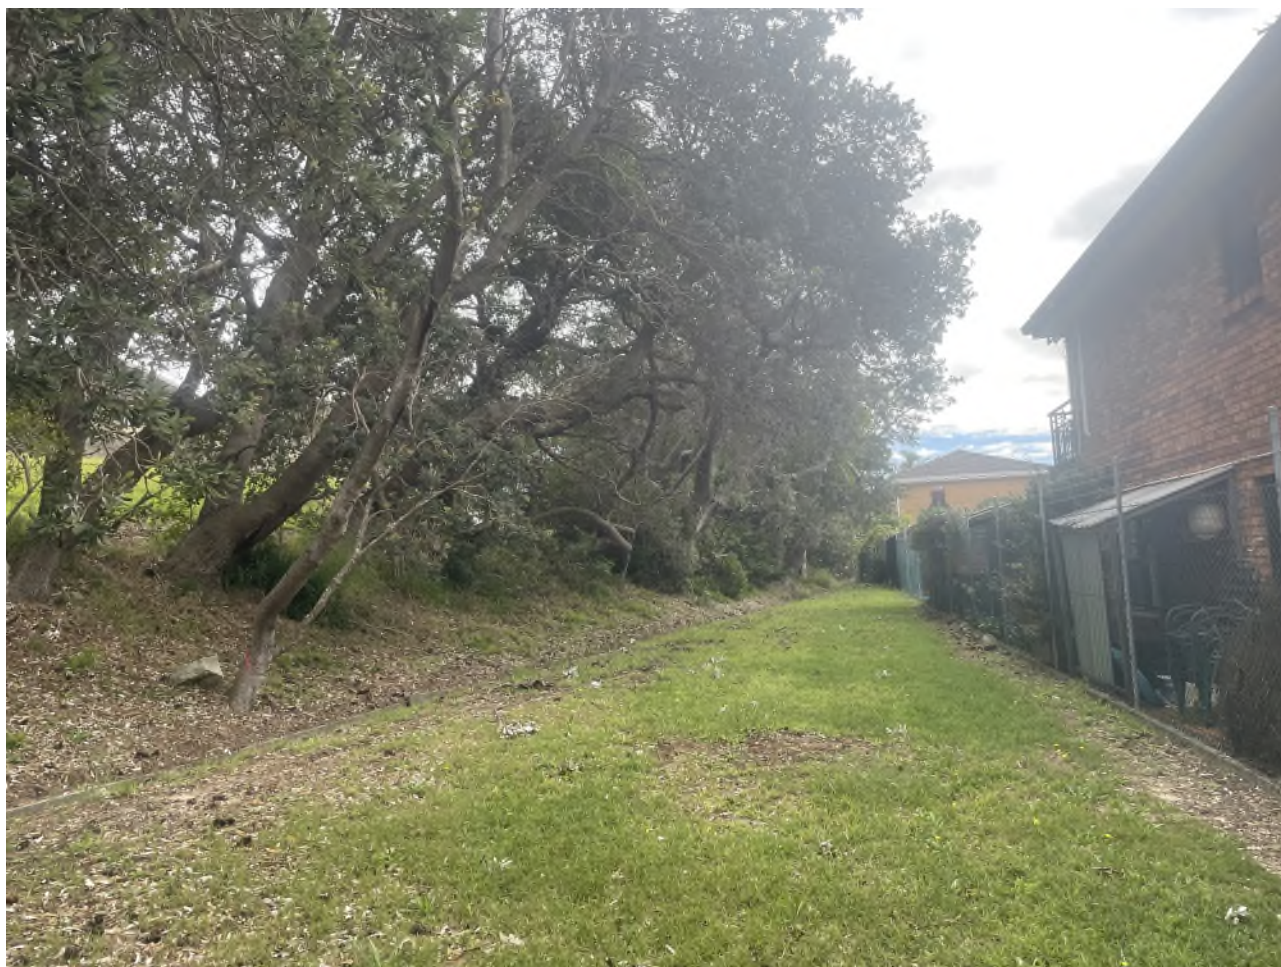
Figure A1: Maroubra Reservoir embankment along the eastern boundary, viewing north and showing vegetation on the embankment that requires removal. Residential properties shown are Fowler Crescent properties.

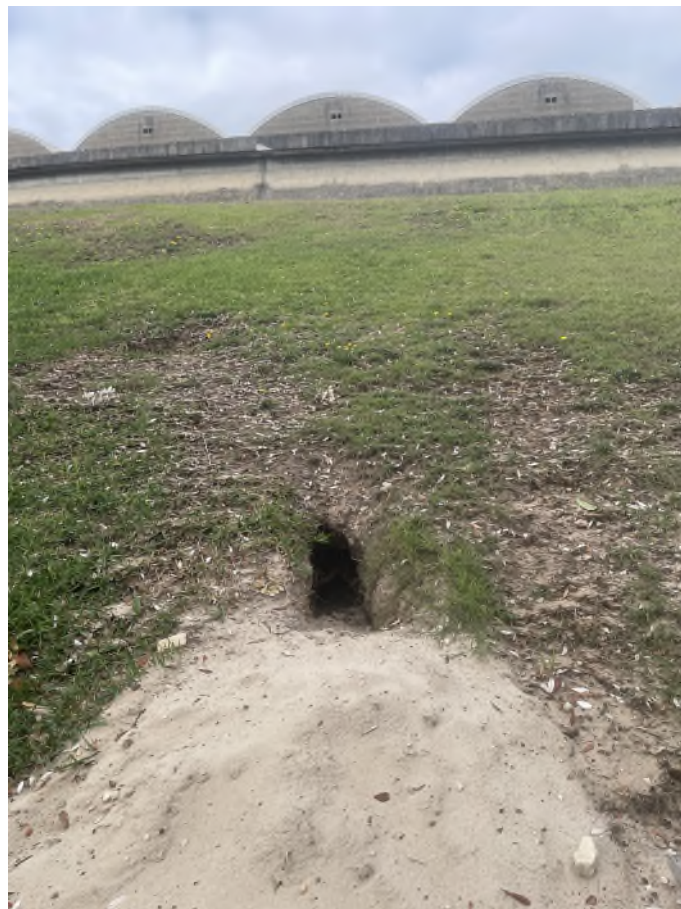
Figure A3: Fox (*Vulpes vulpes*) den constructed into the Maroubra Reservoir embankment.

There is evidence of foxes (*Vulpes vulpes*) occupying the site and digging fox dens within and into the embankment. The fox is a *Priority Pest Animal* in accordance with the *Biosecurity Act 2015*. The biosecurity risks and impacts posed or likely to be posed by priority pest animal species are generally regulated under Part 3 of the *Biosecurity Act 2015* (NSW) and the general biosecurity duty requirements. The condition assessment is unlikely to have a specific, direct influence of foxes, however the implementation of any corrective actions identified from the condition assessment would be expected to support actions that discourage and inhibit foxes. It is expected that the condition assessment would identify the need for a corrective action regarding the existing fox den onsite, and it would likely be infilled in accordance with dam safety requirements.

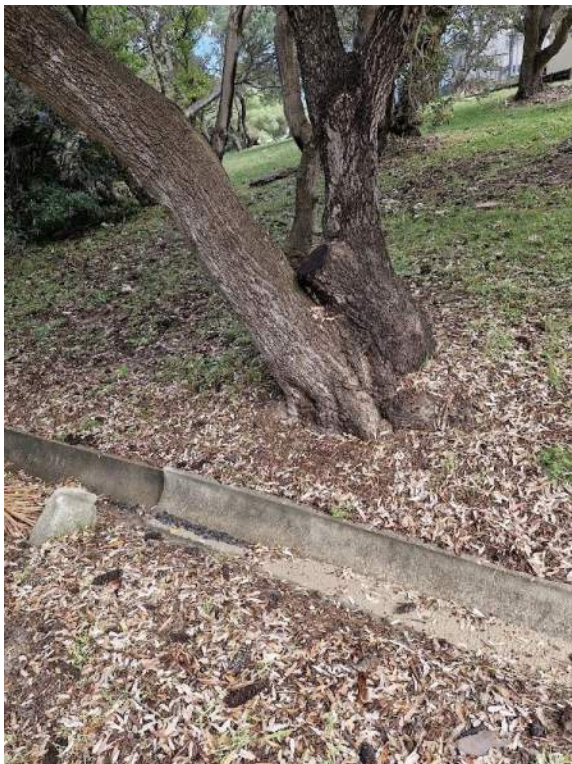
- The culvert adjacent to Tree 134 was absent of damage
- Minor displacement was noted on sections of the culvert adjacent to Trees 162, 176, 178 and 226. These sections of the culvert can likely be repaired with the trees remaining *in situ*
- A surface root from Tree 314 was observed displacing the adjacent culvert.

Figure 4: Tree 162 - Within proximity to displaced culvert

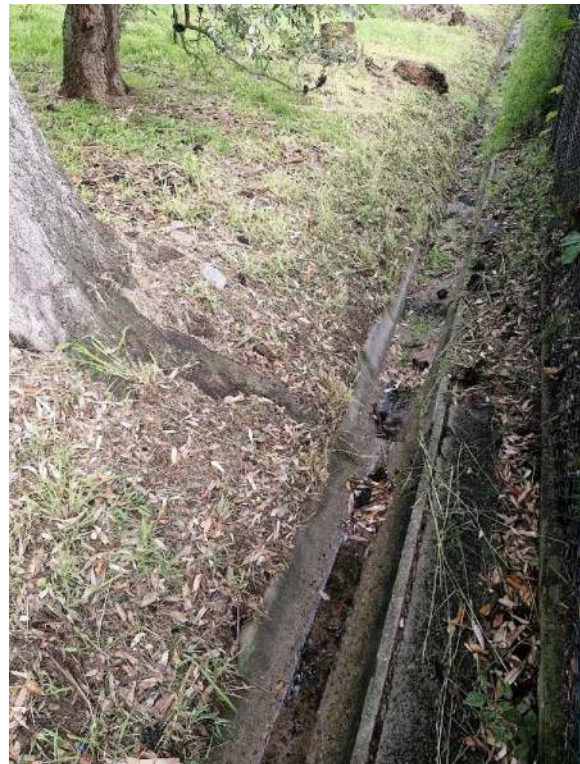
Figure 5: Tree 314 - Structural surface root displacing the adjacent culvert

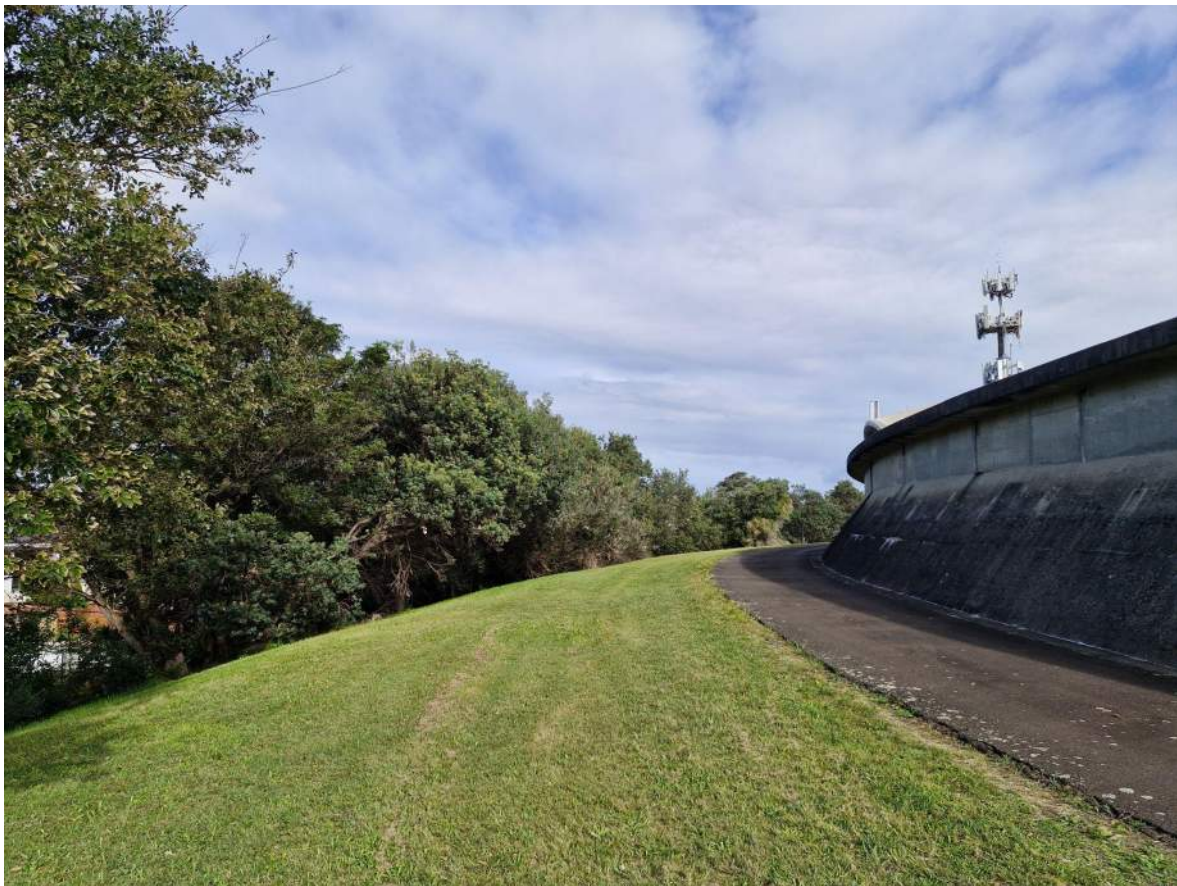
Subsequent multiple risk assessments, Sydney Water has identified specific areas surrounding the reservoir where trees and vegetation is prohibited. To remain compliant with DSC's policy concerning trees near embankment dams, a total of 127 trees located in these designated zones will need to be removed. These include Tree 169, 170, 171, 172, 173, 174, 175, 176, 177, 178, 179, 180, 181, 182, 183, 184, 185, 186, 187, 188, 189, 190, 191, 192, 193, 194, 195, 196, 197, 198, 199, 200, 201, 202, 203, 204, 205, 206, 207, 208, 2, 09, 210, 211, 212, 213, 214, 215, 216, 217, 218, 219, 220, 221, 222, 223, 224, 225, 226, 227, 228, 229, 230, 231, 232, 233, 234, 235, 236, 237, 238, 239, 240, 241, 242, 243, 244, 245, 246, 247, 248, 249, 250, 251, 252, 253, 254, 255, 256, 257, 258, 259, 260, 261, 262, 263, 264, 290, 291, 306, 309, 311, 312, 313, 314, 315, 316, 317, 318, 319, 321, 322, 323, 324, 325, 326, 345, 346, 347, 348, 349, 397, 398, 399, 400, 401, 402, 414 and 418.

Figure 6: Embankment on the eastern side of the reservoir with non-permitted vegetation (Canopy Consulting, 2024)

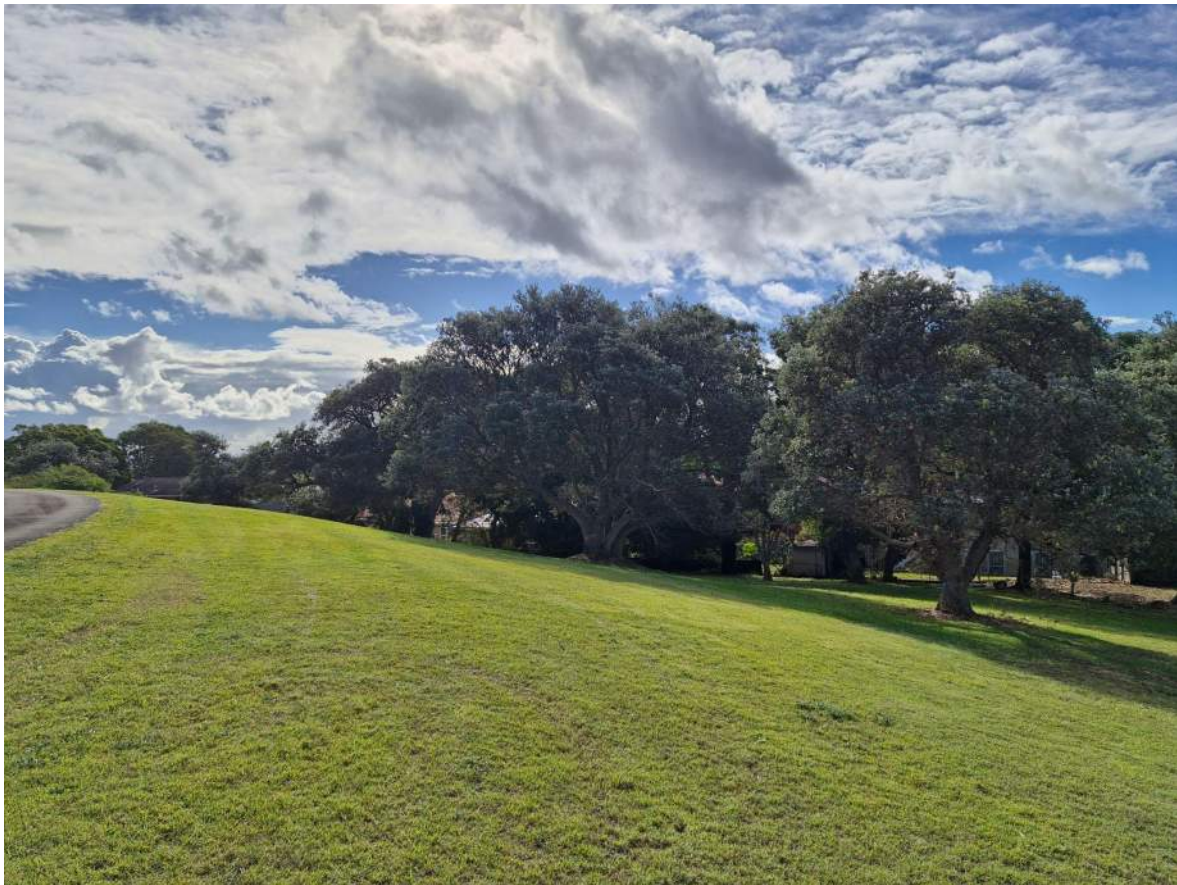
Figure 7: Embankment on the northern side of the reservoir with non-permitted vegetation (Canopy Consulting, 2024)

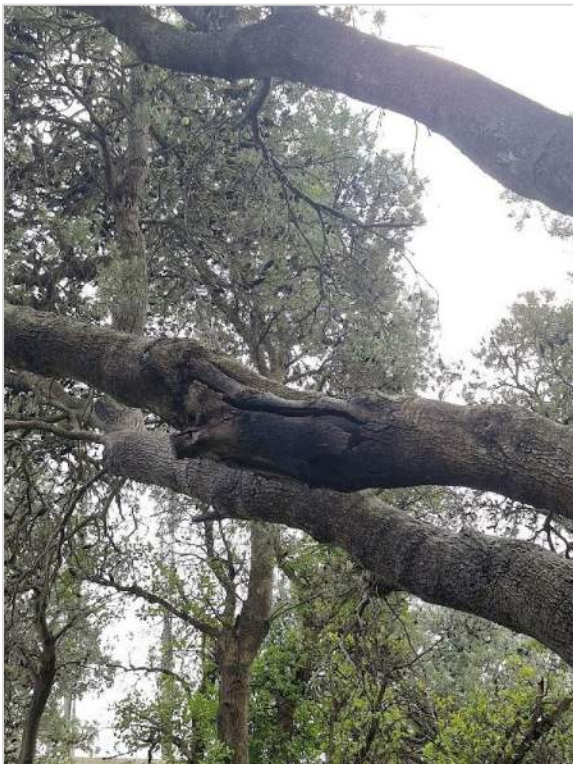
- Trees 126 and 127 were identified to have serious structural faults which have a 'probable' likelihood of failure in the short-term and are unlikely to self-optimize over the long-term. Hence, both trees have been recommended for proactive removal.
- Deadwood overhanging residential yards was identified in Trees 315 and 334. Deadwood removal is regularly included in tree maintenance, as some deadwood can be large enough to cause damage or injury. Hence, in both instances, it was recommended for removal.

Figure 8: Tree 126 - Shear crack with decay on a first-order leader (Canopy Consulting, 2024)

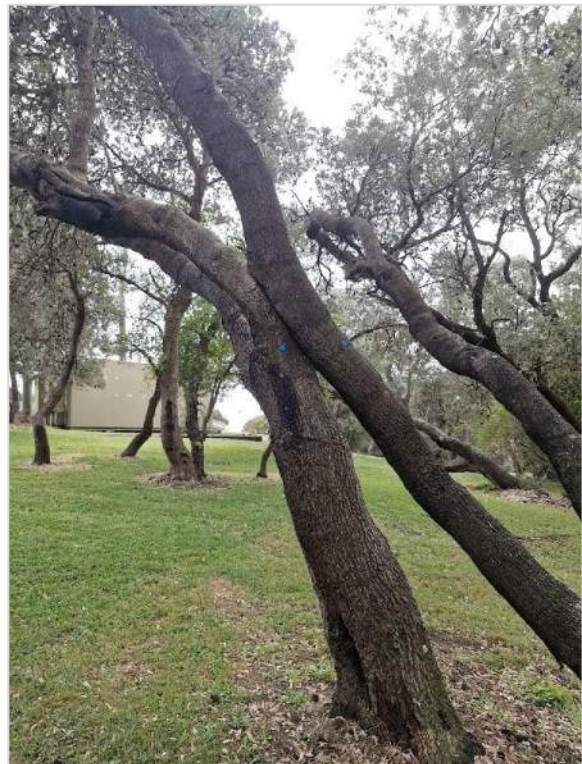
Figure 9: Tree 127 - Using the adjacent tree (Tree 126) for support. This tree is likely not self-supporting (Canopy Consulting, 2024)

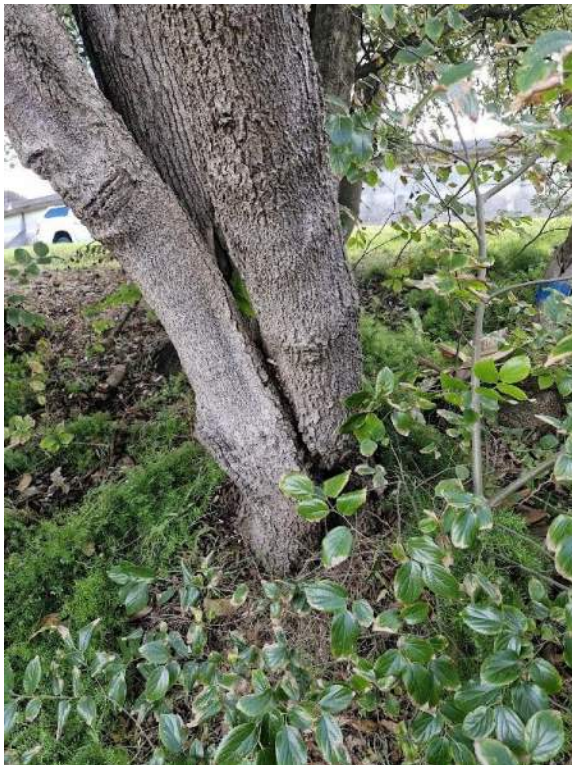
Tree 241 is a *Banksia integrifolia* located along the site's eastern boundary. This tree exhibits poor structure as it bifurcates at ground level, forming a tight ranch junction with embedded bark. Decay is also present within the junction. Additionally, long canker wounds are present on leaders within the crown. It is recommended this tree is removed.

Figure 10: Tree 241 - Included junction at base

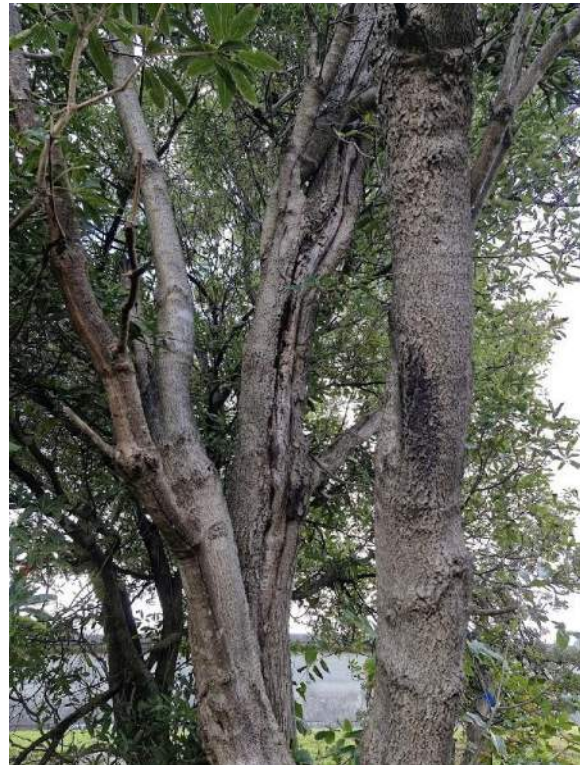
Figure 11: Canker wounds on leaders

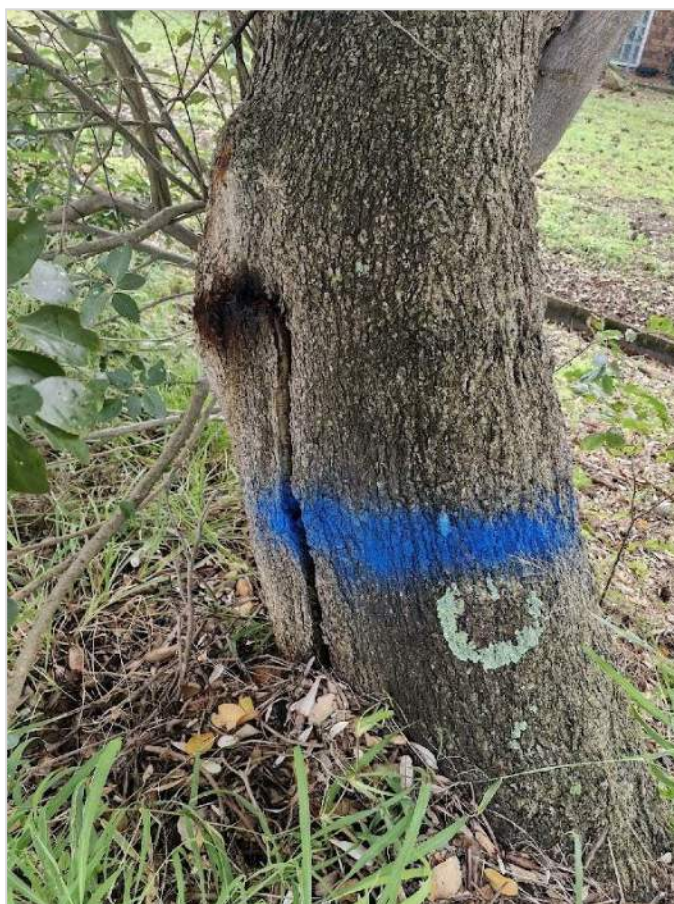
Figure 12: Tree 241 - Longitudinal and transverse crack on the tension side of the trunk
