Deep Ocean Outfalls Assessment

30 August 2025

In Compliance with Preliminary Investigation Notice
Number SR-4851

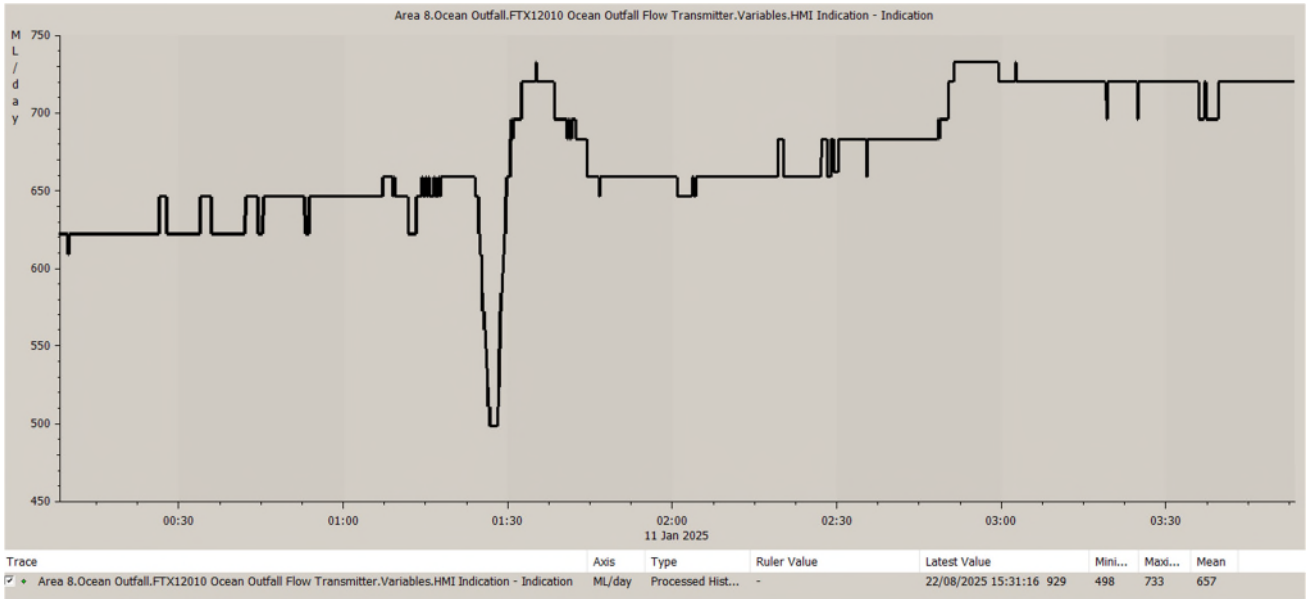
Figure 14: Flow changes on 11th January 2025

Assuming that the mechanism for entrainment of FOG and debris balls is the same as hypothesised for the October 13 event, this rapid change in instantaneous flow could also have given rise to the debris ball landings in January 2025.

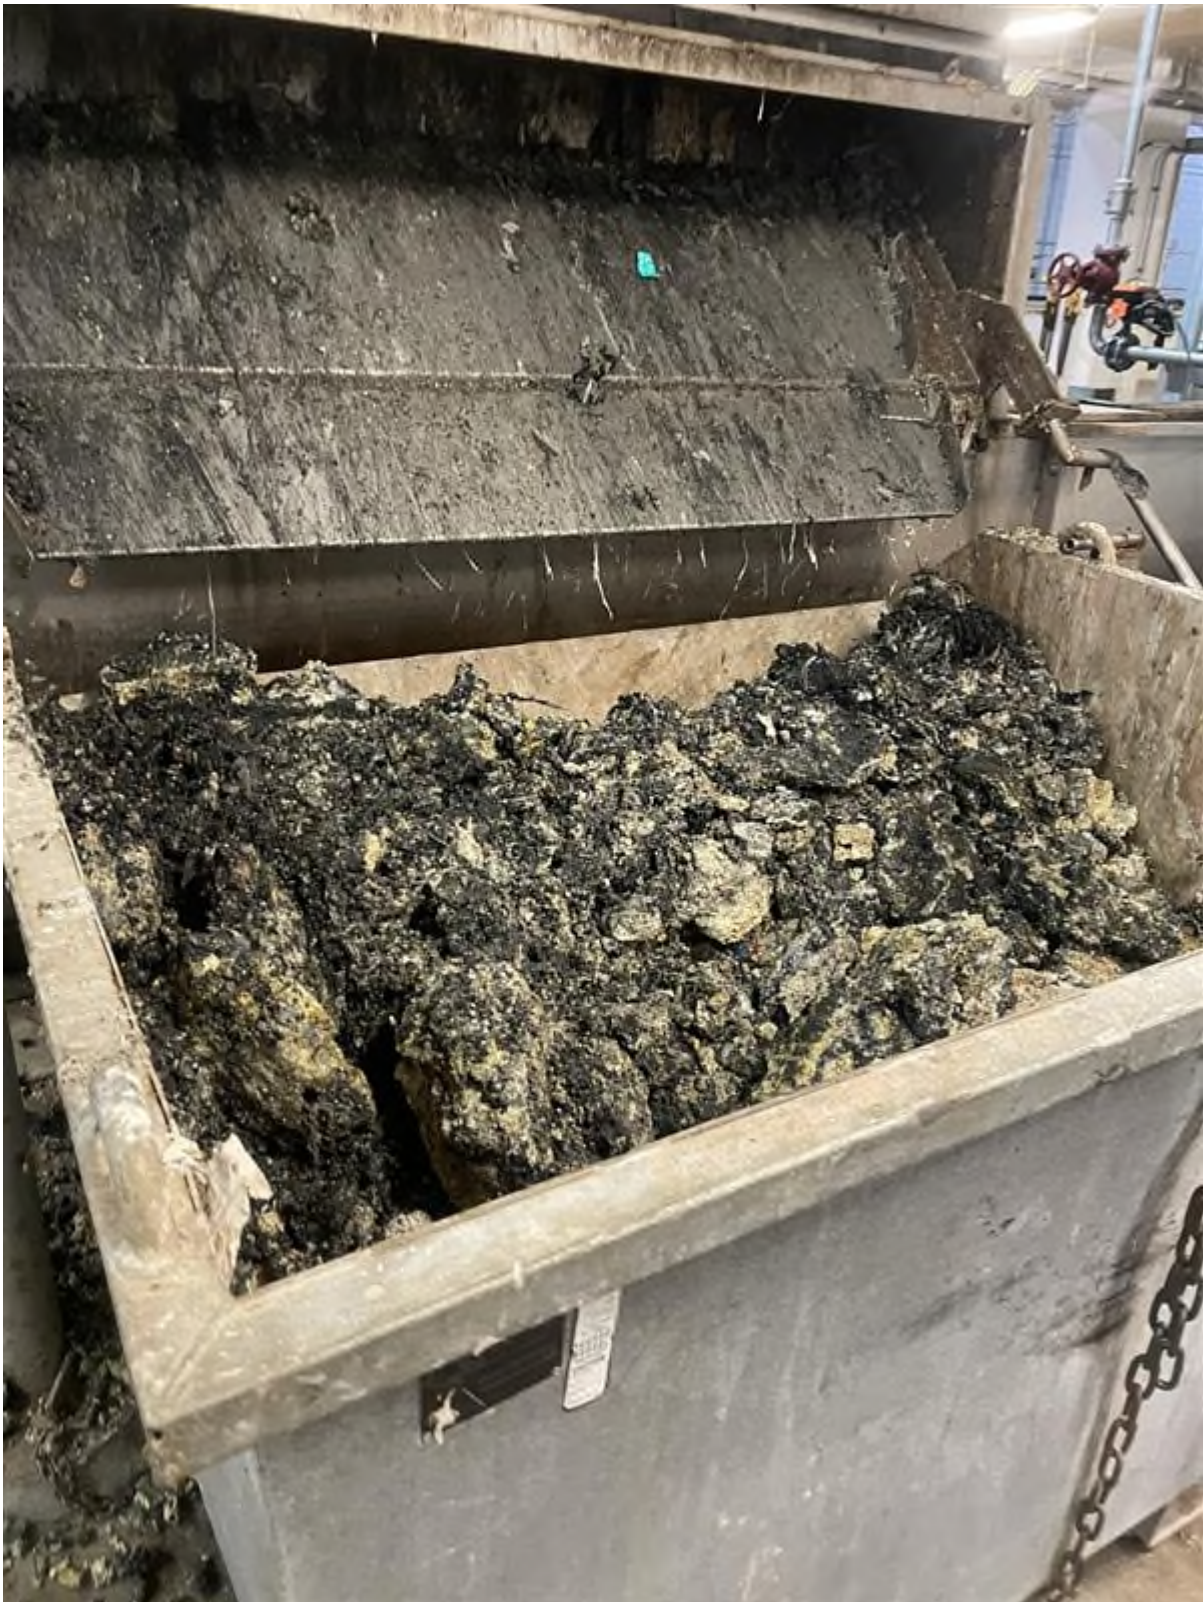
Figure 19: Bin of FOG collected from the Malabar screens during wet weather

While this hypothesis explains the proximate cause of release of debris balls or of FOG that has formed debris balls, the root cause of the build-up of FOG downstream of the PSTs is the 39% increase in FOG entering the Malabar system over the last 10 years. This is discussed further in Section 8 of this report, noting that the treatment process is currently optimised within the capability of the available assets.

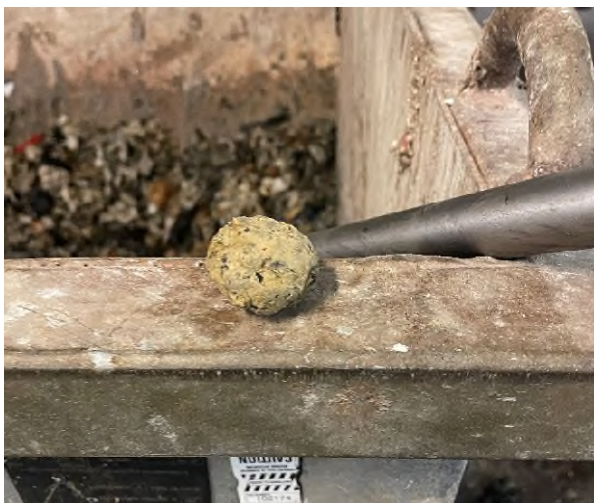
Figure 20: Example of one of several debris ball formed in the network and removed on the plant screens.

In a wet weather event at the start of August 2025, the screens also removed debris balls that had formed in the sewer network. The production team has checked the coarse screens and fine screens and confirmed that they are working as designed. The coarse screens are 10mm aperture and the fine screens are 5mm band screens.

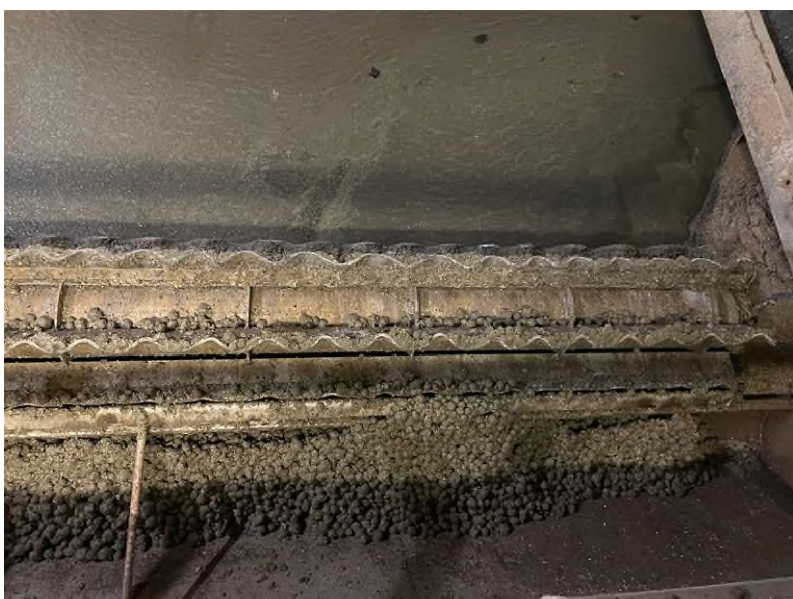
Figure 21: Debris balls captured in the scum systems of PST1 and PST2 on 1 July 2025.

On 1 July 2025, during the first East Coast low in Sydney since July 2022, the production team saw debris balls on the scum collector trough of the PSTs. This was the first time that debris balls had been seen in the plant process. These were removed from the PST.

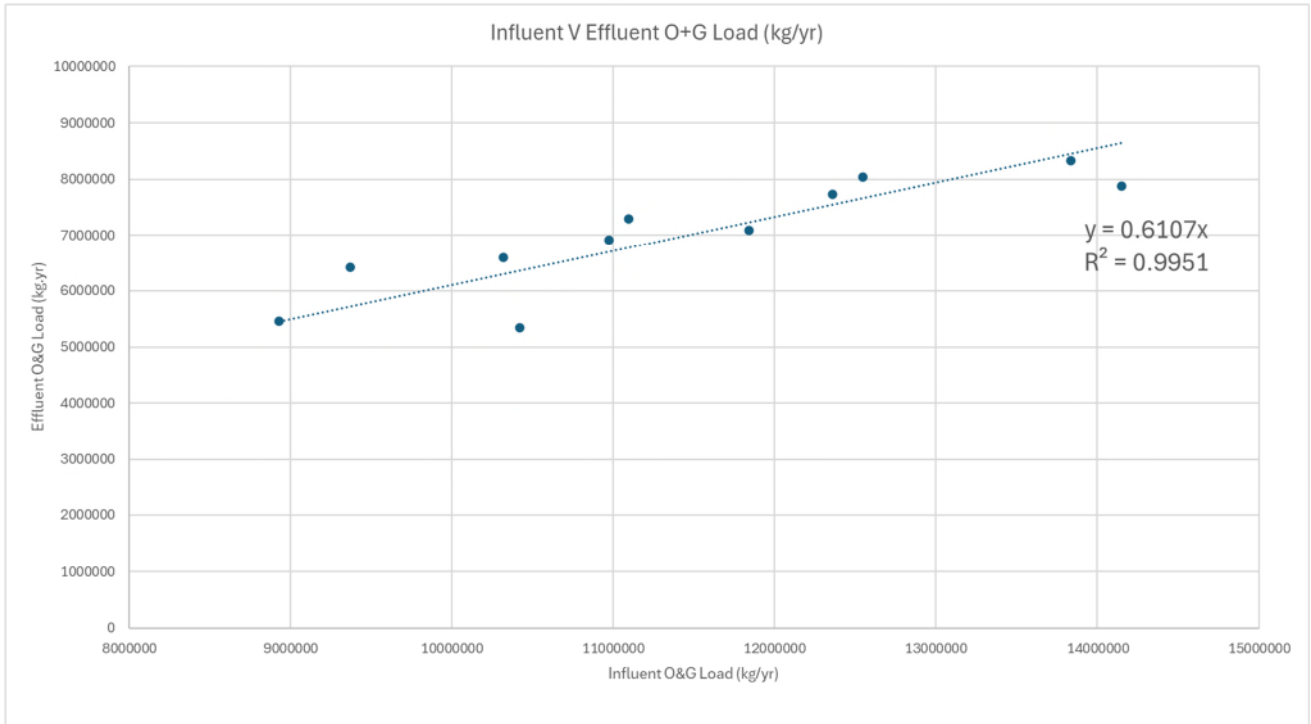
Figure 24: Influent and effluent O&G correlation for the last 10 years

Figure 24 shows the correlation for influent and effluent O&G. The R² value of 0.9951 is a near perfect linear relationship between the influent and effluent O&G loads. This indicates that the plant is consistently (strong R²) removing ~39% of load.

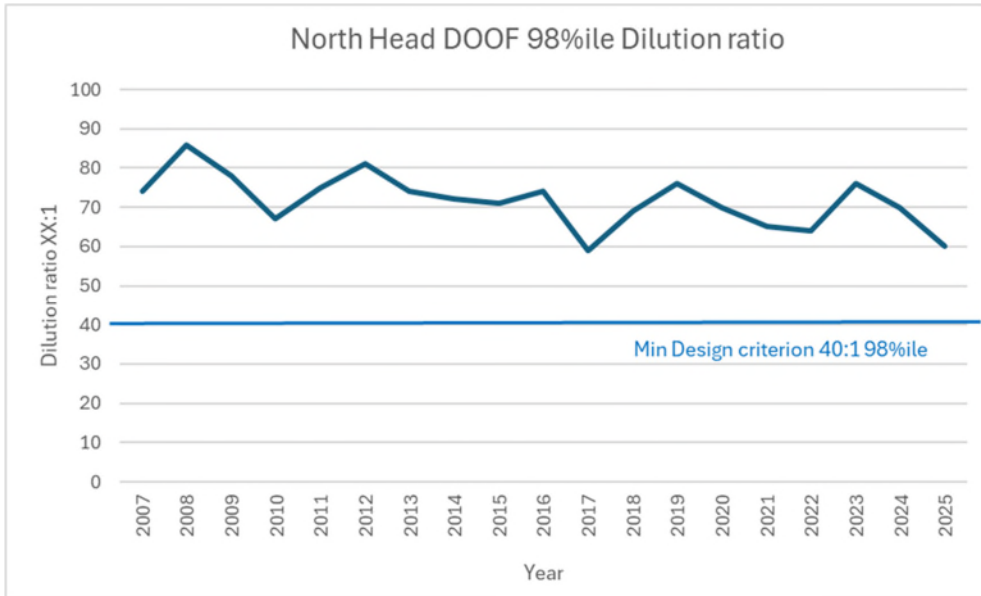
Figure 35: North Head plume dilution for the 98% of time criteria

The plume dilution should exceed the minimum design criterion of 40:1 98% of the time. The following graphs show plume dilution for 98% of the time criteria.

The way to read this graph is that in the year 2025 The North Head DOOF achieved a dilution ratio of 60:1 98% of the time, significantly exceeding the 98% design criterion of 40:1.

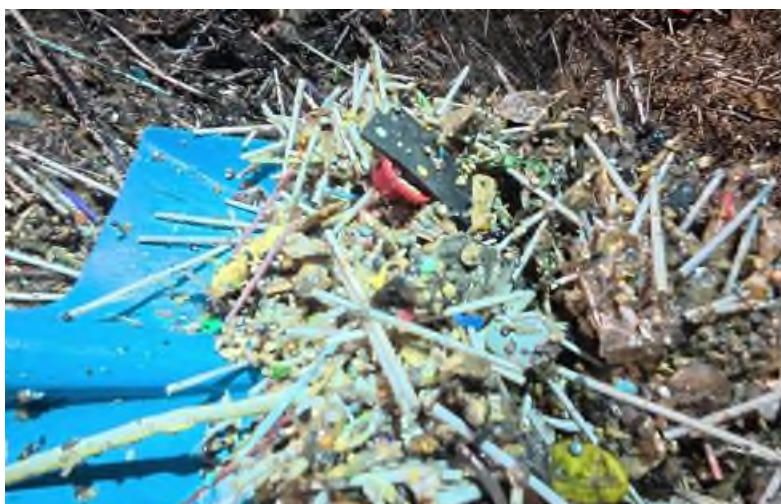
Figure 46: Material removed from behind the North Head bulkhead door

- Sydney Water’s analytical evidence identified the same chemical marker in the debris balls from the northern beaches landings as was found in the Coogee beach landings and Malabar system, matching the signature from the Malabar system, and
- the inspection and cleanout of the North Head bulkhead chamber identified screenings but not accumulated FOG and debris balls (Figure 46).

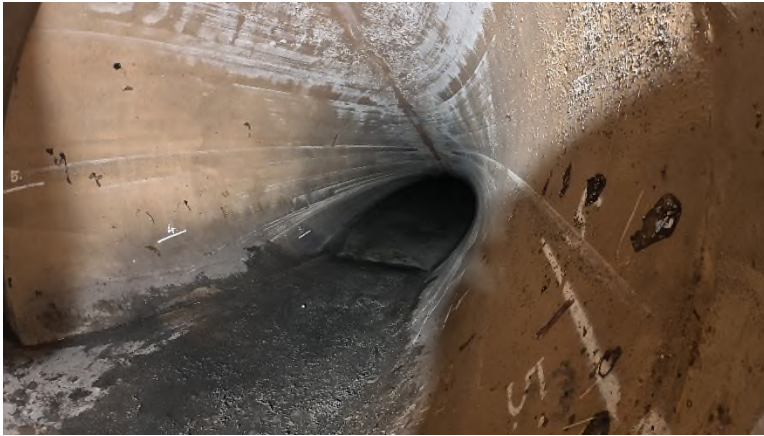
Figure 49: The decline tunnel to the North Head DOOF on the inside of the bulkhead door once cleaning had been completed

Subsequent figures illustrate some of the challenges in performing the inspections and cleaning operations within this part of the DOOF. Figure 49 shows the outcome of the cleaning of the area behind the North Head DOOF bulkhead door.
