# Sydney Water Aquatic Monitoring Program

Volume 1

Data Report 2023-24

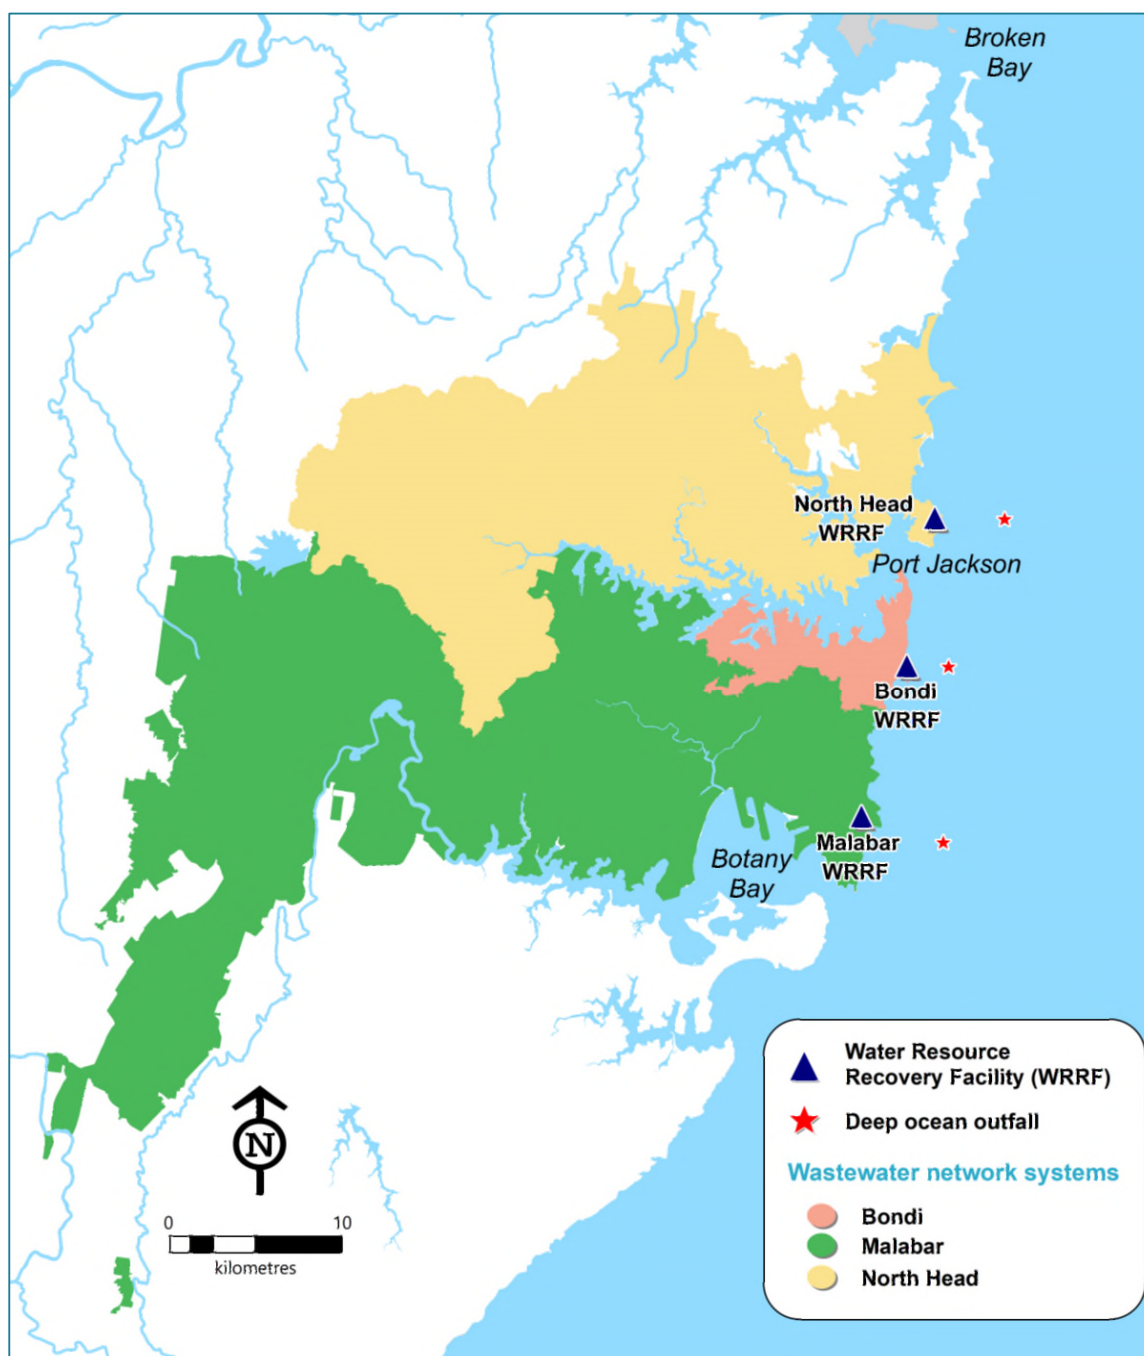
Figure 2-4 Location of WRRFs discharging to the offshore marine environment

There are three deepwater ocean outfalls that discharge primary treated wastewater (Figure 2-4). The Malabar diffuser system consists of 28 diffusers and one sludge riser approximately 25 m apart in 80 m of water. This is located approximately 3.6 km from the shore. The Bondi diffuser system consists of 26 diffusers and one sludge riser approximately 20 m apart in 60 m of water. This is located approximately 2.2 km from the shore. The North Head diffuser system consists of 36 diffusers and one sludge riser approximately 21 m apart in 60 m of water. This is located approximately 3.7 km from the shore.

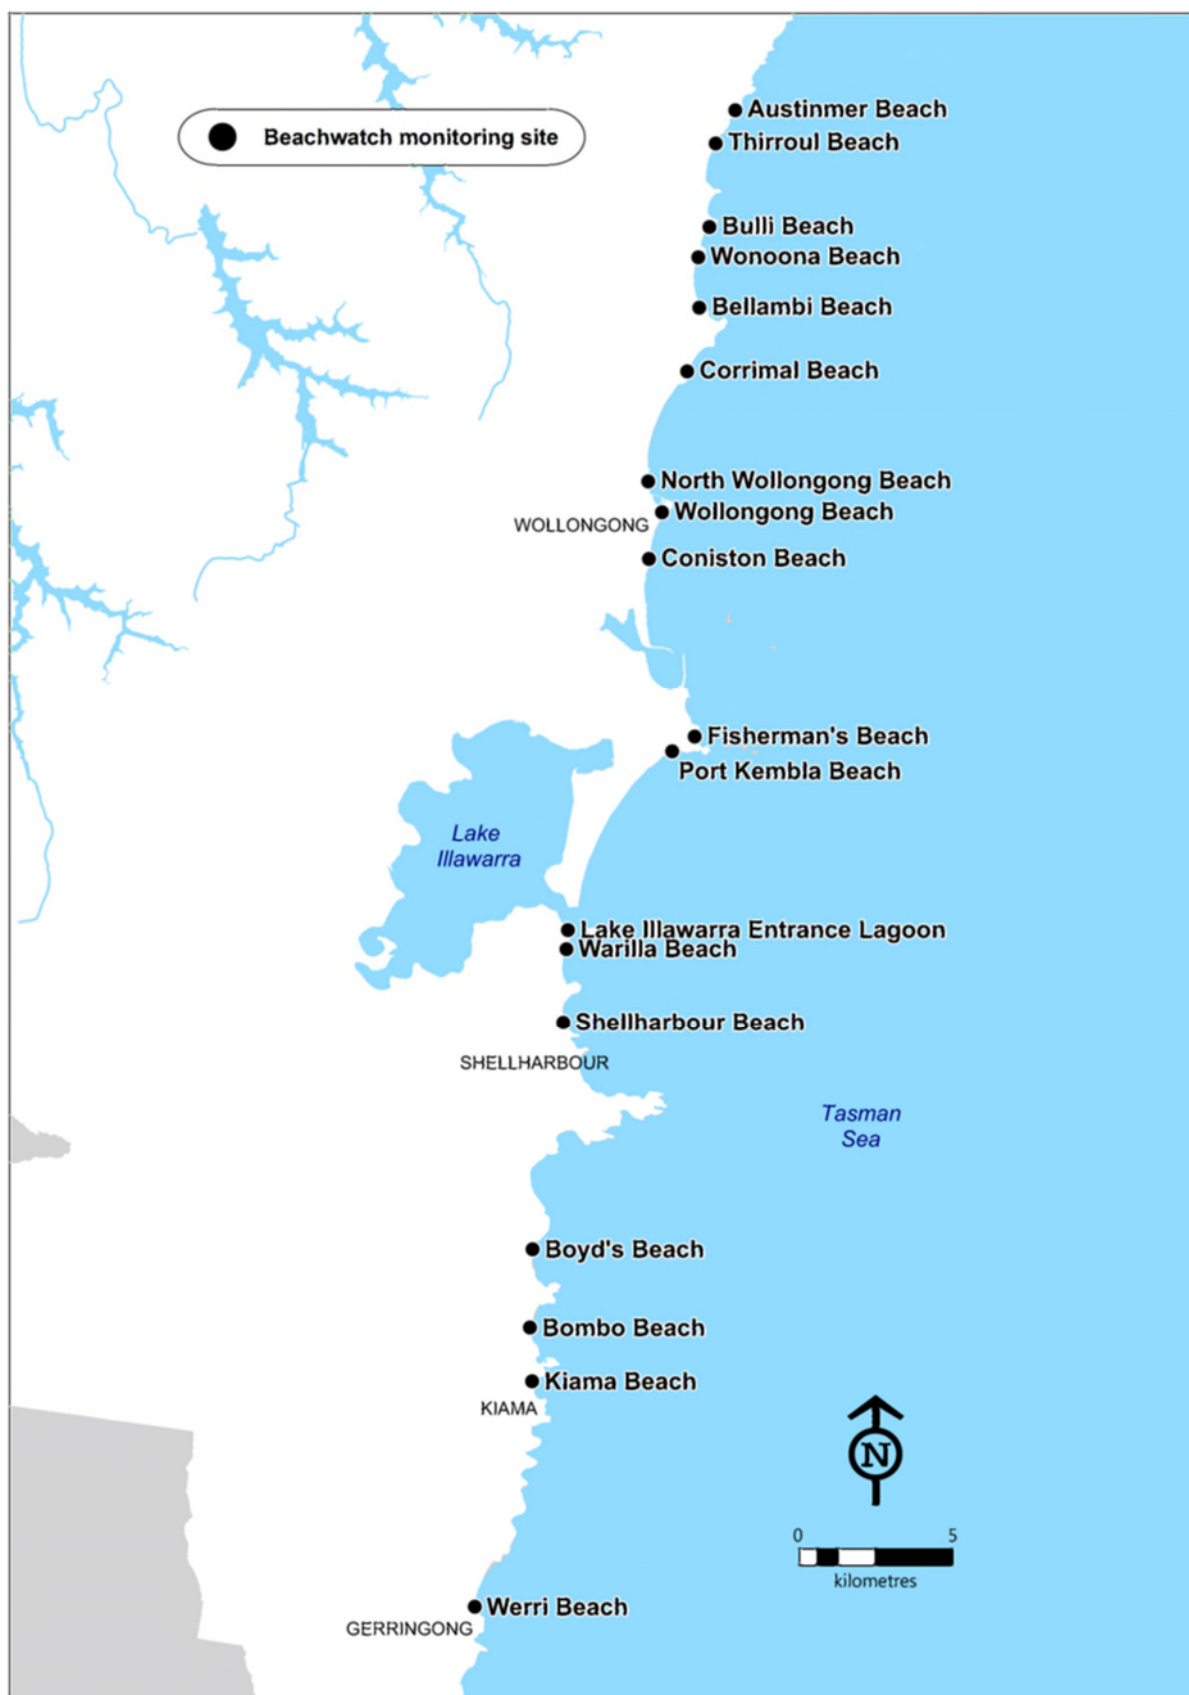
Figure 2-25 Beachwatch Illawarra coastal beach monitoring sites

Sydney and Illawarra coastal beach sites are monitored for *Enterococci* and conductivity (Table 2-26 Figure 2-25) at 6-day intervals throughout the year, except Austinmer, Thirroul and Kiama, which are only monitored from October to April. Harbour beaches are monitored for *Enterococci* and conductivity at 6-day intervals from October to April and monthly outside of this period.

*Enterococci* and conductivity data are collected predominantly by DCCEEW for the Beachwatch program. DCCEEW monitors 41 Sydney coastal beaches and 56 harbour beaches of Botany Bay, lower Georges River, Port Hacking, Port Jackson, Middle Harbour and Pittwater at locations listed in Table 2-23 and Table 2-24 as part of the Beachwatch Program. Location maps for these Beachwatch sites are provided in Figure 2-21, Figure 2-22, Figure 2-23 and Figure 2-24. Sydney Water monitors 18 Illawarra coastal beach monitoring sites on behalf of DCCEEW, although ten of these sites are also a requirement of our EPLs (Table 2-25, Figure 2-25).

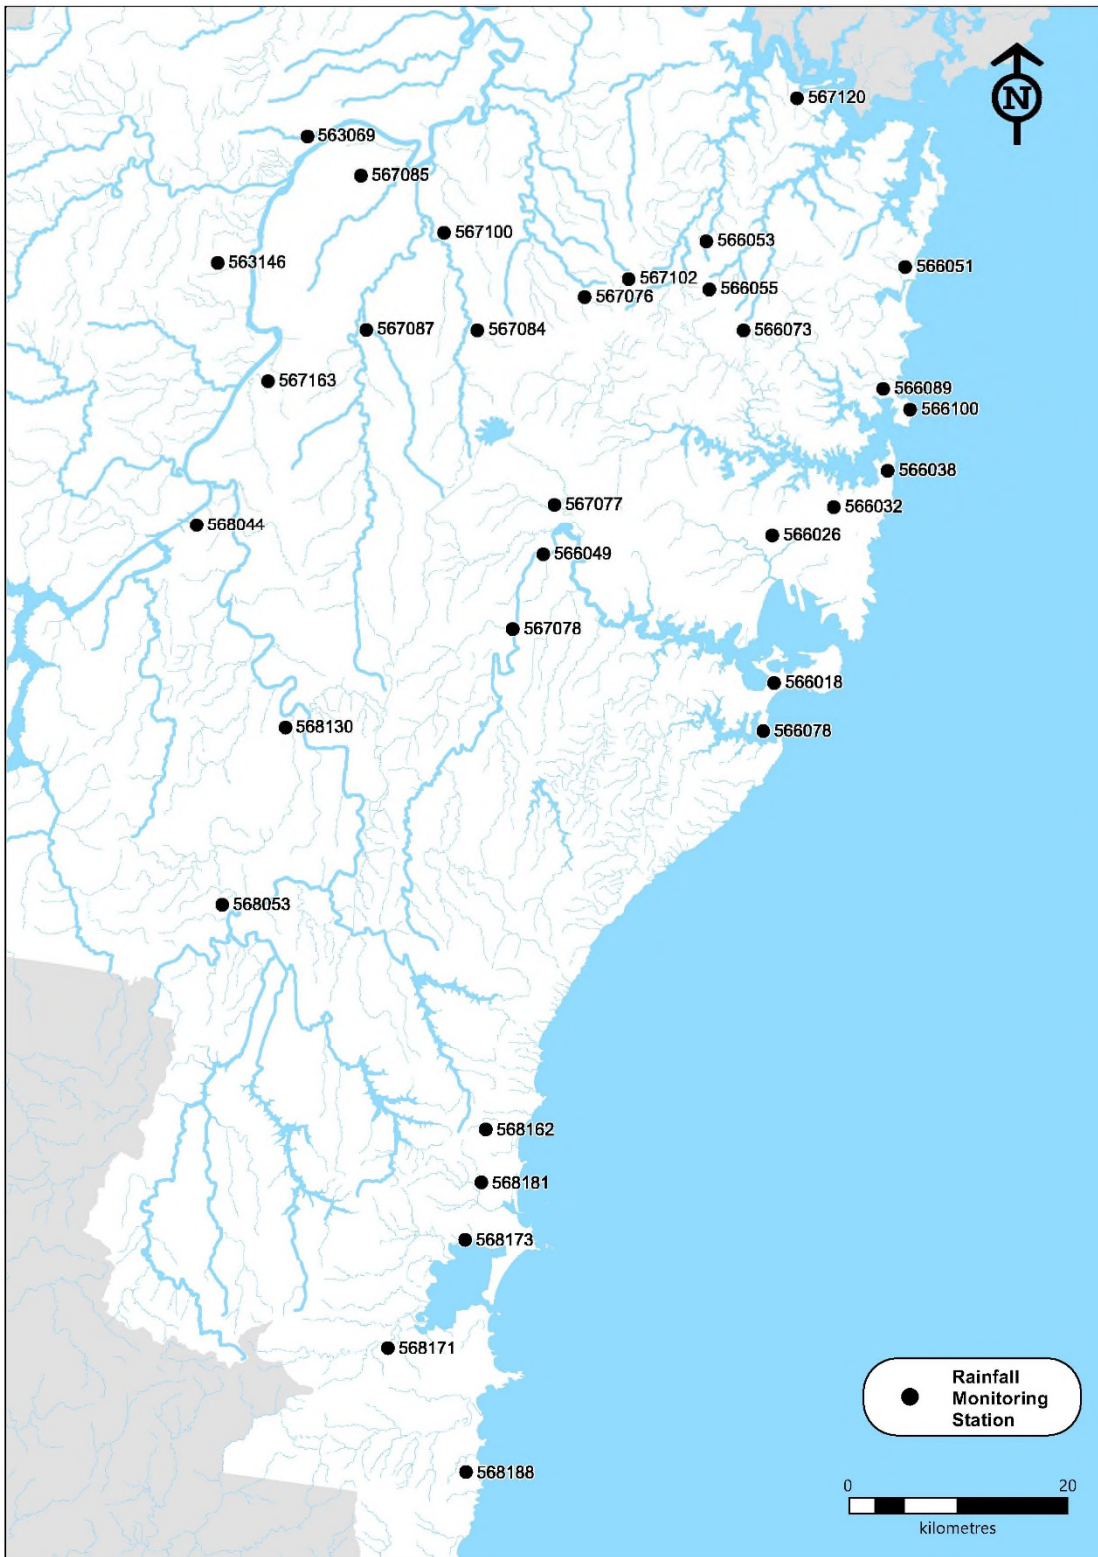
Figure 3-2 Rainfall gauging stations used for assessing the wastewater data

Daily average rainfall data from 35 gauging stations are used to generate WRRF catchment specific trends in rainfall in comparison to wastewater inflows and discharges (Table 3-2 and Figure 3-2). These data are provided as an electronic appendix (Appendix H-1).
