# Sustainable Destination Partnership - Water Efficiency Summary Report

Reference: R.S20544.011.01 - SDP Water Efficiency Summary  
Report.docx  
Date: June 2020  
Confidential

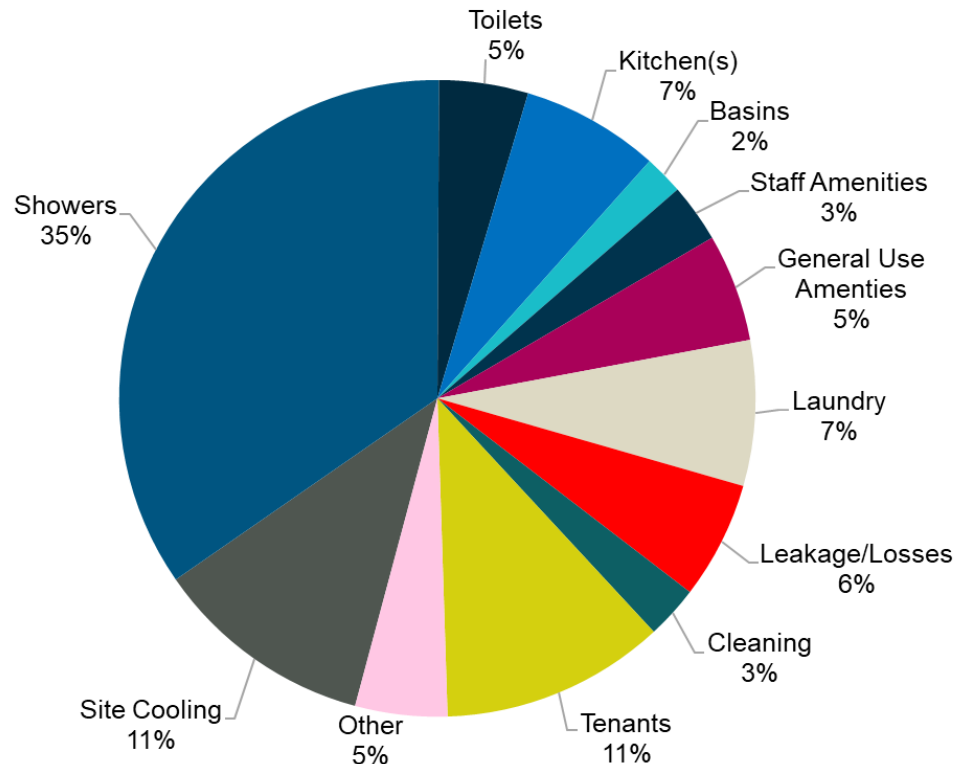
**Figure 4-1 Potable Water Use Breakup by Area/End Use (%) – Hotels**

- Showers (35%) make up the largest water usage by a significant margin. This is despite all sites having invested in showerheads with reduced flowrates, and several sites implementing best-practice flowrates of 6-7 L/min.
- Cooling towers were installed at 3 out of 4 sites and consumed an average of 11% of total site consumption.
- Leakage/losses accounted for an average 6% of total water use across all sites. These were typically attributed to toilet leaks, tank overflows and cooling tower issues. Commonly recommendations to mitigate these losses included proactive checking/site maintenance and flow monitoring (See Section 5.1).
- General use amenities (i.e. conference/common area toilets and basins) were estimated to make up 5% of total water use.
- Kitchen water use averaged 7% however savings measures were commonly found regarding cleaning and hose down practices (see Section 5.2).

- Room toilets (5%) and basins (2%) make up a small percentage of site water use. This is largely due to the significant focus placed upon replacement toilets with water efficient models (3 – 4.5L flushes) and installation of flow regulation in room and amenities basins (4 – 6 L min). Note this is not current best practice (3-4L min) however it is an improvement on no flow regulation (15 – 25 L/min).
- Tenants make up 11% of total site waster use. The tracking of tenanted areas was included as a recommendation in flow monitoring (See Section 5.1).
- For the purposes of this assessment 'Other' included end uses including general cleaning/end of trip facilities/laundry/fire testing where it was not a specific metered activity.

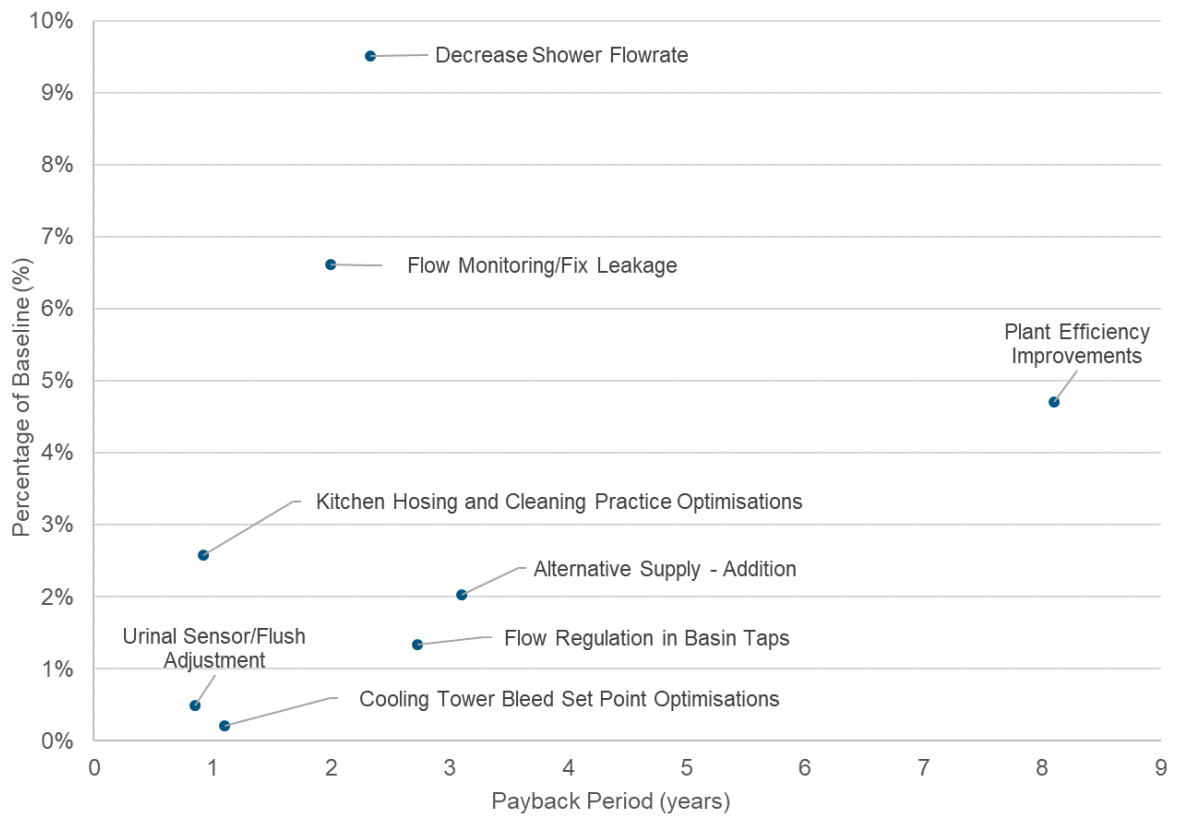
**Figure 4-2 Hotel Recommendations – Percentage of Baseline against Payback Period**

Recommendations for potential water savings opportunities for each of the four sites are summarised in Table 4-2 and Figure 4-2 including percentage of baseline saved and payback period (years). Water savings recommendations have been ordered from highest percent of baseline usage to lowest.

- Flow monitoring and provides the second highest average saving (9%) to baseline water use, with a relatively low average payback period (1.3 years). This is due to the fact that most hotel sites have a large number of water end use points, and this is almost certain to mean that over time a range of leaks and unexpected losses will occur in rooms, plant areas, pools, tanks, cooling towers, kitchens, bathrooms etc. With many of these leaks hidden and unlikely to immediately cause damage or complaints, it is necessary for there to be a dedicated means of identifying and alerting new and existing issues. Section 5.1 discusses this further.

- Plant efficiency recommendations in this case refer to laundry improvements at one site. Leakage and losses in plant areas are captured in the Flow Monitoring to Identify Leakage, losses and Optimisations

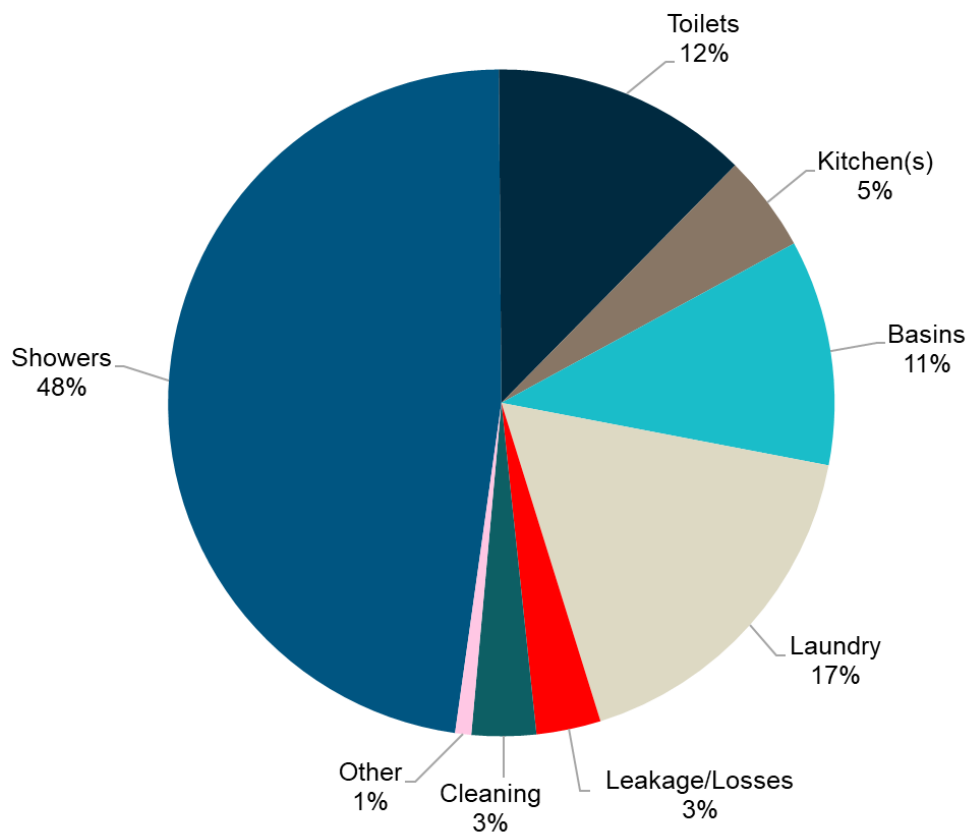
**Figure 4-3 Potable Water Use Breakup by Area/End Use (%) – Hostel**

- Showers (48%) make up the largest water usage by a significant margin.
- Leakage/losses accounted for 3% of total water use. This is considered relatively low for a site of this use – likely assisted by preventative maintenance and regular leak checking practices.
- Laundry (washing machines) account for 17% of the baseline water use, even with upgrades to best practice washing machines.
- Basins (11%) and toilets (12%) make up a similar percentage of site water use.
- For the purposes of this assessment 'Other' included end uses including water features and common area items such as coffee machines.

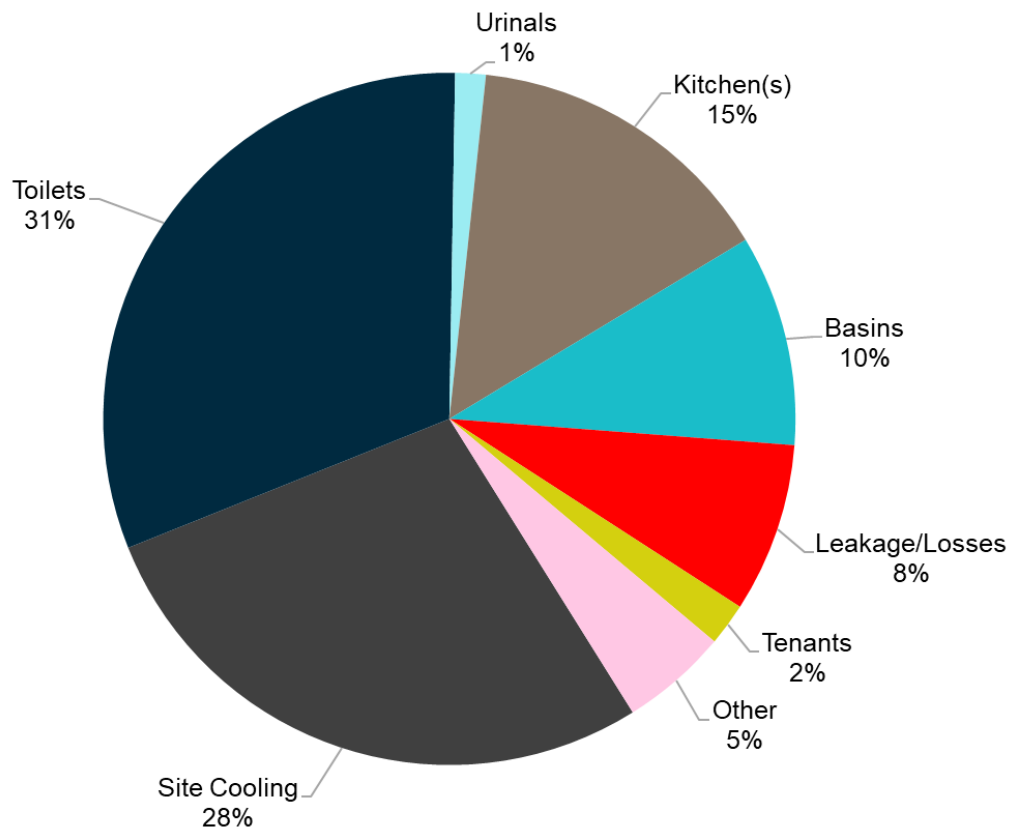
**Figure 4-4 Potable Water Use Breakup by Area/End Use (%) – Large Entertainment Venues**

A potable water use breakup is intended to represent a snapshot of current baseline use, unaffected by seasonal factors. It was developed from a combination of analysis of flow monitoring, meter reading records, site inspections and discussions with site staff. Figure 4-4 illustrates the average breakup of water use.

- Leakage/losses accounted for an average 8% of total water use. Leaks identified included toilet leaks, tank overflows, pool leaks and cooling tower losses. Common recommendations to mitigate these losses included regular tracking of submetering with flow monitoring (See Section 5.1).

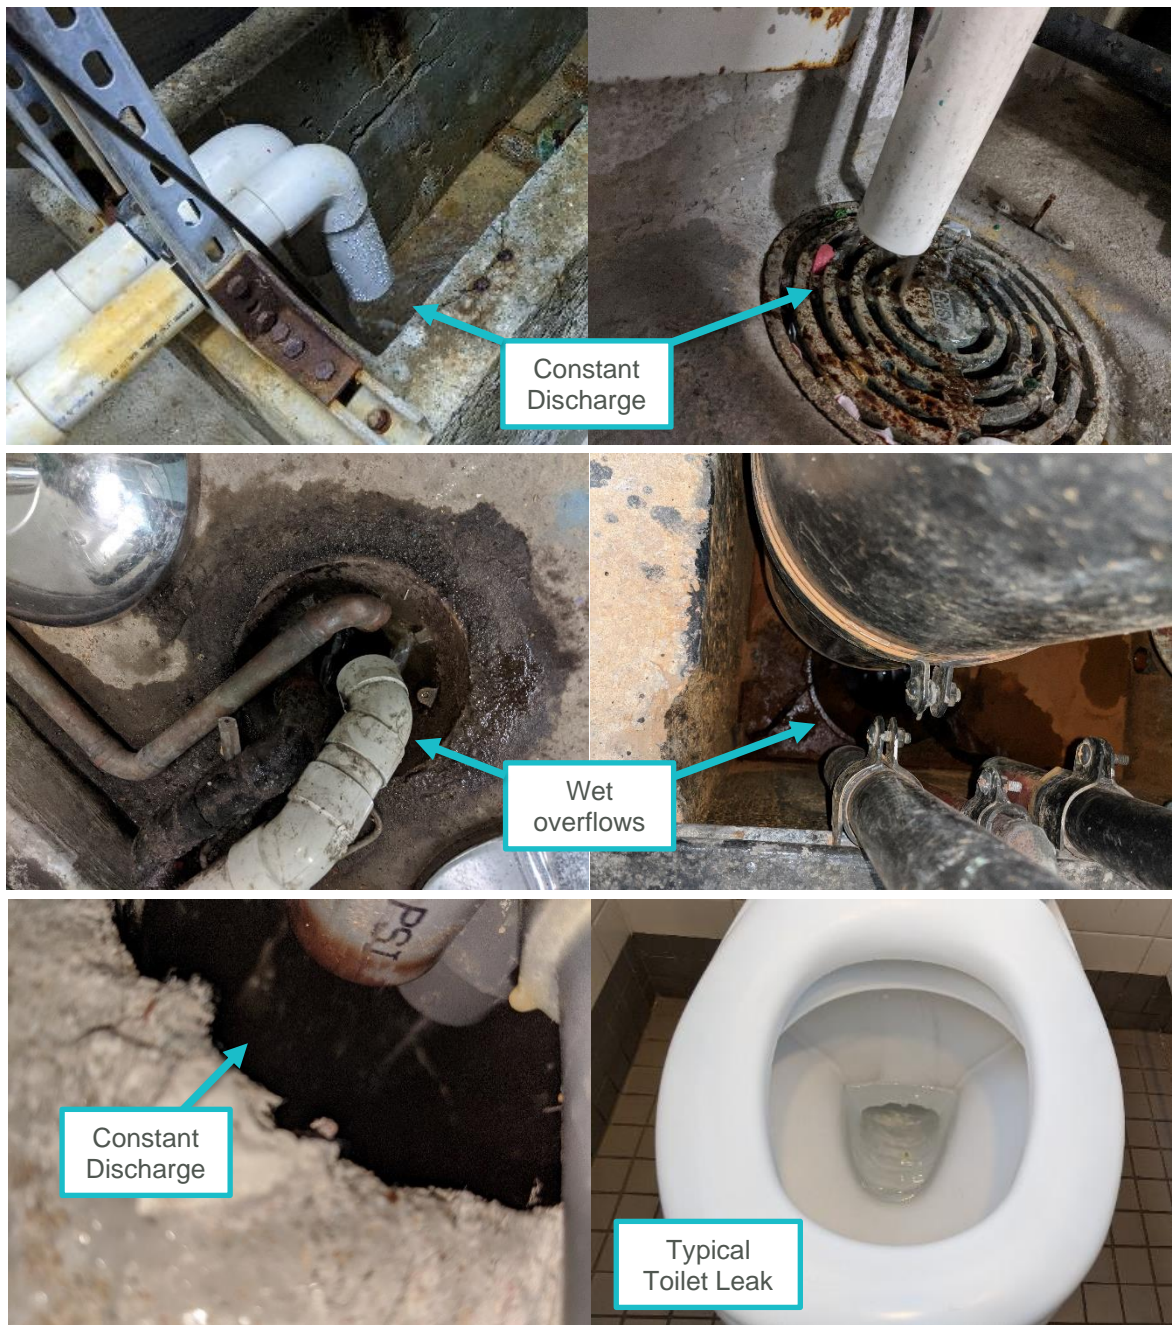
**Figure 5-2 Examples of Overflow, Leaks and Losses**

Examples of issues observed (Figure 5-2) that could be highlighted with flow monitoring include:

- Constant discharge from the pool filters to drain as a result of a failed valve.
- Constant discharge to drain linked to constant pool top up, with water constantly overflowing the overflow drainage along the perimeter of the pool.
- Intermittent or constant tank overflows – common with wearing float valves or pressure imbalances.
- Cooling tower losses via overflow or other leaks.
- Excessive kitchen washdown consumption, leakage or equipment malfunction.
- Hot/cold water cross connections.
- Unreported bathroom leakage – especially toilet leaks.
- Excessive water feature top-up.
- Uncertainty about water supply to public spaces.

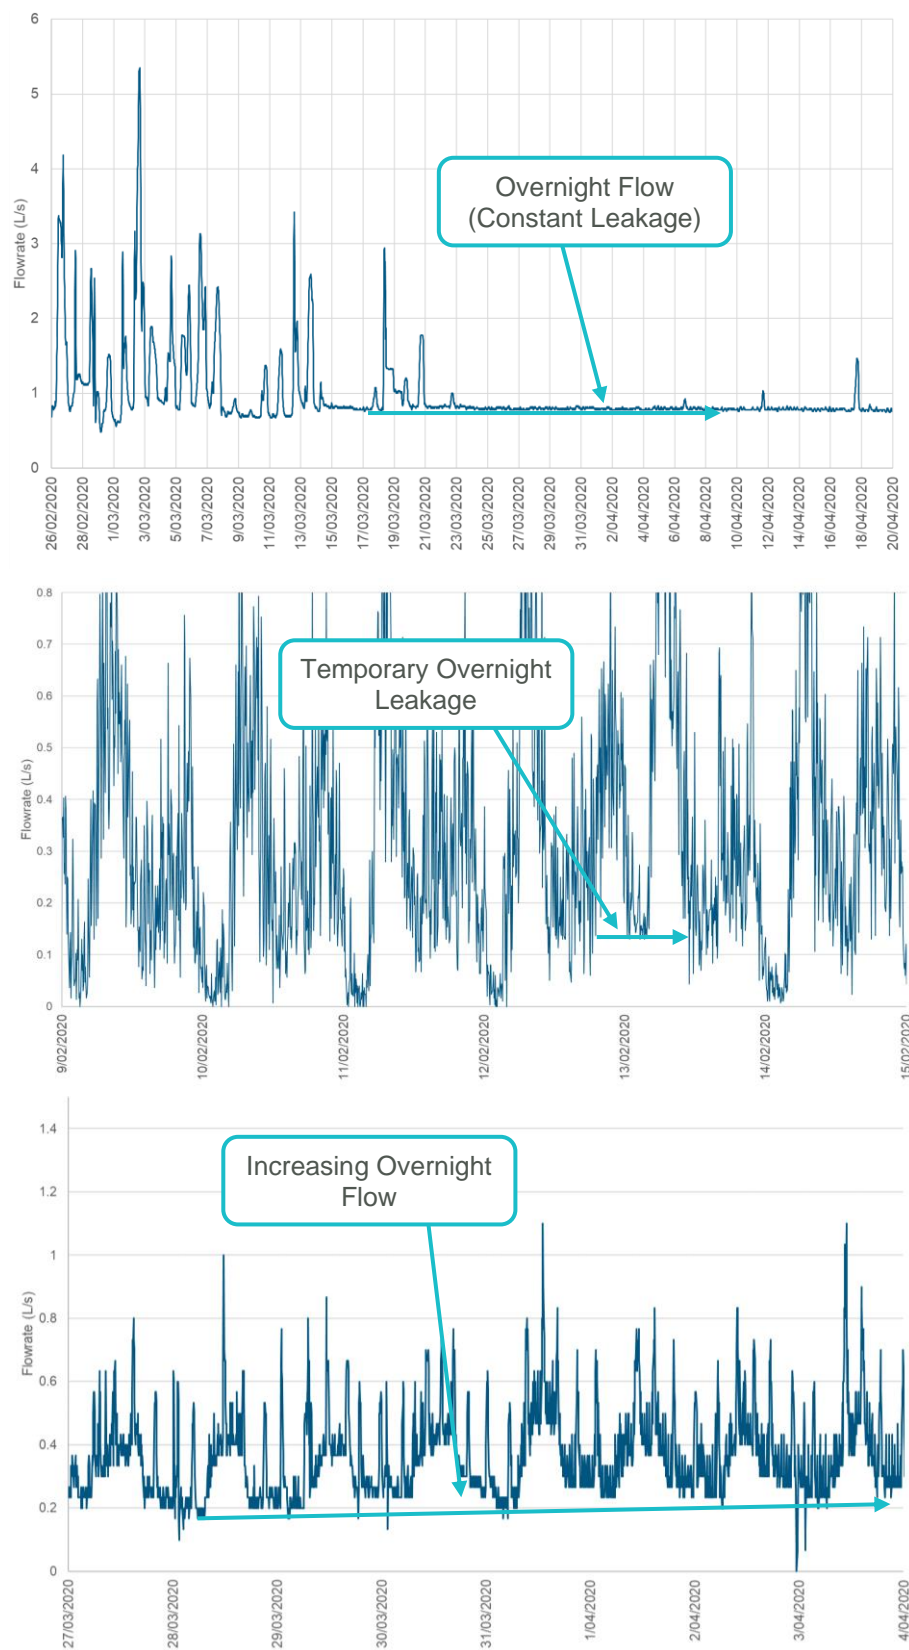
Figure 5-3 Examples of Flow Tracking Identifying Leakage/Losses

The regular review of sub meter flow data can help highlight these anomalies, many of which would be difficult or impossible to track without this additional information. Examples of flow data graphs are shown in (Figure 5-3).

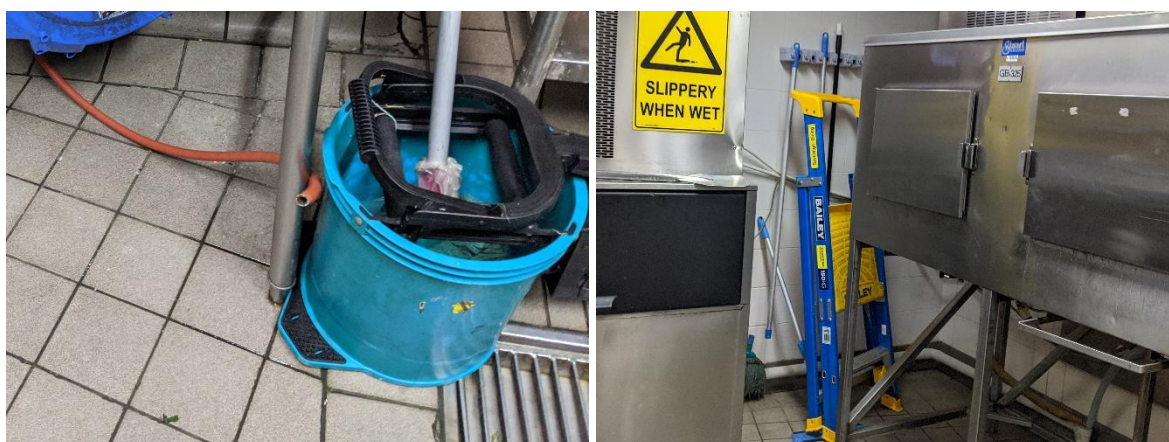
Figure 5-5 Examples of Buckets, Squeegees and Mops Observed

**Bucket cleaning** methods for different floor types typically include:

- Tiled floor: a broom to sweep up material followed by a mop and squeegee. This typically involves a mop with cleaning chemicals and a hot water cleaning mop to follow.
- Epoxy floor: a broom followed by an application of floor cleaning chemical and water which is then scrubbed with a stiff broom. Clean water is then applied followed by a squeegee to dry the floor. Typically, water is placed on the floor using a bucket rather than a hose. This assists with reaching dirt and grime from hard to reach places such as under benchtops.

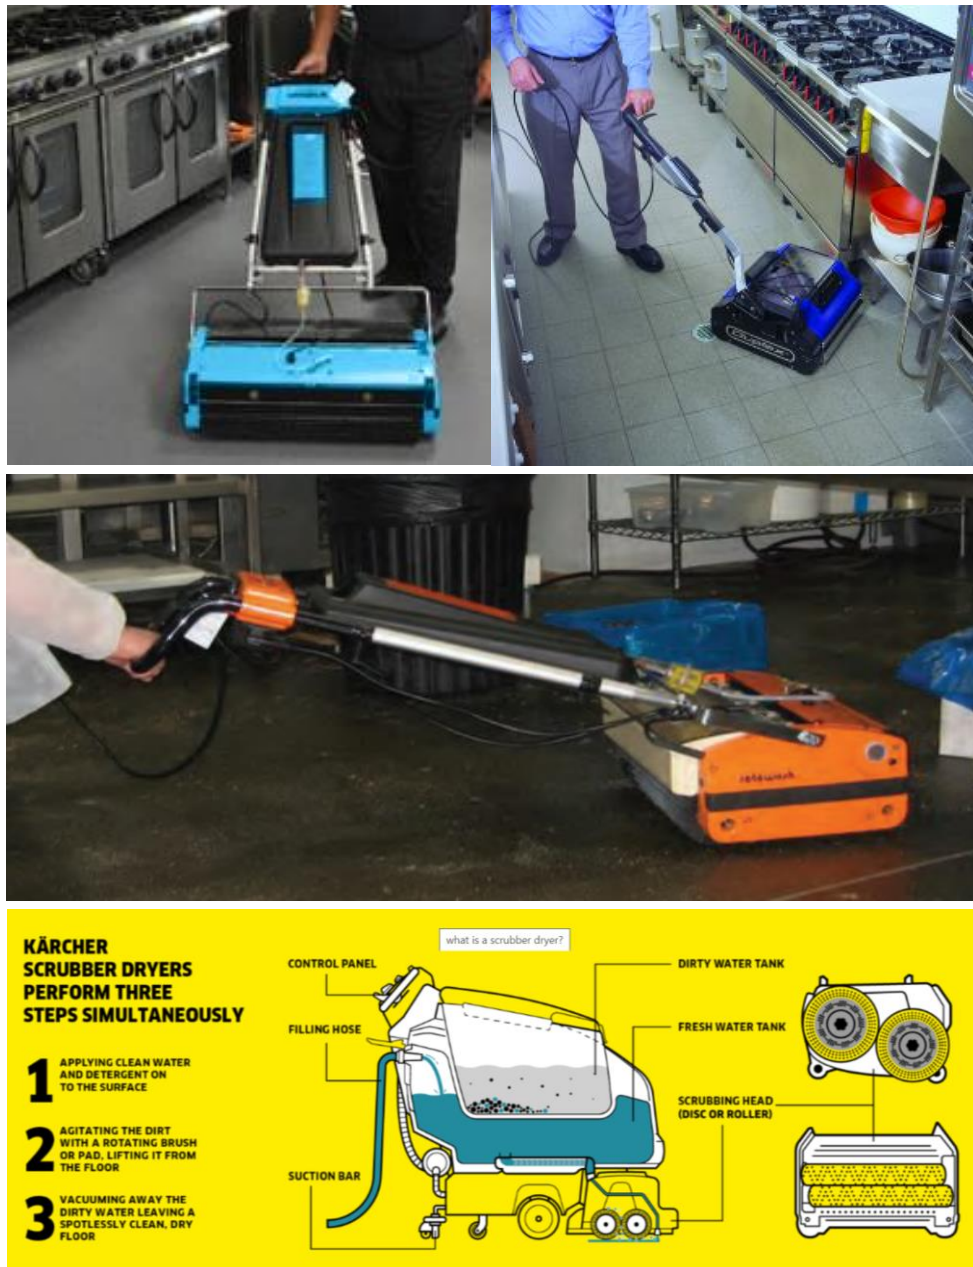
Figure 5-6 Examples of Kitchen Floor Scrubbers <sup>5,6</sup>

These have different specifications and can suit a wide range of kitchen conditions, and water use is optimised and very low.

Barriers to the wide use of scrubbers include high cost (compared to hosing fixtures), ability to access tight spaces, and perceptions of potential damage to the kitchen fixtures from impacts – especially to pipework and cabling. A manager from the SDP mentioned that floor scrubbers could be problematic to get into tight spaces and under benches, and potentially cause damage pipework and cabling that are close to the floor.

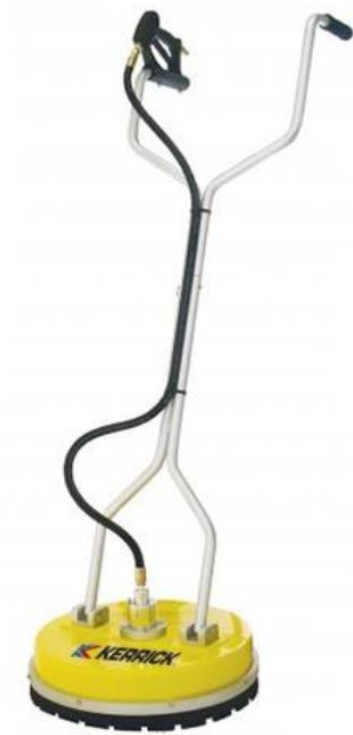
Figure 5-7 Pressure Cleaner with Rotary Head<sup>7</sup>

**Pressure cleaning with a rotary head** combines high pressure water spray and rotary scrubbing. The cleaning disk sucks to the floor via a vacuum hose, and therefore confines the water spray inside the disk with little splash outside (Figure 5-7) – an advantage over typical pressure washing guns.

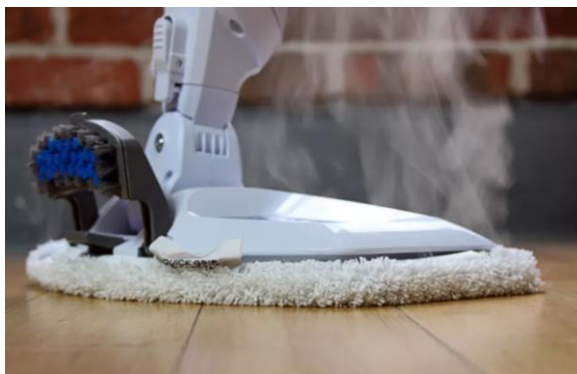
Figure 5-8 Steam Mop

**Steam cleaning** uses a jet of steam through a jet or a mop pad (Figure 5-8) to loosen dirt off the floor with heat and minimal water. This provides an option for chemical-free sanitising and is highly effective on grease.

It is not suitable for unsealed floors, or floorings that are sensitive to hot water, and adhesive tiles with lifting corners due to the high temperature of the steam.

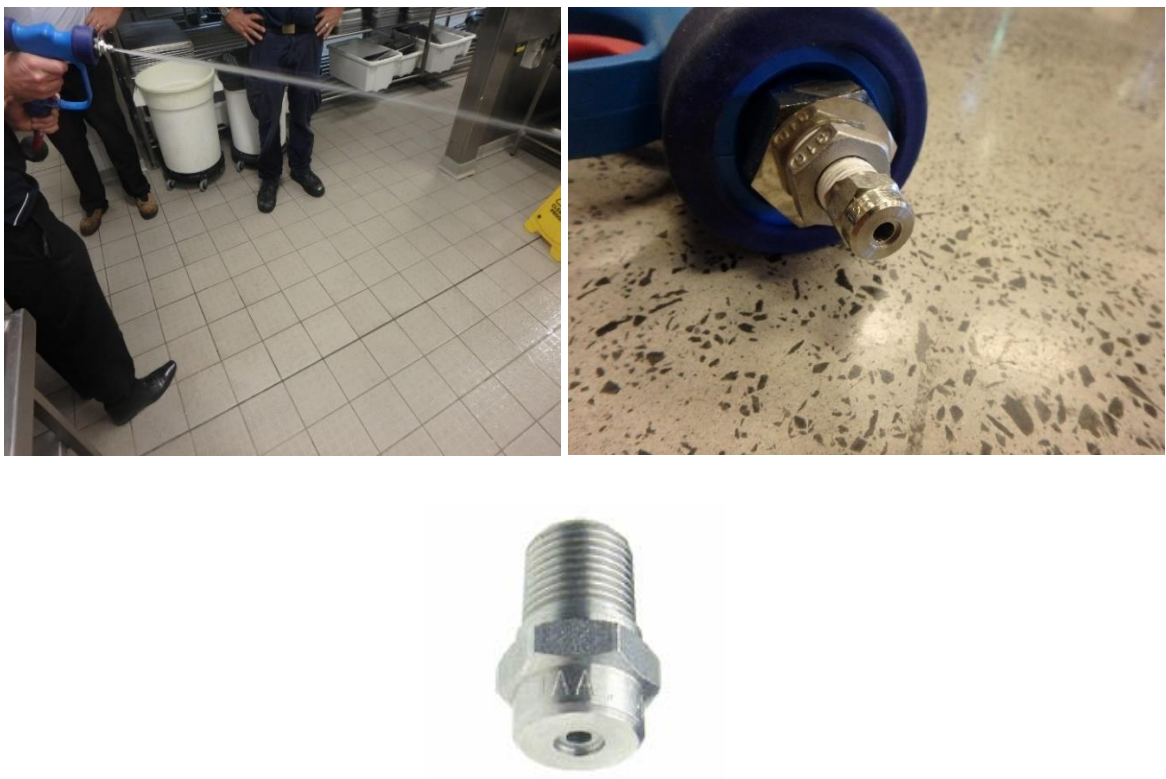
Figure 5-9 Threaded Washdown Gun and Solid Jet Nozzle Installed in Another Kitchen

Commercial grade spray guns can be ordered with a standard threaded fitting on the outlet that is designed to take a water jet nozzle (Figure 5-9). An ideal 'solid jet' nozzle can be selected from on-site testing to provide the optimum balance of spray force and flowrate for the kitchen space.

This has been found in many applications to reduce hosing time even at a lower flowrate due to the much higher effectiveness of the tighter stream.

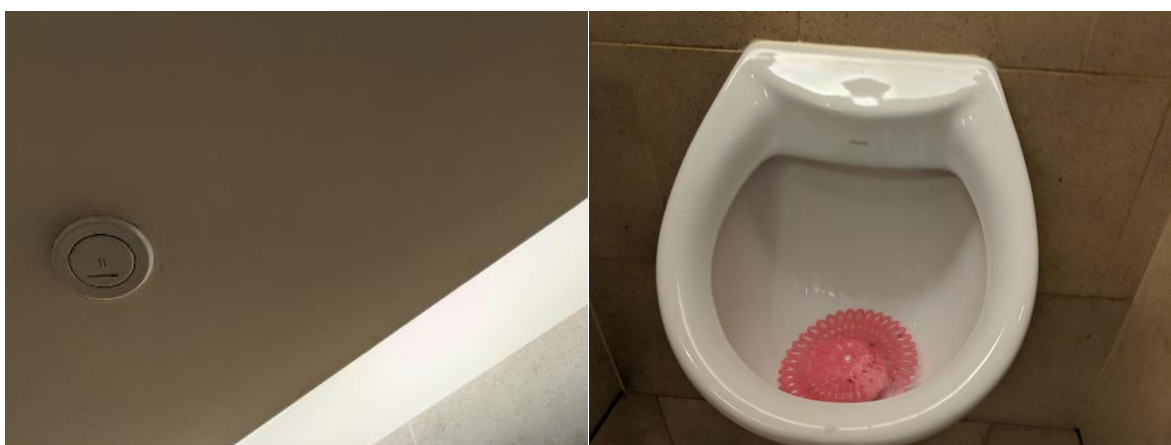
**Figure 5-11 Example of Misaligned Urinal Sensor**

Misaligned sensors cause the urinal to flush more frequently than necessary, as they are triggered as people walk past rather than only being triggered by those who walk up to the stalls. Typically, most sensors are set up to have the sensor 'slots' to run parallel to the urinal wall, however some sites were found to have sensors aligned in a way that is being triggered by anyone walking past - causing unnecessary flushes (Figure 5-11).

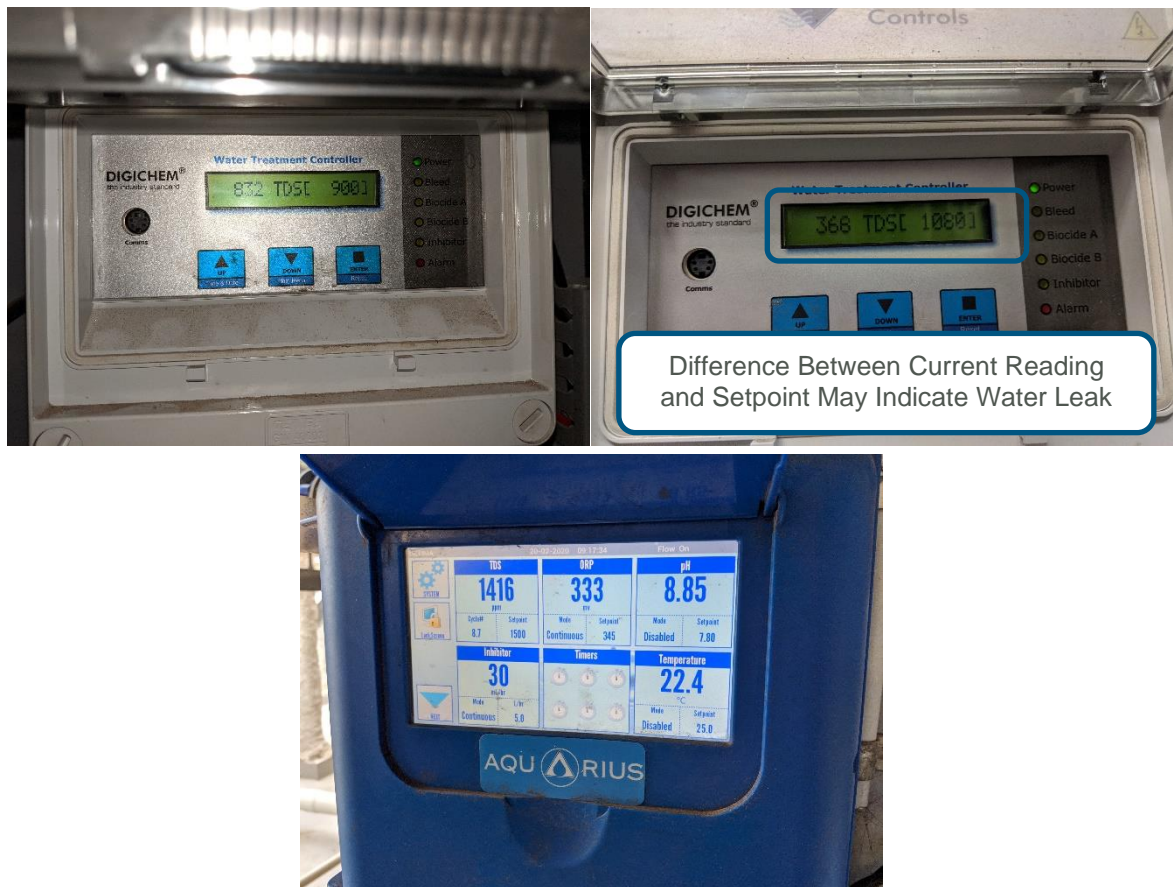
Figure 5-13 Examples of Cooling Tower Control Panels

For sites with a lower setpoint than this it was recommended that a change to the bleed set point be discussed with the site cooling tower contractors to determine if this change would be suitable with current dosing chemical parameters.

Where a low conductivity (for example less than 70% of the bleed setpoint) is observed, this is likely an indicator that there is leakage occurring from the system – and it is recommended that overflow and drain points be checked for unintentional flow.

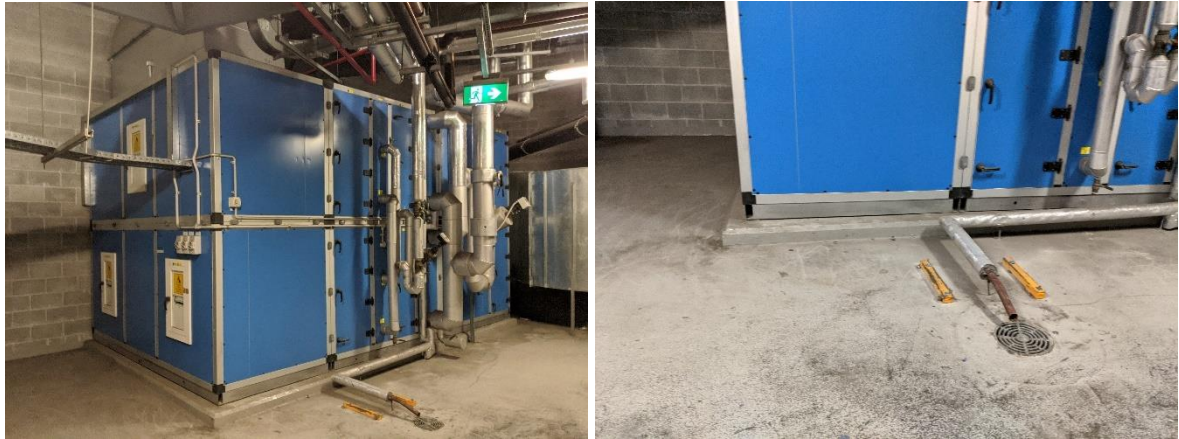
**Figure 5-14 Air Handling Unit Condensate Drain Lines**

Each of the air handling units in an air conditioning system produces an (unknown but potentially significant) quantity of condensate water as moisture from the air. This is generally very clean water that has condensed out of the air onto the coils as the humidity is reduced, and normally drains to sewer as shown in Figure 5-14.

This water could be used for toilet or urinal flushing or even irrigation or cooling tower makeup.
