# Flooding, Ecohydrology and Geomorphology Assessment

Northwest Treatment Hub Review of  
Environmental Factors Report Addendum

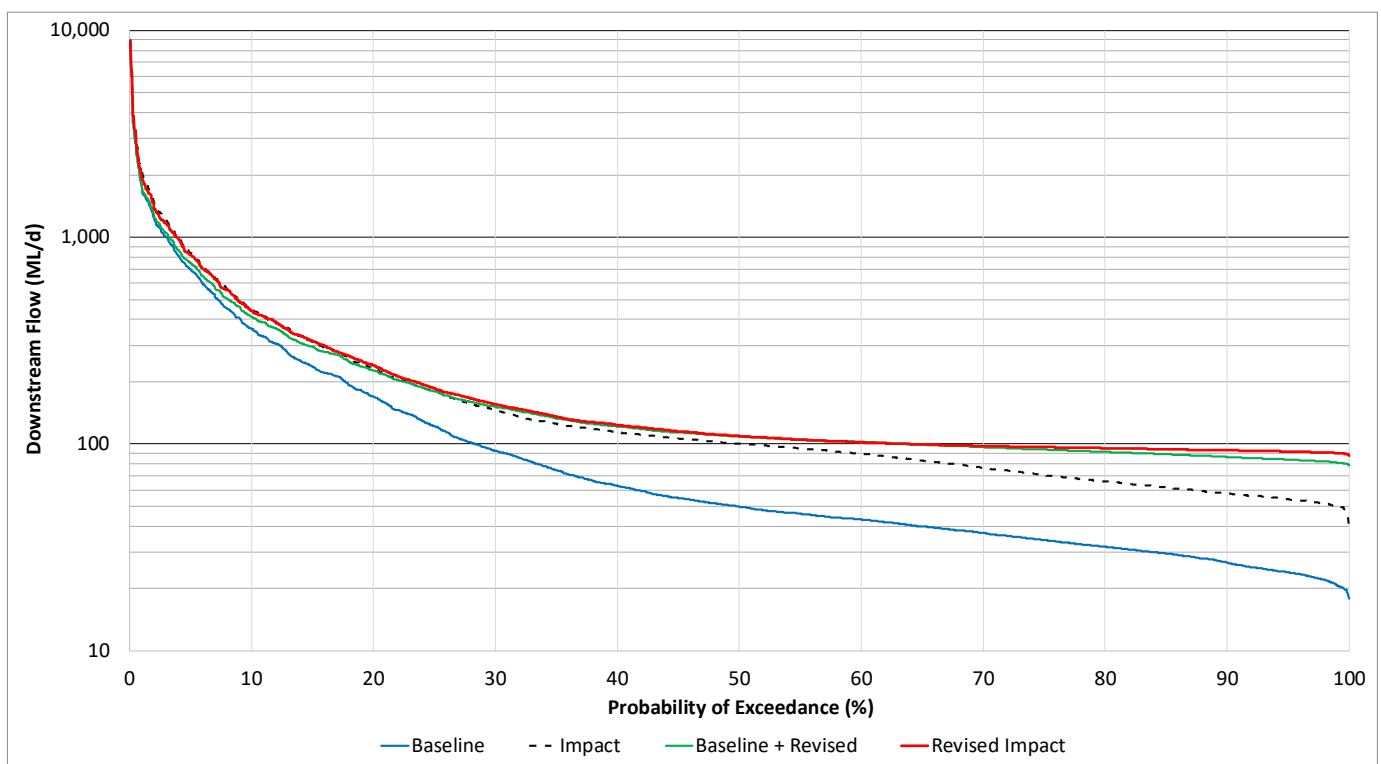
The flow duration curves for each scenario are presented in Figure 3-1 below:

**Figure 3-1 Eastern Creek flow duration curves by scenario modelled downstream of Riverstone WRRF**

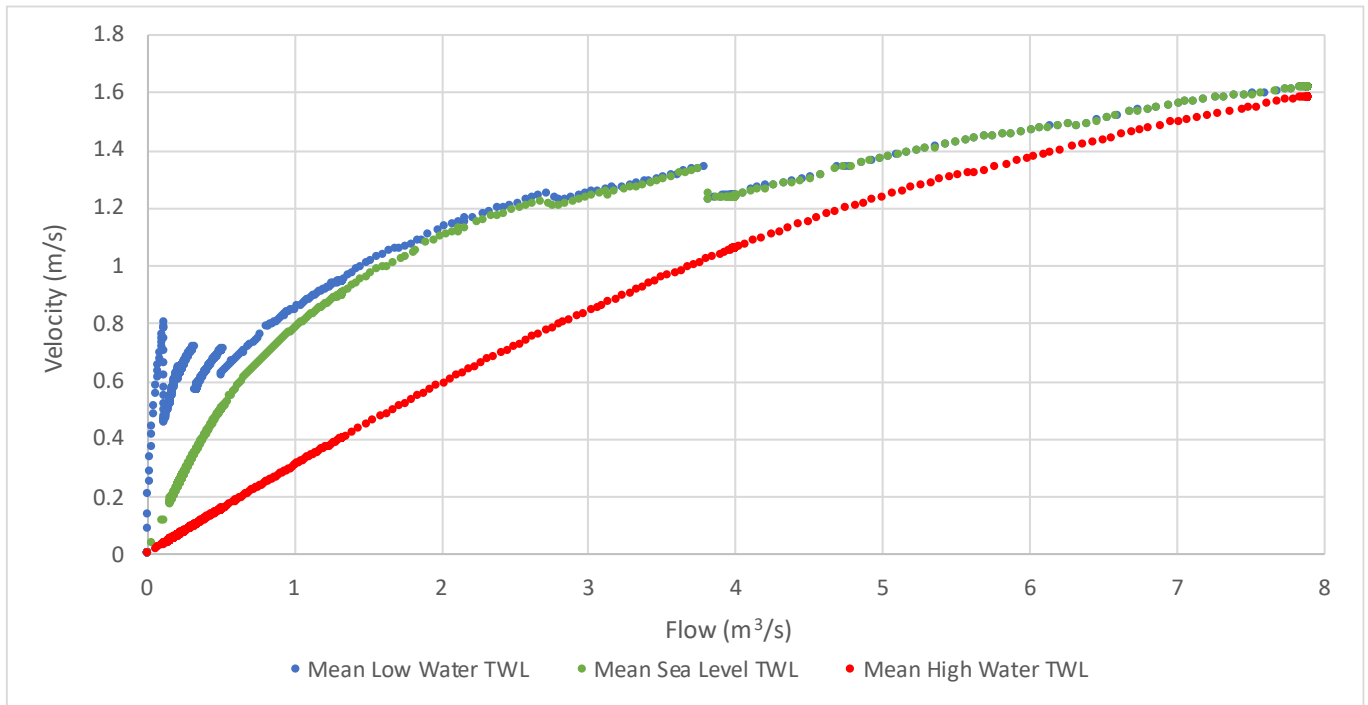
The threshold velocities of these species are associated with specific flows within Eastern Creek downstream of the Riverstone WRRF. These velocities have been used to identify the flows at which they will occur for all three reporting locations under the three tailwater conditions identified. An example of a rating curve for velocity based on flow for Reporting Location B is demonstrated in Figure 3-3.

**Figure 3-3 Rating curve of velocity with respect to flow for Reporting Location B in Eastern Creek downstream of Riverstone WRRF**

The rating curve for the mean low water tailwater level demonstrates that the system is very sensitive to flow when this tailwater condition is occurring. Multiple flows for the nominated velocity are possible, indicating a supercritical flow condition that is dominated by kinetic energy (i.e. velocity). This tailwater condition is, therefore, the most conservative mean tailwater condition for the passage of fish; however, these velocities represent the thalweg flows in the system and are not representative of the conditions along the banks where velocities are most likely to be sufficiently reduced.

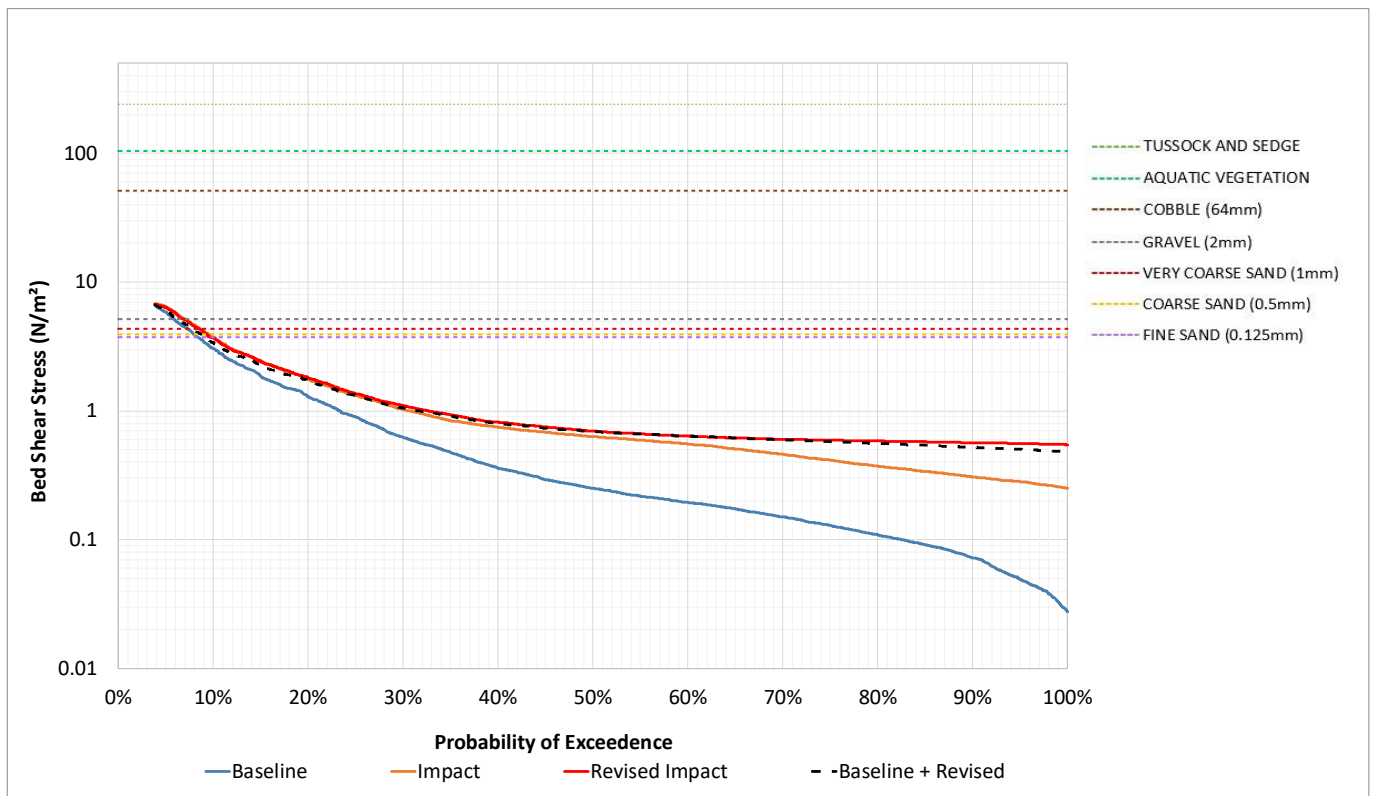
Impact assessment for erosion based on threshold shear stress conditions is provided in Table 3-10 below and complemented by a threshold shear stress exceedance curve in Figure 3-6.

**Figure 3-6 Threshold bed shear stress exceedance curve for Reporting Location A in Eastern Creek**

The results of this analysis predict that there is a low likelihood of erosion or dislodgement of macrophytes at Reporting Location A. Furthermore, any impacts that are attributable to the flow regime changes from Riverstone WRRF are likely to have low to negligible significance.

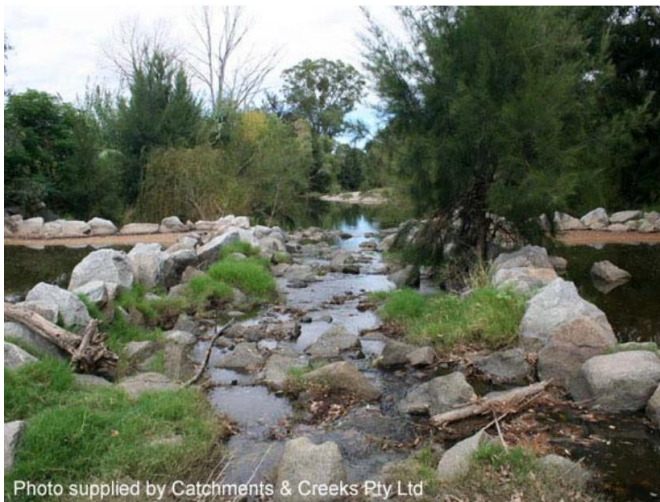
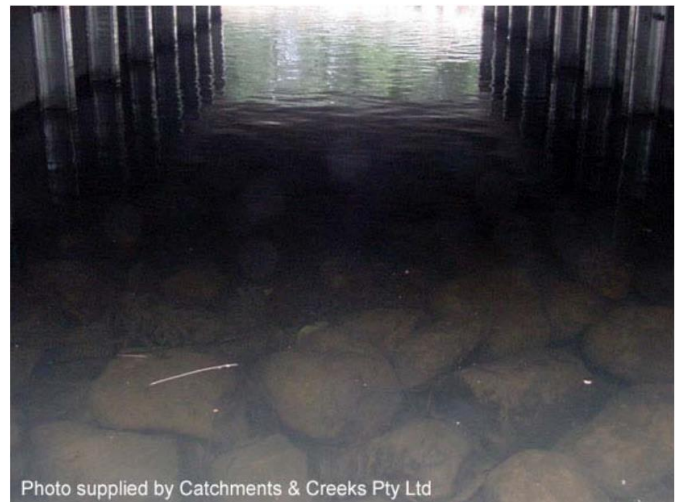
For the purpose of controlling erosion downstream of the Riverstone WRRF, rockwork has been recommended as both a proactive and reactive erosion control. Sizing of the rockwork can be undertaken using rock sizing equations and guidance provided by Catchments & Creeks (Catchment & Creeks, 2011).

**Figure 3-9 Rockwork examples for erosion control (Catchments & Creek, 2011)**

Rockwork should be installed only if it is deemed acceptable to have reduced outcomes for the ecology of the waterway.

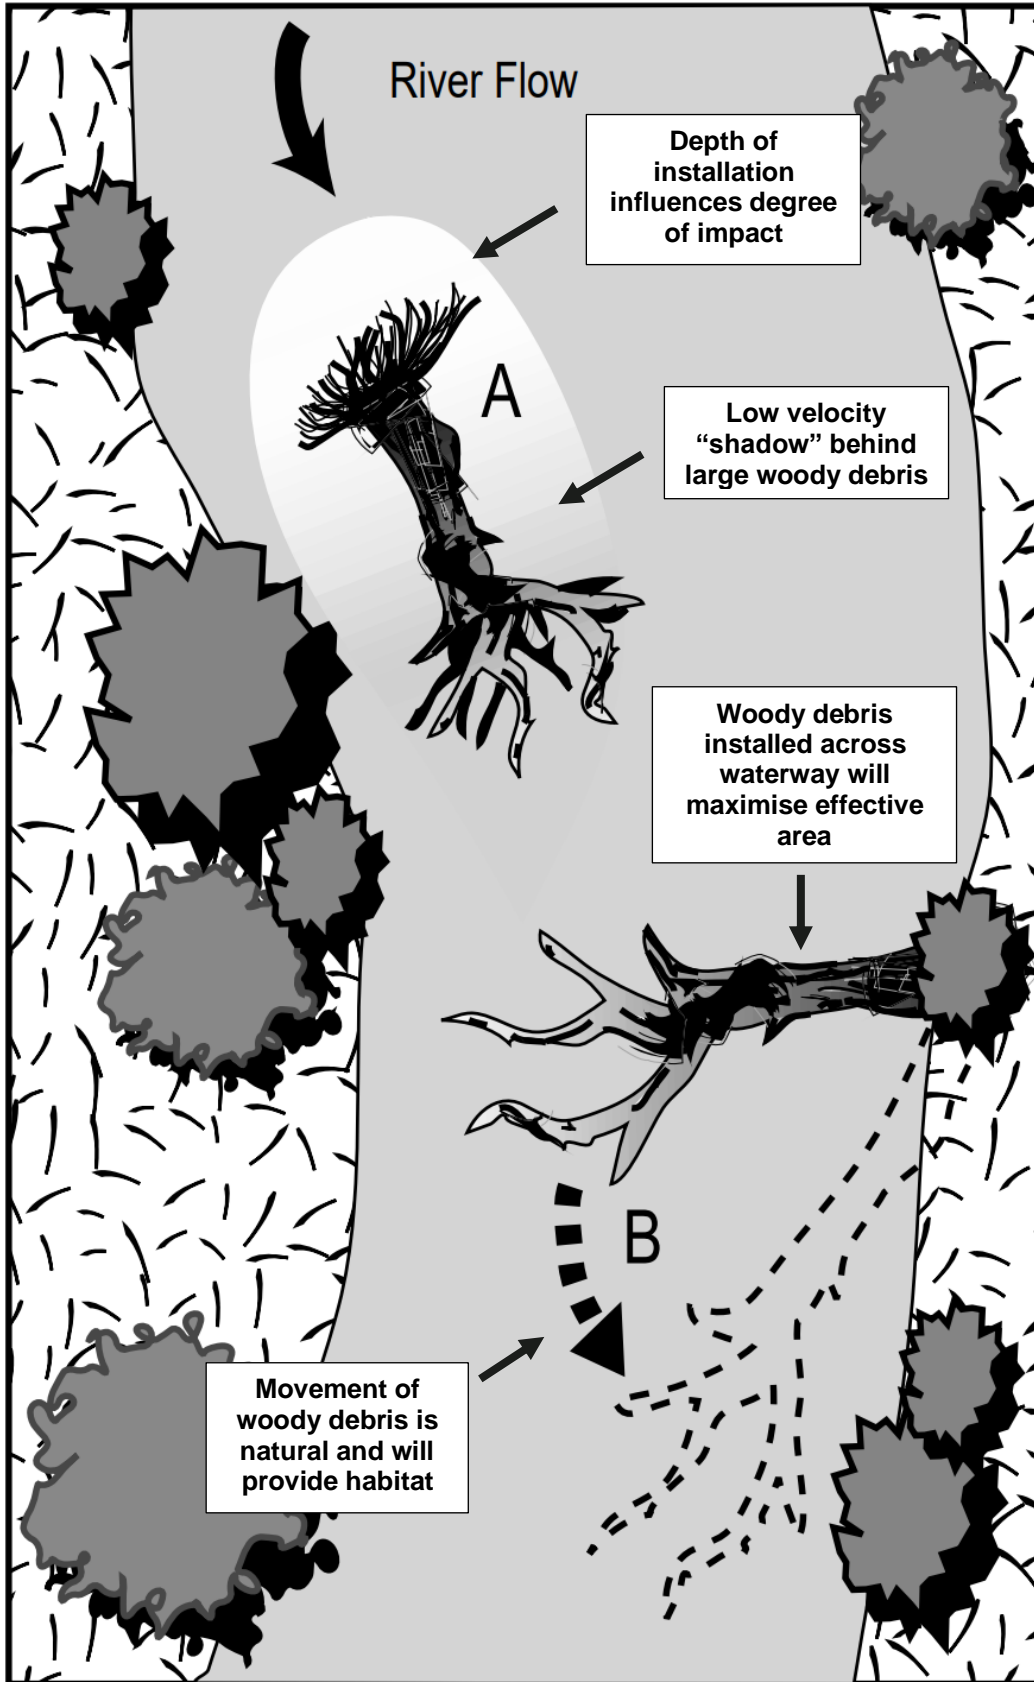
introduced in line with the Land and Water Australia’s design guideline for the reintroduction of wood into Australian streams (Brooks et al., 2006). An example of the effect to be achieved through the installation of large woody debris is provided below in Figure 3-10.

Figure 3-10 Large woody debris examples for velocity reduction and expansion of habitat (Department of Natural Resources and Environment Tasmania, 2003)

Velocity controls for Eastern Creek are recommended to consist of natural materials including native vegetation and large woody debris. These materials are recommended for their ecological benefits and relative ease of construction and installation.
