## Surface Water Quality and Aquatic Ecology Assessment

Document no: IA330200-00-T-V-RPT-00-05  
Version: 05

Quakers Hill WRRF Advanced Treatment Upgrade project  
21 July 2025

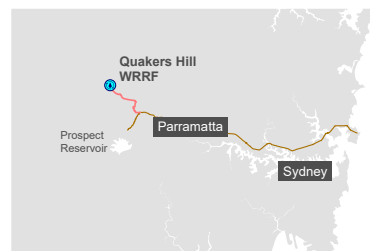
**Figure 3-2** Rapid field assessment sites

A rapid field assessment of aquatic habitat condition was performed in Breakfast Creek (between the storm drain upstream of Wright Street Bridge and the confluence with Eastern Creek) and Eastern Creek (1 km stretch of the creek downstream of the confluence with Breakfast Creek) on 17 and 18 September 2024. The sampling sites are shown in Figure 3-2. Further details on the river segments surveyed are shown in Figure 4-16 through Figure 4-20. Note that sites B1 through B19 are upstream of the WRRF outfall. Sites B20 through B36 and E1 through E8 are all downstream of the outfall Impact Assessment methodology

Field observations were used to assess habitat quality at 36 sites in Breakfast Creek and 8 sites Eastern Creek. A Riparian, Channel, and Environmental (RCE) inventory (Chessman et al. 1997) was used to assess habitat quality at each site based on surrounding land use, bank vegetation and structure, habitat features (such as boulders and snags), and watercourse structure. An example RCE scoresheet is included in Appendix A. Other negative features, such as rubbish, foams, and oil sheens, were noted. Riparian and aquatic vegetation were identified to the lowest possible level and noted if native or introduced/invasive.

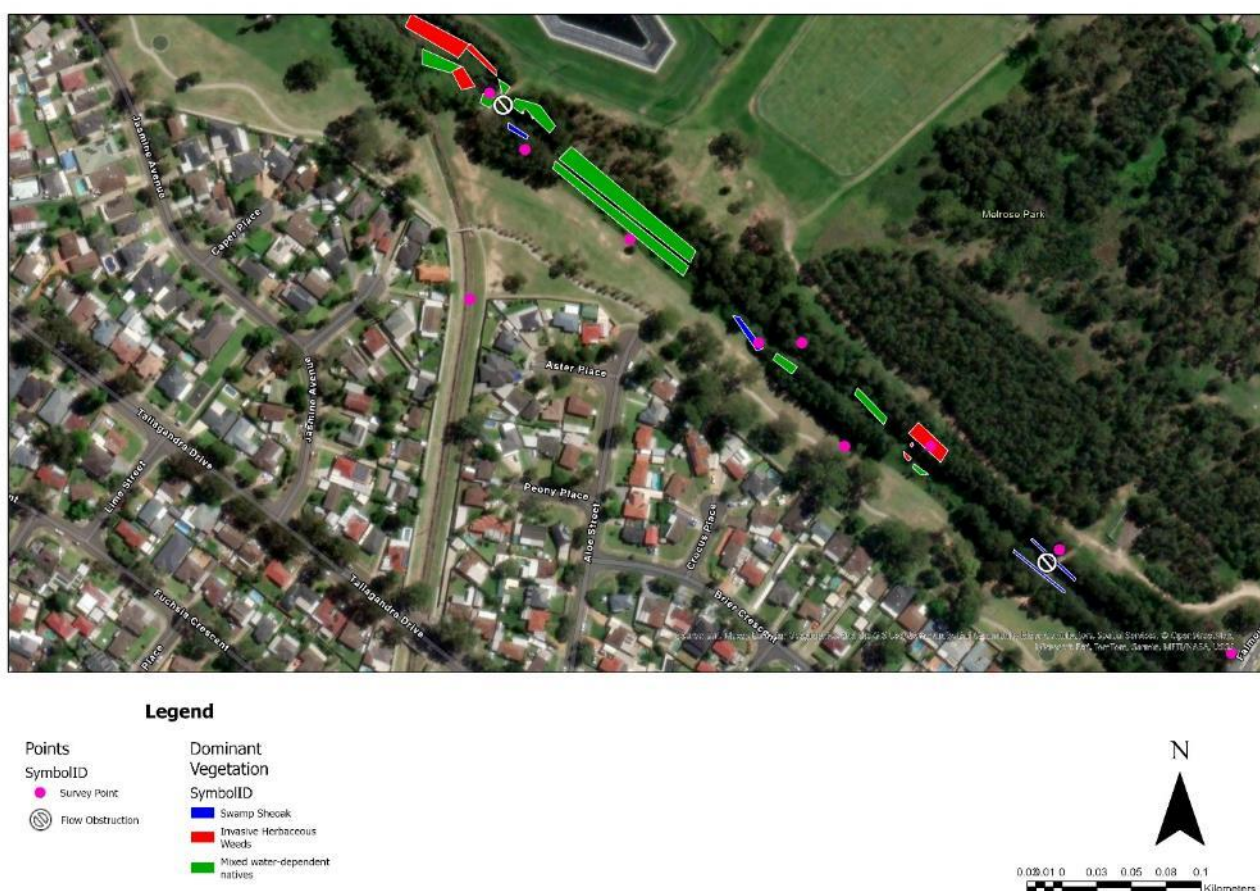
Figure 4-17 Survey points and dominant vegetation in Breakfast Creek from Falmouth Road to the large storm drainage canal

The habitat was ranked as severely to moderately disturbed with RCE scores ranging from 15 to 24, based on collapsed, poorly vegetated banks and loose sediment and silt.

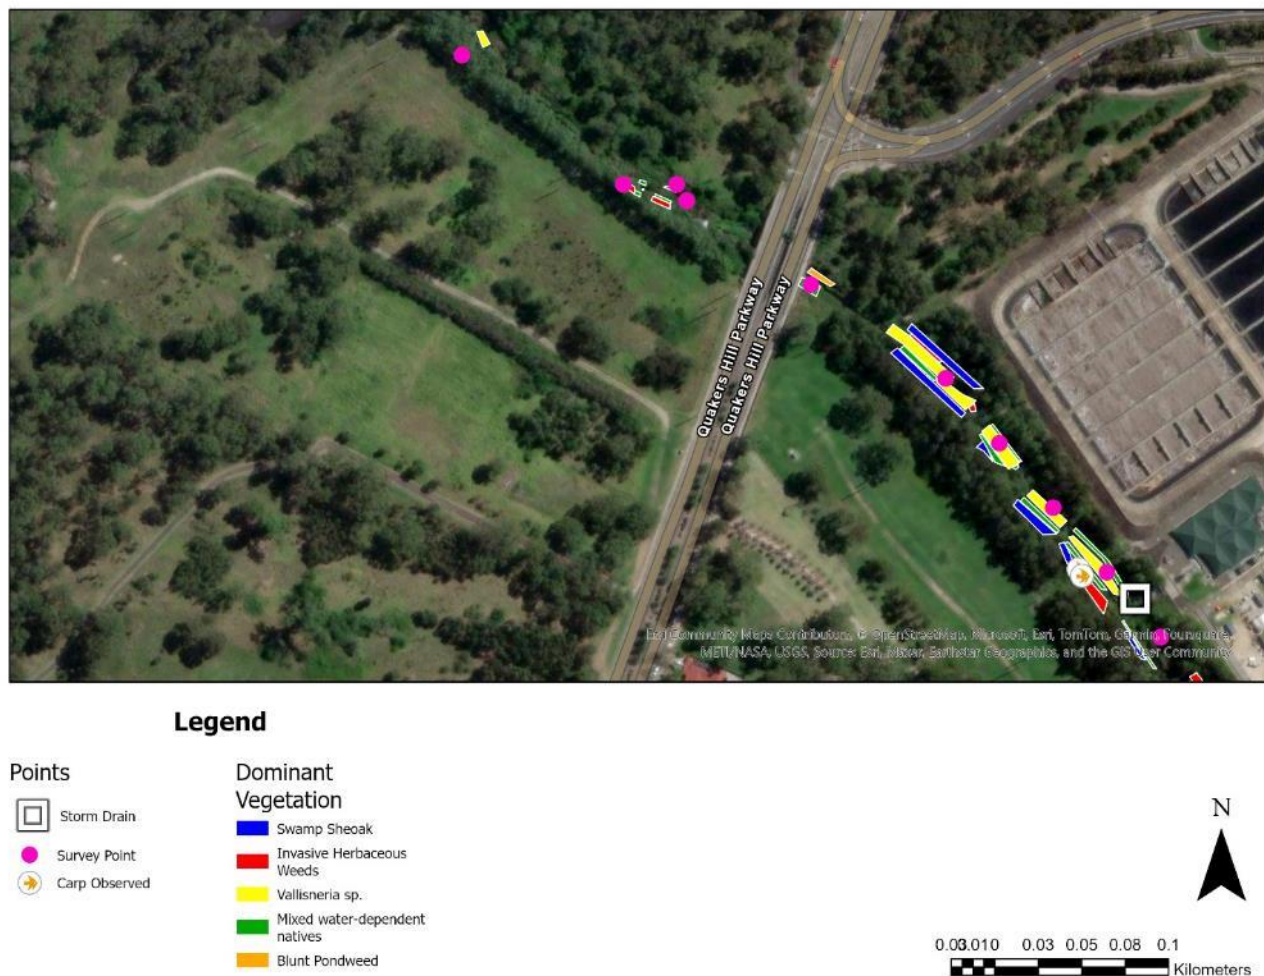
**Figure 4-19** Survey points and dominant vegetation in Breakfast Creek from the WRRF to Quakers Hill Parkway

RCE scores ranged from 31 to 34, indicating a moderately disturbed habitat. Habitat features that scored highly that were commonly present included snags and boulders, alternating riffle/pool sequences, and a lack of loose sediment accumulation, however the scores were lowered by a continuing presence of bank undercutting and breaks in bank vegetation.

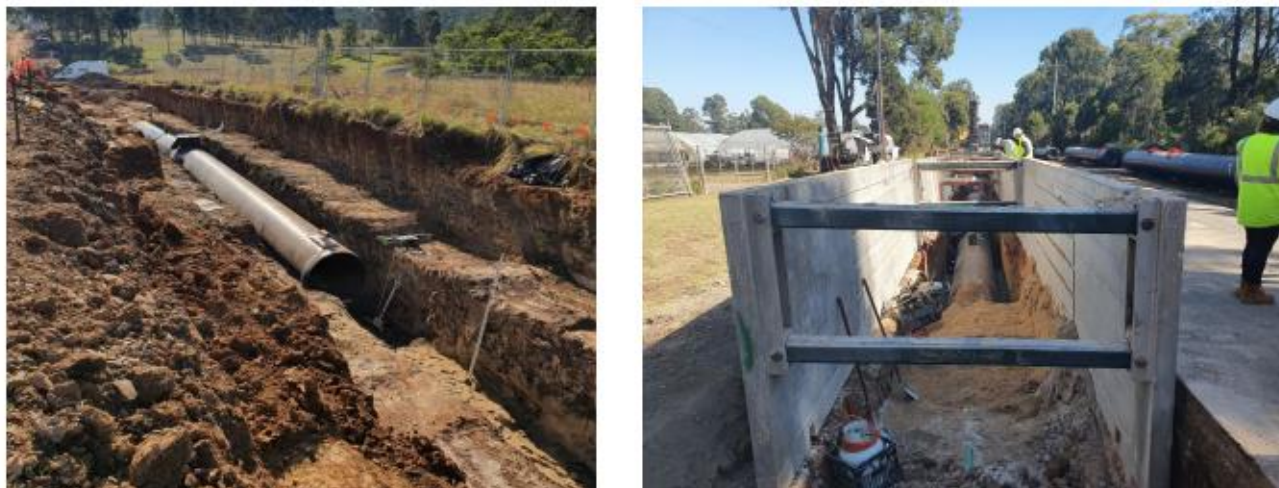
Figure 8-3 Typical illustration of the proposed excavation for the brine pipeline

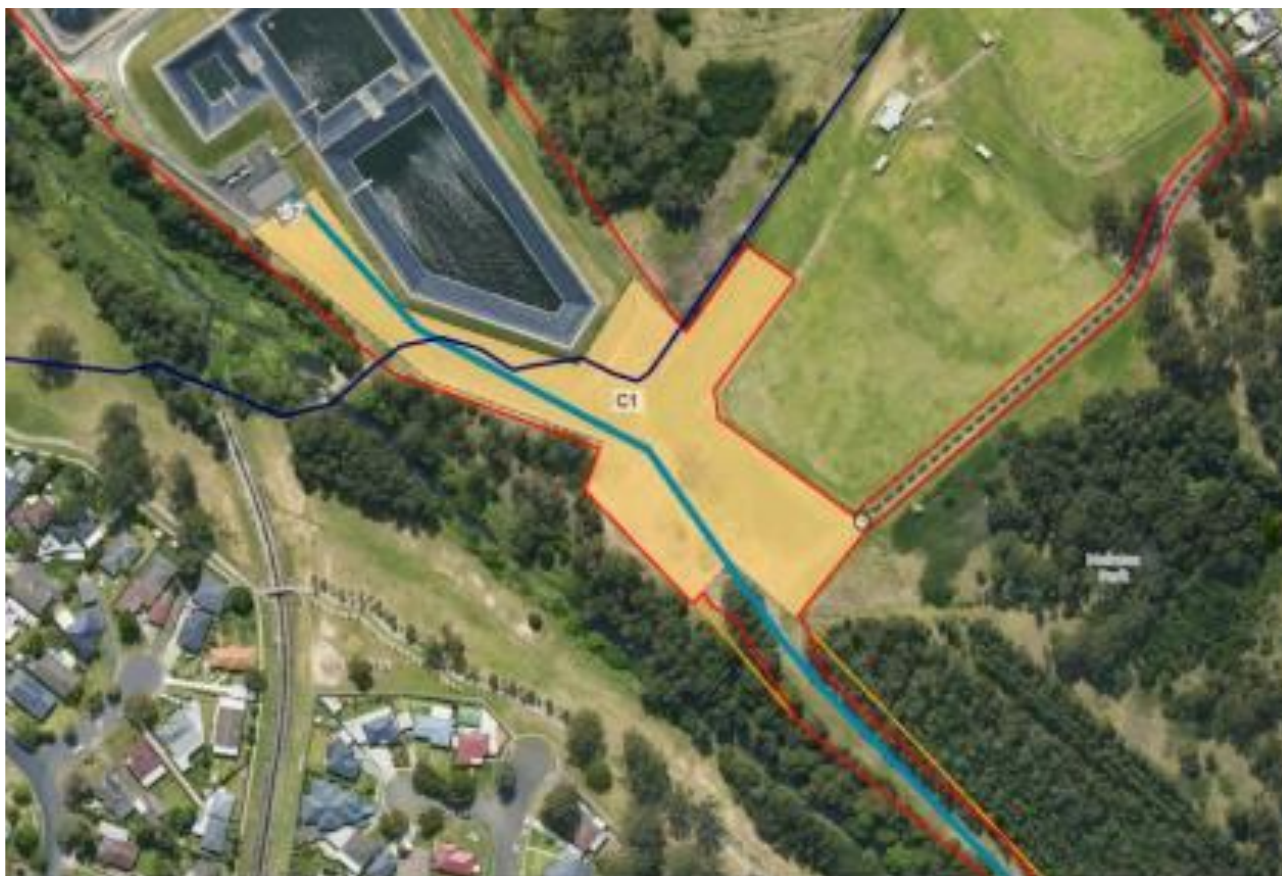
Figure 8-4 Example of a site compound area

Several site compound and construction equipment laying areas are proposed along the alignment of the brine pipeline. An example of such a site compound area is given in Figure 8-4. Temporary sediment basins would not be required for these areas as they are not very large areas, and such would not warrant sediment basins. Sediment fences would be required at all downslope areas of the site and external runoff diversion drains would also be required for all upslope areas. Stabilised access points would also be required at the entrance to the site to prevent soil deposition on public roads from construction vehicles exiting the site.

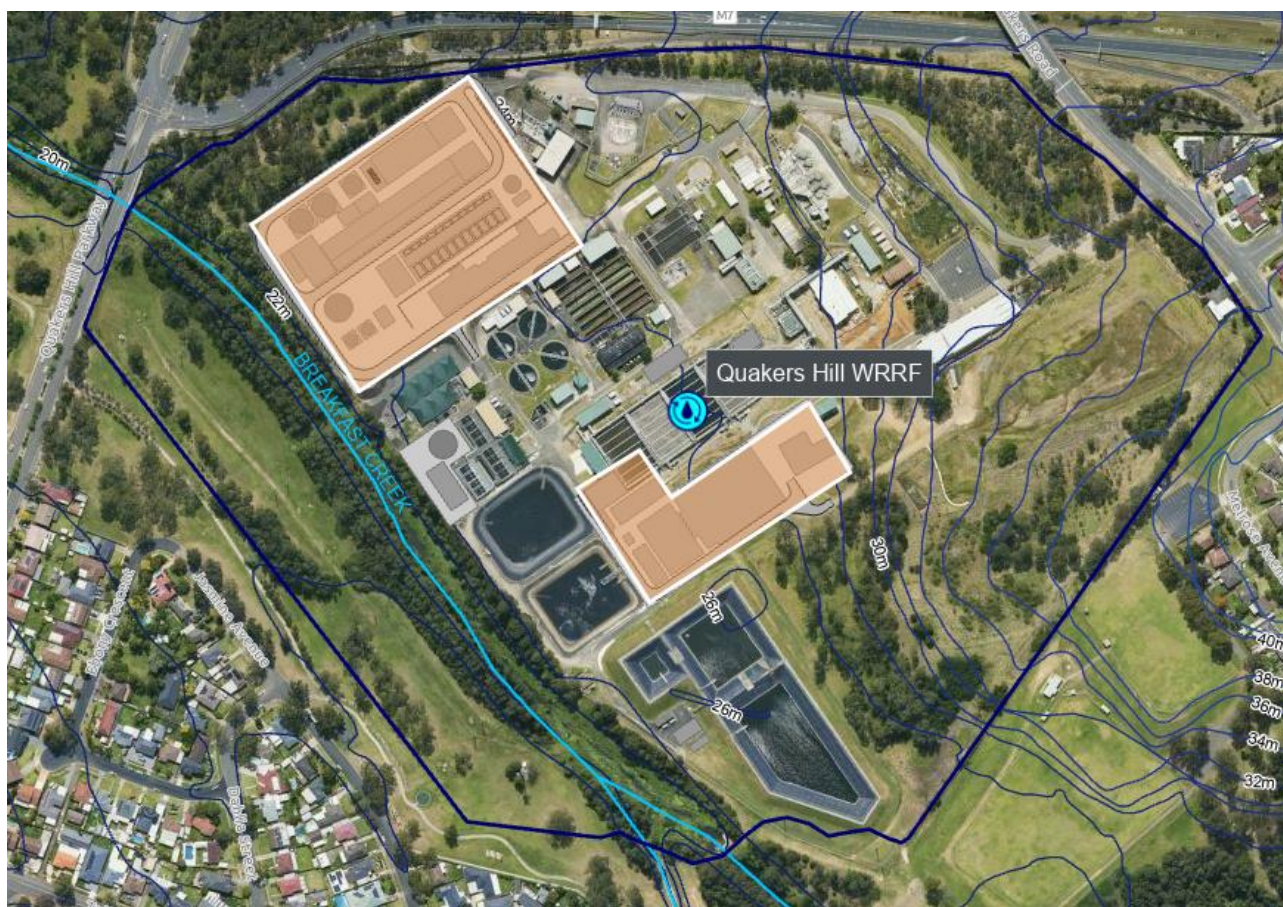
Figure 8-5 Advanced water treatment plant and secondary treatment system at Quakers Hill WRRF

Figure 8-5 shows the locations of the AWTP and secondary treatment system.

The 50% design report indicates the total area of the site is approximately 29.3 ha (Jacobs 2025b). The percentage imperviousness for the existing conditions has been estimated to be approximately 50% of the total site area. This means that approximately 14.65 ha of the existing site is impervious. For the proposed conditions, this imperviousness would increase to 55% because of the proposed 1.62 ha increase in impervious area on the site. Therefore, the new impervious area would be 16.27 ha and the pervious area would reduce from 14.65 ha to 13.03 ha.

For the operational phase of project, following the proposed upgrade works, there are two main areas on site where changes in imperviousness will impact on surface runoff and discharges, hence an impact on pollutant loads into Breakfast Creek. The main pollutants of concern during this phase are total suspended solids, total phosphorus, and total nitrogen.

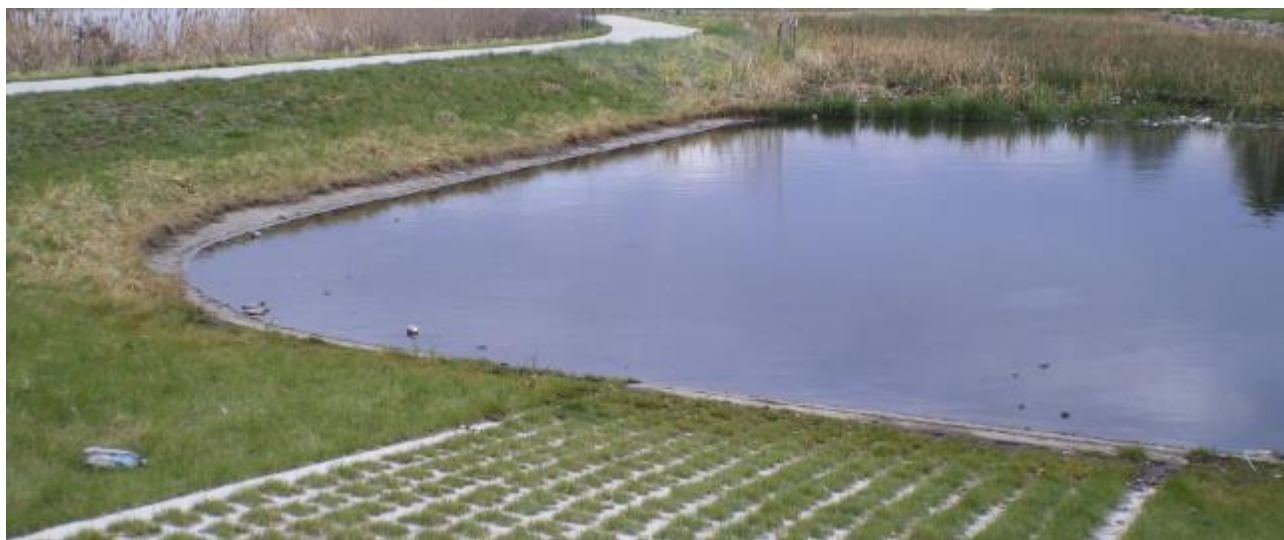
**Figure 8-9 Example of a water quality basin**

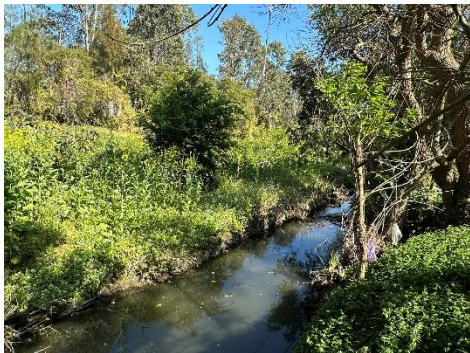
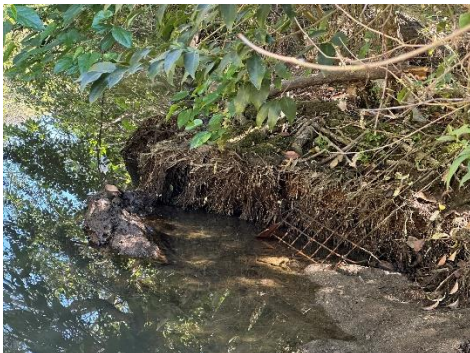
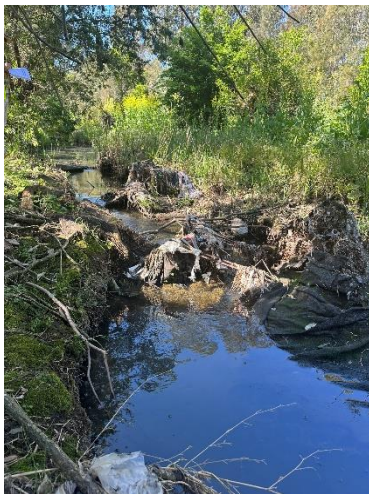
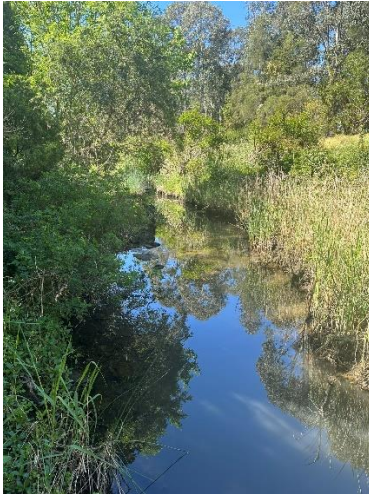
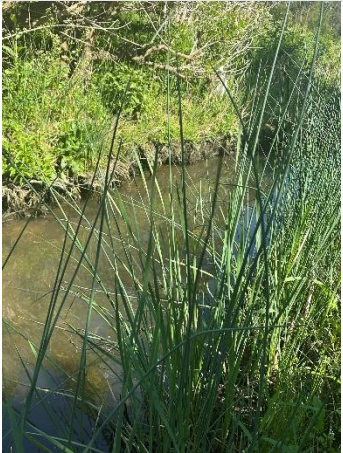
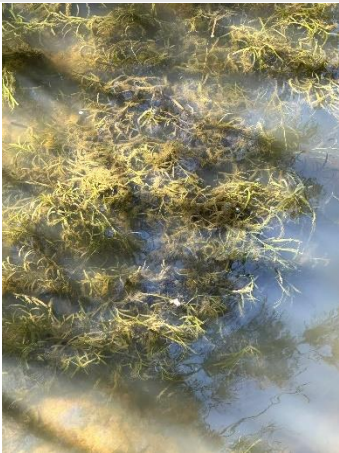
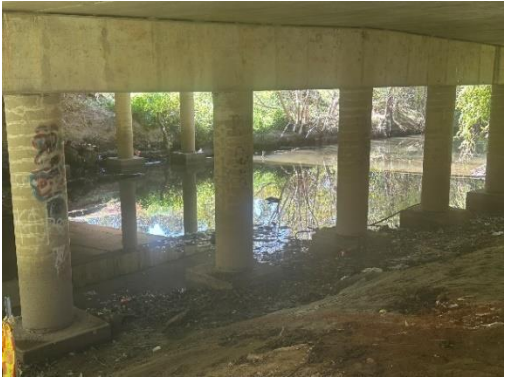
| Site reach and sites | Site photographs | | | Description |
|---|---|---|---|---|
| Breakfast Creek –<br>Storm drain to<br>Falmouth Rd (Sites<br>B1 to B8) | | | | <p>Eight sites (B1–B8) were visited within this stretch of Breakfast Creek. The creek appears to be in moderate ecological health with healthy riparian vegetation and relatively clear water, although invasive weeds were present.</p> <p>Breakfast Creek has both natural banks and sections passing under manmade structures such as bridges and culverts (B8). These structures impact on both habitat connectivity and flow.</p> <p>Generally, the banks are well vegetated with dense grasses, reeds and shrubs (B2, B5). Both submerged and emergent vegetation was visible in sections of the creek (B6, B8).</p> <p>Aquatic habitat complexity varied throughout the reach and included woody debris, overhanging branches and a variety of plant types (B3, B5).</p> <p>There was evidence of algae and dense growth of aquatic plants which indicates that nutrient enrichment may be an issue. Additionally, the creek appears impacted by stormwater with rubbish and debris accumulating in sections (B5, B3).</p> |

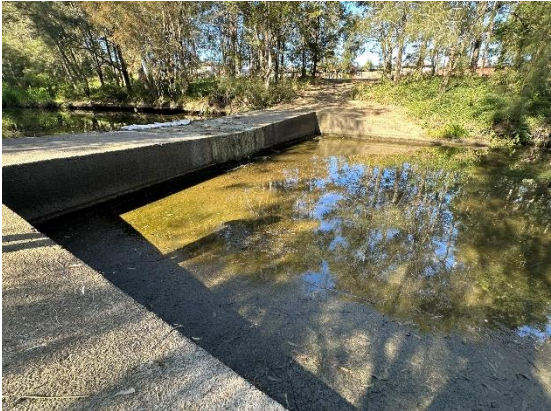
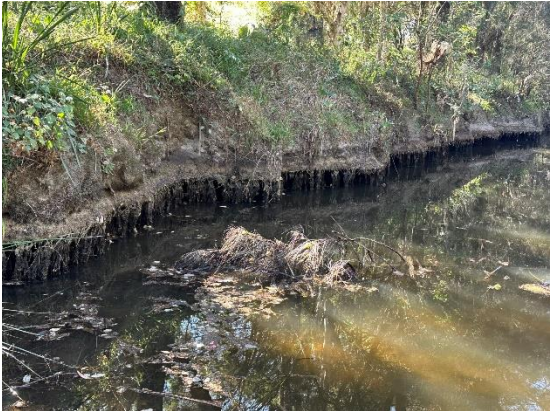
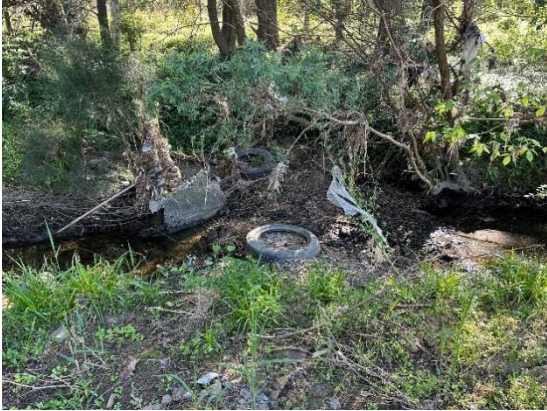
| Site reach and sites | Site photographs | | | Description |
|---|---|---|---|---|
| Breakfast Creek<br>Falmouth Road to<br>large storm drain<br>canal (Sites B9 –<br>B15) | | | | Seven sites (B9–B15) were visited in this stretch of Breakfast Creek between Falmouth Road to large storm drain canal (refer Figure 4- 17). Breakfast Creek in this reach exhibits a mix of natural and impacted conditions. Flow at the time was low and obstructed in some sections by an unculverted concrete crossing (B9) and build-up of sediment and rubbish (B10, B11).<br><br>Several sites along the creek show evidence of bank erosion with exposed soil and undercut banks, likely a result of altered flow conditions and limited bank stabilising vegetation (B9, B12). |

| Site reach and sites | Site photographs | Description |
|---|---|---|
| | | <p>Water clarity varied throughout the reach, with some sections exhibiting relatively clear water (B14) and others were murky (B9) likely due to creek/sediment substrate and organic matter.</p> <p>The creek is impacted by high flow events which wash rubbish and debris into the waterway (B10).</p> <p>Overall, the creek in this reach exhibits a combination of semi-natural to degraded sections with limited riparian vegetation.</p> |

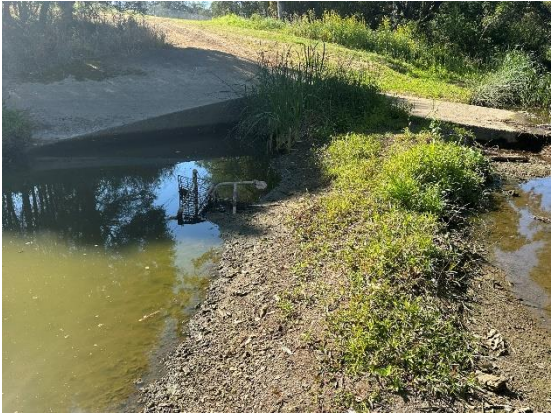
| Site reach and sites | Site photographs | | Description |
|---|---|---|---|
| <b>Breakfast Creek</b><br><b>Storm drain to Water</b><br><b>Resource Recovery</b><br><b>Facility (Sites B16-</b><br><b>B19)</b> | | | <p>Four sites (B9–B15) were visited in this stretch of Breakfast Creek between the large storm drain canal to just upstream of the WRRF discharge. The creek in this reach exhibited shallow banks, with very low flow and sections of stagnant water. The banks of the creek generally have significant growth of grasses and vegetation, with limited evidence of erosion. The presence of both open water and vegetated margins (B17) increases the habitat complexity and is likely able to support a community of invertebrates and small fish.</p> <p>Flow is variable due to the unculverted concrete crossing (B16) and overgrown vegetation within the creek bed which can impede flow (B16) and would provide a barrier to fish passage outside of flood conditions.</p> <p>The creek bed comprises of sediment and gravel with some debris, an indication of the variable flow conditions experienced by this creek.</p> <p>Water clarity was generally poor with murky conditions observed likely due to stagnant water (B19).</p> |

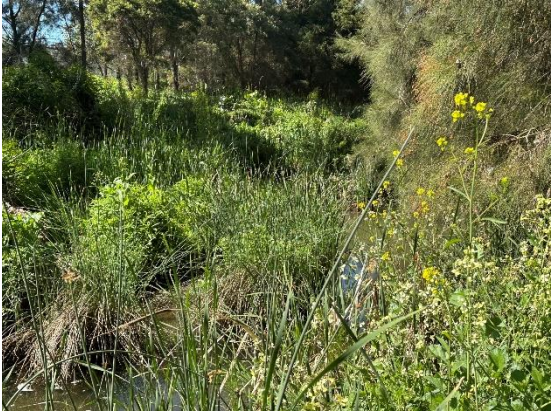
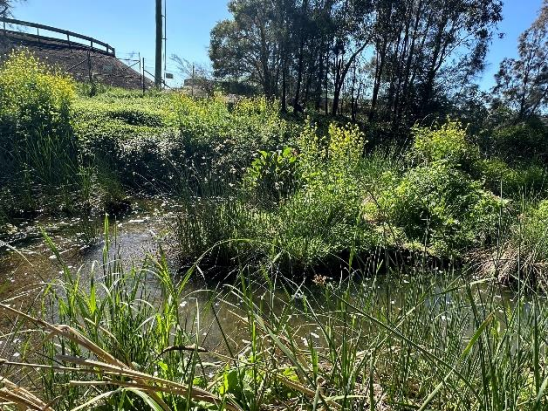
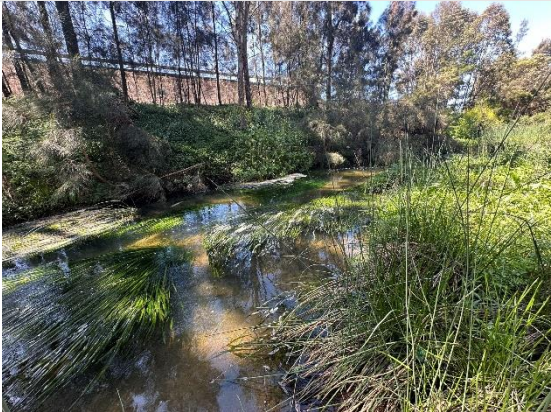
| Site reach and sites | Site photographs | Description |
|---|---|---|
| <p data-bbox="163 786 376 927"><b>Breakfast Creek<br/>WRRF to Quakers Hill<br/>Parkway (Sites B20 –<br/>B24)</b></p> | <div> <p data-bbox="407 1209 454 1236">B20</p> </div> <div> <p data-bbox="967 1209 1014 1236">B20</p> </div> | <p data-bbox="1632 786 2080 850">Five sites (B20–B24) were visited between the WRRF and Quakers Hill Parkway.</p> <p data-bbox="1632 863 2080 1026">This section of the creek exhibits a relatively natural riparian zone comprising of grasses shrubs and trees. Due to the vegetated banks, there was limited evidence of erosion (B20, B23).</p> <p data-bbox="1632 1038 2080 1278">Flow in this reach significantly increases just downstream of the discharge point from the WRRF (B21). Despite the increased flow there were section of the creek where water appears shallow or stagnant, likely due to the dense aquatic stands of aquatic macrophytes impeding flow in sections (B23).</p> |

| Site reach and sites | Site photographs | | Description |
|---|---|---|---|
| | | | <p>There are also sections of submerged aquatic plants, this together with emergent aquatic vegetation indicates eutrophication and nutrient enrichment of the creek (B23, B24).</p> <p>The presence of both submerged and emergent aquatic macrophytes would provide habitat for aquatic species. Additionally, the mix of open water, vegetated banks and rocky features would provide microhabitats for fish and macroinvertebrates.</p> <p>In this section of the creek there was limited evidence of rubbish aside from a shopping trolley and water appeared relatively clear (B22).</p> <p>The creek was flowing under the Quakers Hill Parkway, although water was shallow, and bed substrate comprised of fine silty sediment with small boulders (B24).</p> |

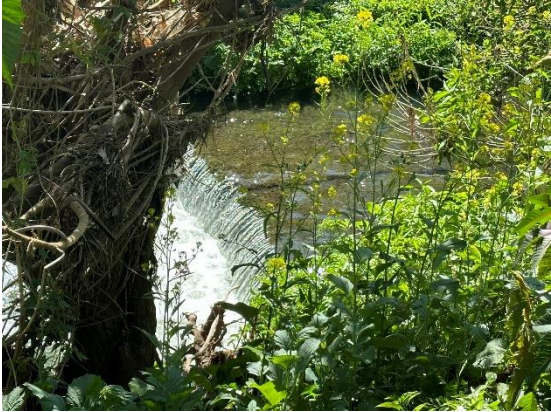
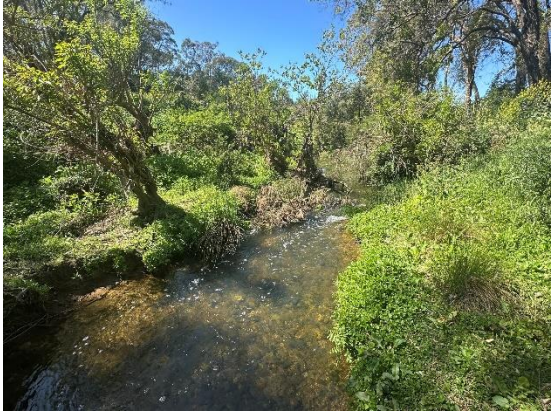
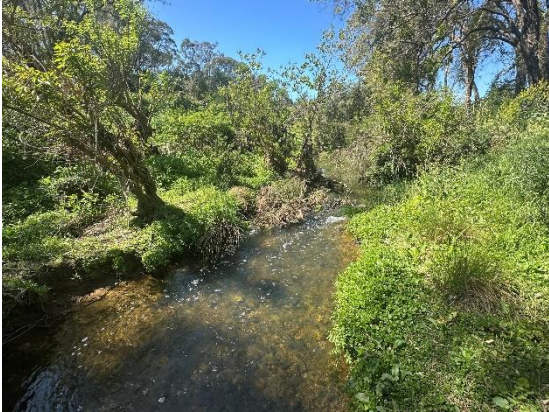
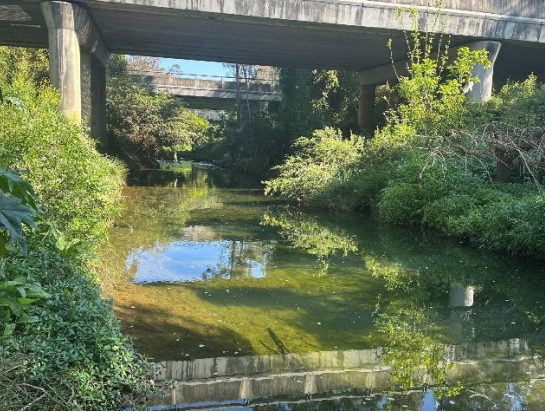
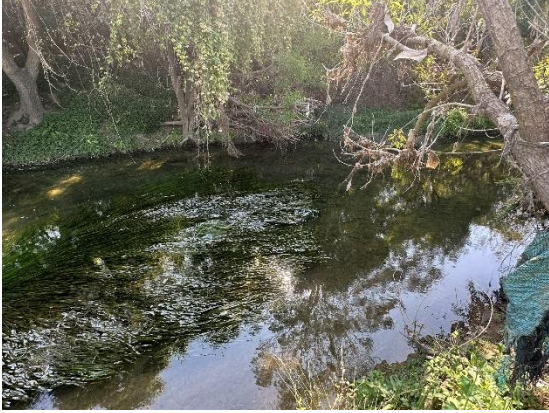
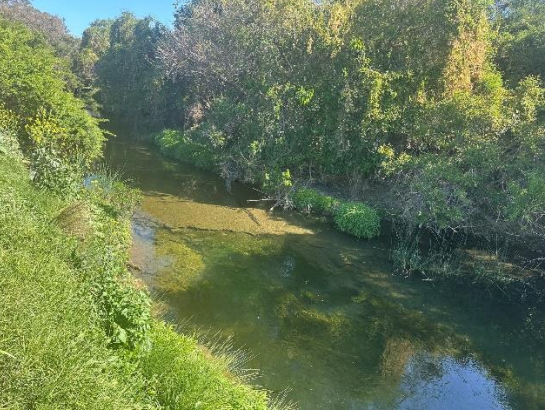
| Site reach and sites | Site photographs | Description |
|---|---|---|
| <p><b>Breakfast Creek<br/>M7 to Eastern Creek<br/>confluence (Sites B25<br/>– B36</b></p> | <div> <p data-bbox="407 1209 450 1236">B25</p> </div> <div> <p data-bbox="969 1209 1012 1236">B27</p> </div> | <p>Twelve sites (B25–B36) were visited in Breakfast Creek between the M7 motorway and the confluence with Breakfast Creek.</p> <p>The creek in this reach appeared to be in fair to good ecological condition with diverse aquatic habitats, a mostly natural channel with healthy riparian vegetation.</p> <p>The creek provides a variety of aquatic habitats including shallow riffles, deeper pools and overhanging vegetation and woody debris (B25, B27). In this reach of the creek there was less evidence of emergent or submerged aquatic macrophytes which were only observed at B31, B32 and B34.</p> |

| Site reach and sites | Site photographs | Description |
|---|---|---|
| | | <p>The water clarity was generally good, particularly in areas of rocky substrate (B27), but where sediment was the dominant substrate water appeared slightly murky.</p> |

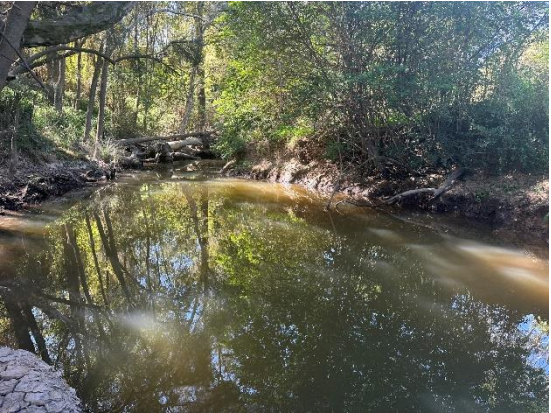
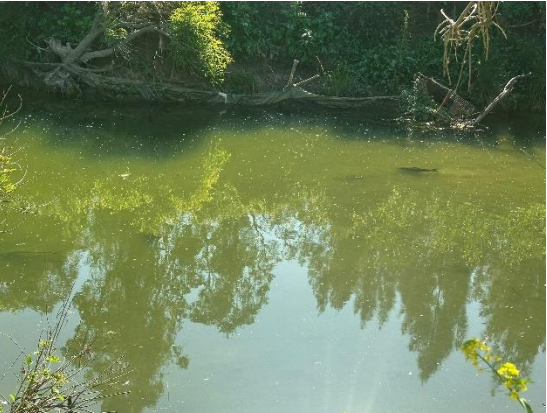
| Site reach and sites | Site photographs | | Description |
|---|---|---|---|
| <b>Eastern Creek<br/>Confluence with<br/>Breakfast Creek to<br/>Stonecutters Ridge<br/>Golf Club (Sites E1 –<br/>E8)</b> | | | <p>Eight sites (E1–E8) were visited in Eastern Creek from just upstream of the confluence with Breakfast Creek to Stonecutters Ridge Golf Course. Site E1 was located upstream of the confluence and all other sites were located downstream.</p> <p>Eastern Creek varied between flowing to stagnant with large slow flowing pools where the invasive fish species Carp were observed (E2). Flow upstream of the confluence (E1) was lower than downstream, E1 also showed evidence of erosion and exposed banks.</p> <p>Aquatic habitat comprised of submerged and emergent woody debris, which can offer shelter and breeding grounds for fish and macroinvertebrates. Submerged aquatic plants were also observed (E3). Good riparian vegetation including Swamp She-oak was observed along the length of the creek.</p> <p>Water clarity varied along the creek with a greenish tint observed at some sites suggesting the presence of algae (E6).</p> |
