**Ryde to Pymble Pipeline Upgrade**  
**Aboriginal Heritage Due Diligence Assessment**

Prepared for Sydney Water

Ku-Ring-Gai and Ryde Local Government Areas

June 2025

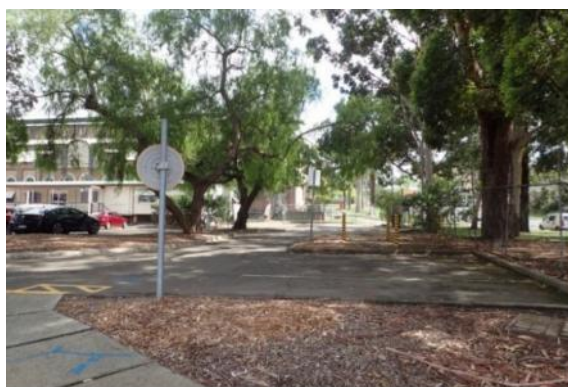
Inspection of the study area alignment commenced in the southern portion of the study area at the Sydney Water compound located at 51 Hermitage Road, West Ryde. This area was a level bitumen covered block with demountable offices, driveways, car parking spaces and some tree plantings. The study area extended north-east from this location as two separate arms up the moderate to steep slopes of Hermitage Road and Anzac Avenue. The soils in this section of the study area were modified, truncated or highly disturbed by existing infrastructure and roads.

**Plate 1.** View to northwest at existing Sydney Water compound, 51 Hermitage Road (southern end of study area).

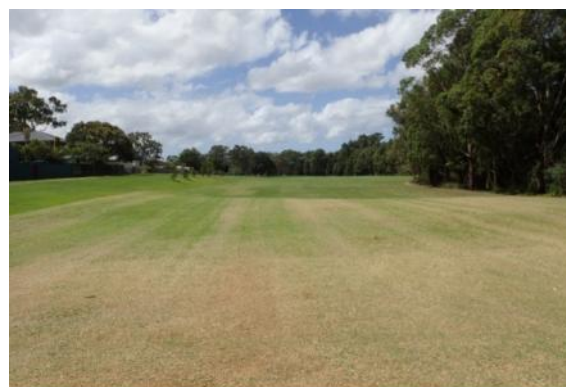
**Plate 2.** View to northeast at Santa Rosa Park, Ryde. Levelled and down cut sports field. Planted trees and Shrimptons Creek at right.

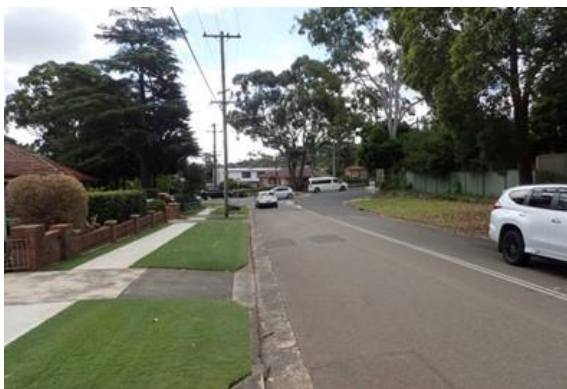
The inspection of the study area continued northwest, traversing the existing road corridors of Bridge Road, Abuklea Road, Balaclava Road, Agincourt Road, Dayman Place and continued along Vimiera Road before intersecting the M2 Motorway. This portion of the study area alignment displayed high levels of disturbance from existing infrastructure.

**Plate 3. View to northwest at Abuklea Road. Intersection with Balaclava Road in background.**

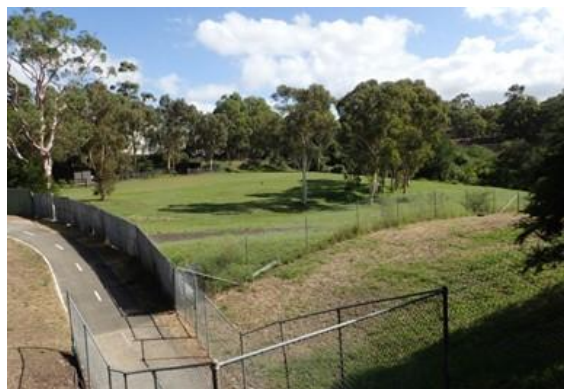
Two proposed compound locations on the eastern and western sides of the cul-de-sac at the northern end of Vimiera Road were also inspected. The western proposed compound area was located on a levelled and landscaped block utilised for horses and the eastern proposed compound area was located on a cleared crest landform adjacent to a unit complex. Both areas were considered to display low archaeological potential due to disturbance and previous land clearing. No Aboriginal objects or areas of archaeological potential were identified within these proposed compound areas or within this portion of the study area alignment.

**Plate 4. View to southwest at proposed compound location on western side of cul-de-sac at northern end of Vimiera Road. Drainage works for M2 at right.**

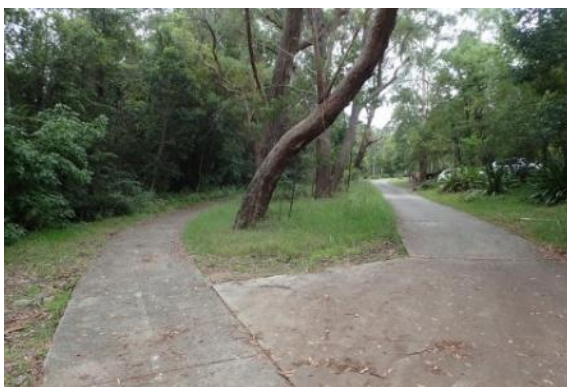
Inspection of the study area continued north along the existing roadway of Kissing Point Road, and included a proposed compound located at the southern end of Kissing Point Road. This proposed compound area showed evidence of ground surface disturbance from an existing vehicle carriageway. Two other proposed compound locations on the western side of Kissing Point Road were inspected, these included a cleared block and Auluba Reserve which was identified as a modified, levelled sports field. Large erosion scours showed good exposure, no Aboriginal objects were identified on exposures. No Aboriginal archaeological sites or areas of archaeological potential were identified at the proposed compound areas.

**Plate 5. View to north. Proposed compound area at southern end of Kissing Point Road, South Turramurra. To left of road is minor tributary creek gully.**

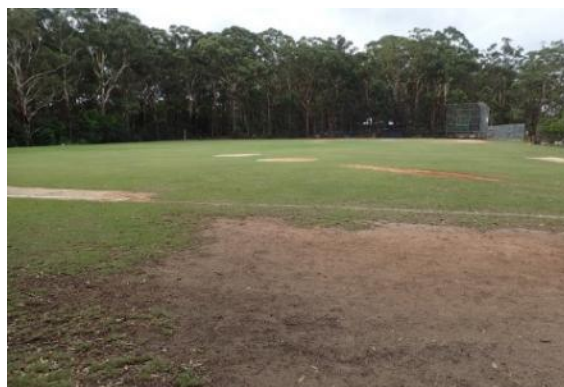
**Plate 6. View to north-west at Auluba Reserve, South Turramurra. Proposed compound area. Level playing field used for baseball.**

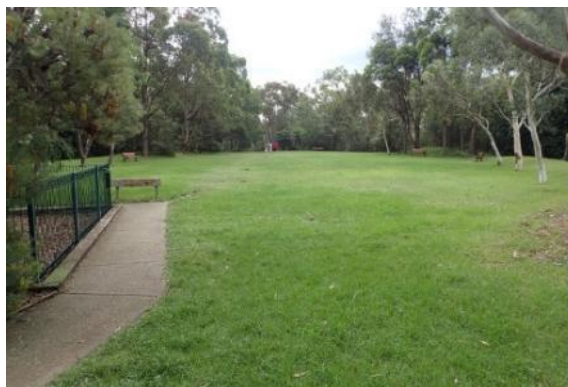
The study area alignment continued northwest, following in the roadways of Monteith Street, Montrose Street, Rothwell Road, Mitchell Crescent and Roland Avenue. This northern portion of the study area alignment followed steep side slopes off crests into gullies formed by the headwaters of Water Dragon Creek and Peppermint Creek, ending at a small sewer reserve. These areas comprised existing roadways with no Aboriginal archaeological sites identified. Inspection of the proposed compound location at Mitchell Crescent Reserve at the northern end of Twin Creeks Reserve identified disturbance from ground levelling and landscaping.

**Plate 7. View to southwest at Mitchell Crescent Reserve. Proposed compound area. This area has been levelled with a playground present. Landscaped mounds along southern and northern edges.**

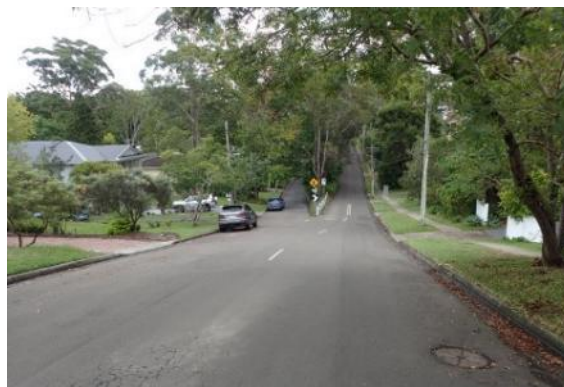
**Plate 8. View to northwest at Rothwell Road, north of Mitchell Crescent. Study area alignment runs down into a gully formed by headwaters of Peppermint Creek, following the left side of the fork in the road.**

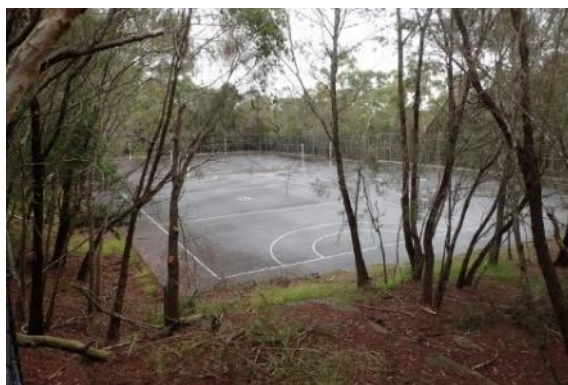
Several isolated proposed compound areas were inspected. These proposed compound areas consisted of existing Sydney Water compounds, car parking areas, cleared vacant blocks, public parks and recreation areas. Most proposed compound locations were in proximity to the main study area alignment with two located further to the north at Wahroonga. Inspection of these areas identified disturbed soils from existing infrastructure, landscaping, land clearing and buried water infrastructure, as well as constructed sports and recreational areas including tennis courts and netball courts. No Aboriginal objects, Aboriginal archaeological sites or areas of archaeological potential were identified at the proposed compound locations.

**Plate 9. View to south-west at Canoon Road Recreation Area. Proposed compound area. Netball courts constructed by levelling and downcutting on a ridge crest.**

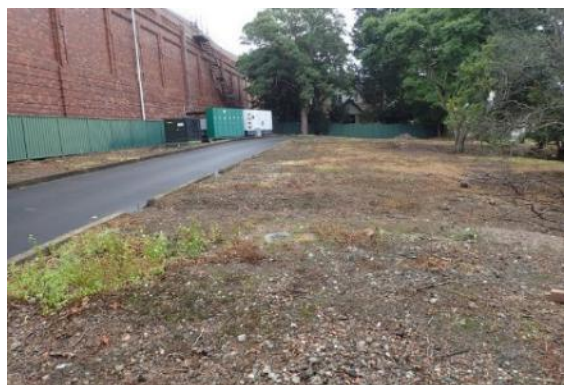
**Plate 10. View to west at Neringah Avenue South, Wahroonga. Proposed compound area. Ground surface covered in demolition rubble.**
