**WEST DAPTO PACKAGE 3: PART 3A CONSISTENCY ASSESSMENT
WATER AND WASTEWATER SERVICES, NSW**

Aboriginal Archaeological Assessment

Test Excavation Report

Prepared for Sydney Water

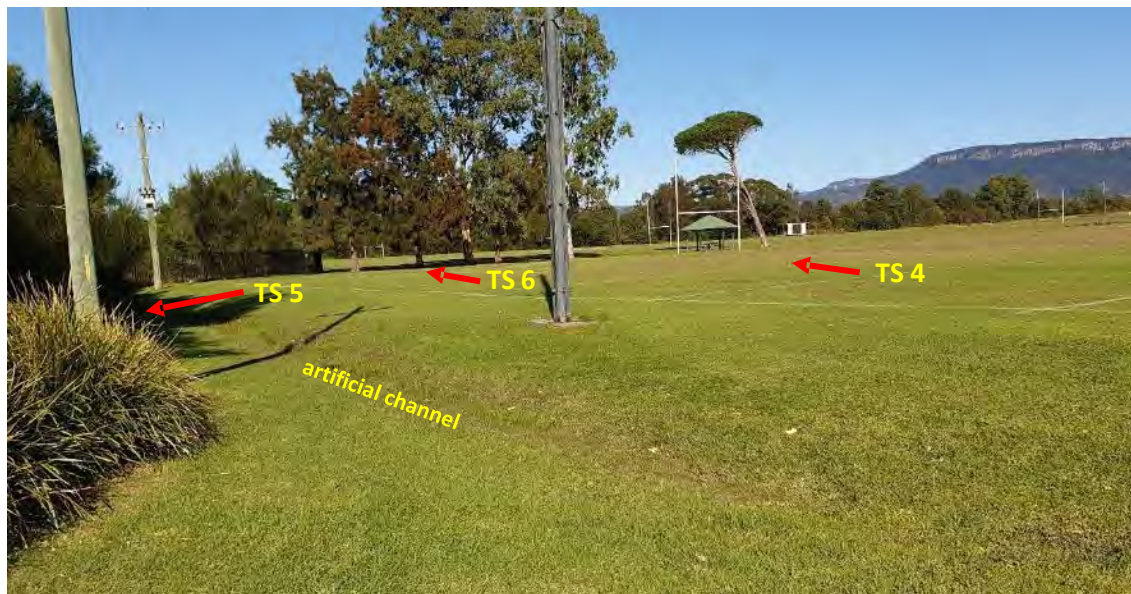
Plate 3. AAS at Reed Park, facing south-west, flagged TS 4, 5 and 6. banks to the left and artificial channel marked in foreground.

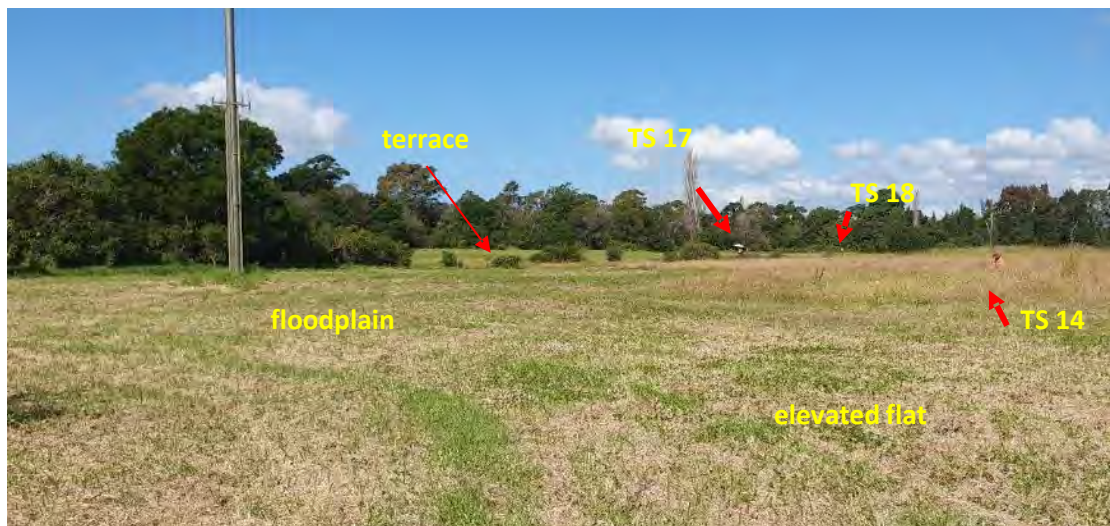
Plate 4. View south east across floodplain and elevated flat west of the anabranch, and terrace in the distance; excavation in progress at TS 14 at right, and at TS 17 and 18 on the terrace in the distance.

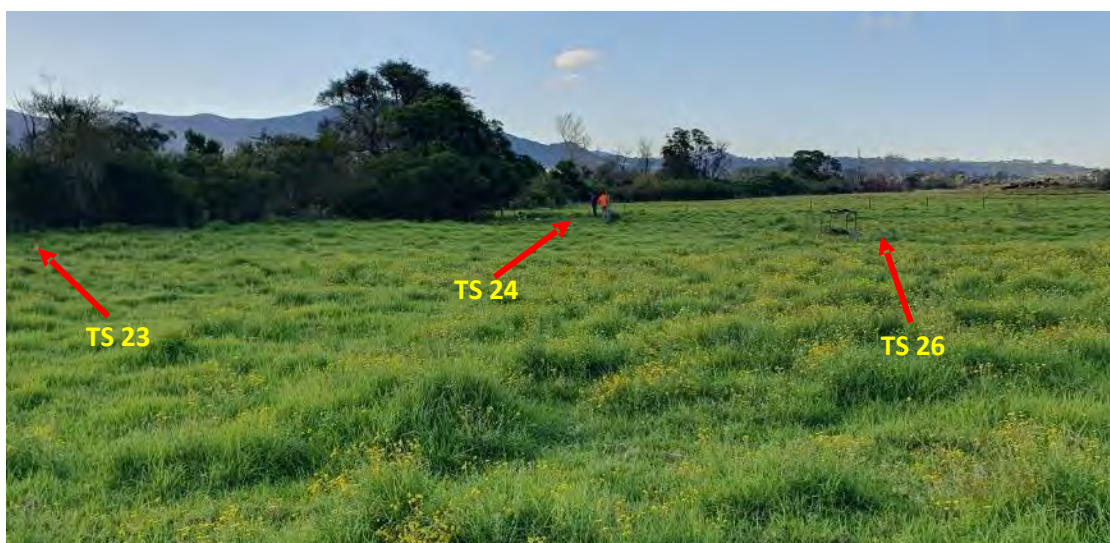
Plate 5. Terraces along the eastern side of facing north; flagged TS23 and 26, excavation in progress at TS 24 in the distance.

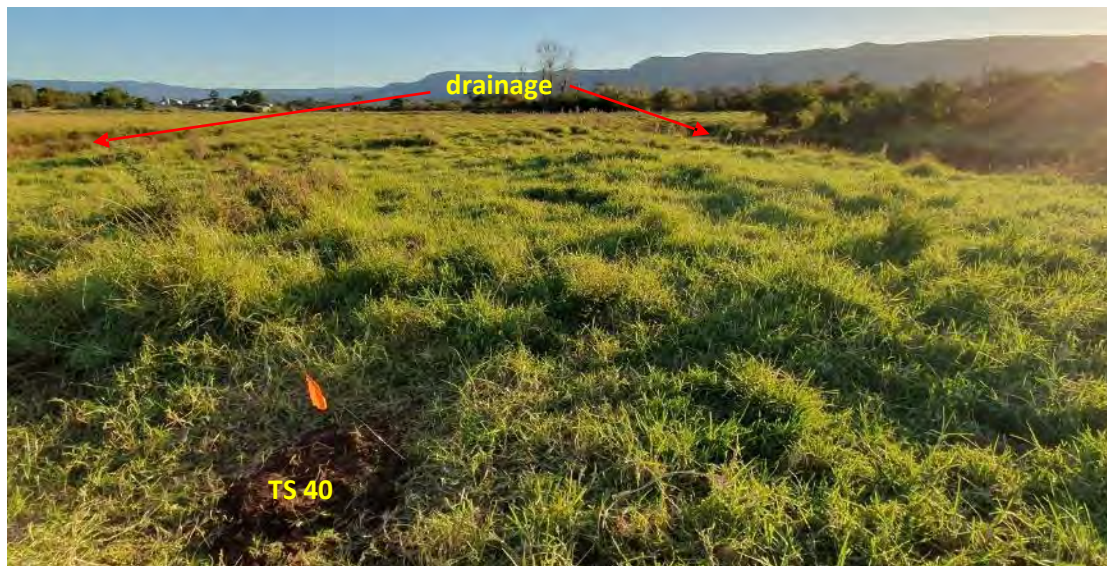
Plate 6. Terrace at the northernmost portion of [REDACTED] AAS, flagged TS 40 in the foreground, facing south east, drainage lines demarcating terrace to the left and right.

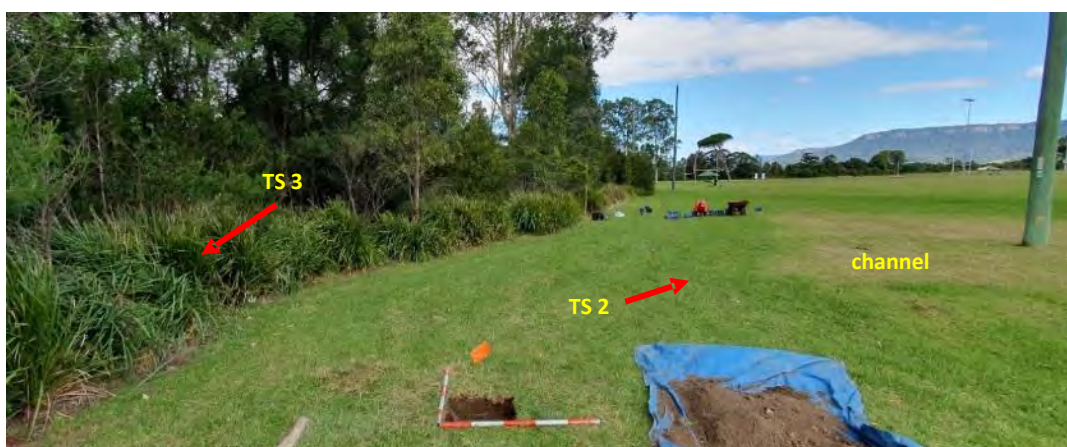
Plate 7. South of Bong Bong Road, excavated TS 1 in the foreground, excavation in progress at TS 2 in the background, marked location of TS 3 to the left adjacent to [REDACTED] banks, facing south.

The southernmost portion of the [REDACTED] AAS was located within the eastern part of [REDACTED] south of [REDACTED]. The alluvial flat landform extended from [REDACTED] in the north to the [REDACTED] confluence in the south (Plate 8). The entire area was within a significantly modified landscape due to the installation of sports fields; the area was flat with dry turf and grass cover. An above ground transmission line runs north-south across the study area with transmission poles located along its eastern boundary. One small artificial cut drainage channel ran north-south from Bong Bong Road to the [REDACTED] dam located at the centre of the study area alignment (Plate 3). Another small drainage was also noted running east into the dam. Review of the historical aerial (Plate 2) indicates that modifications to [REDACTED] have taken place during the recent past however the extent of these could not be observed on the surface. The creek banks were covered in dense regrowth native and exotic vegetation, with very few mature trees. A total of 10 test squares were placed on a 20 to 40 metre interval across the area of impact along the western side of [REDACTED]. One test square (TS 5) was placed between [REDACTED] and the artificial channel in an area that was slightly more elevated in order to establish if natural soils adjacent to the creek banks were still present. The area to the south of [REDACTED] is a distinct elevated flat between [REDACTED] to the east and a channel to the west and south; three test squares (TS 1-3) were placed in this area, with TS 3 located within the vegetated strip adjacent to the creek banks (Plate 7).

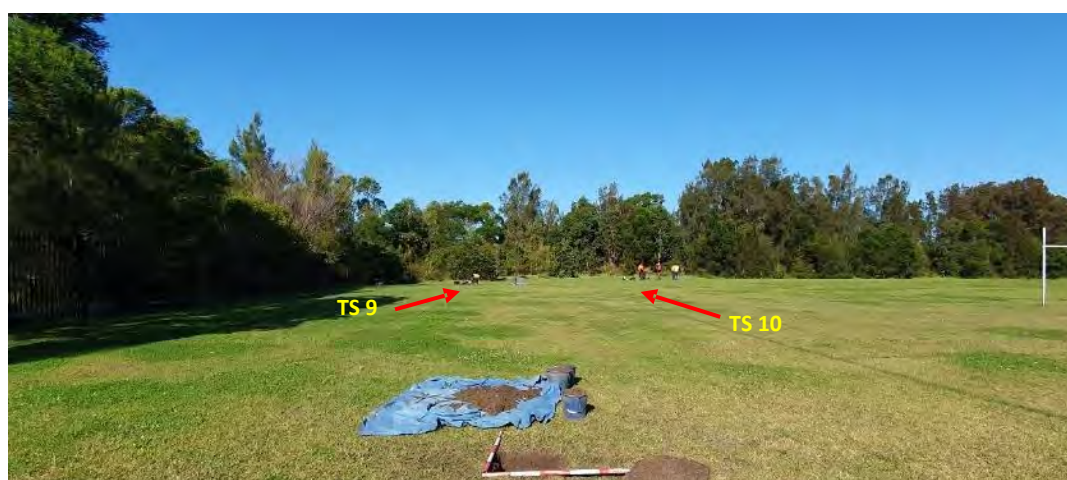
Plate 8. Alluvial flat at the southern end of Reed Park, north of [REDACTED] confluence, facing south, excavated TS 8 in the foreground, with excavation in progress at TS 9 and 10 in the background.

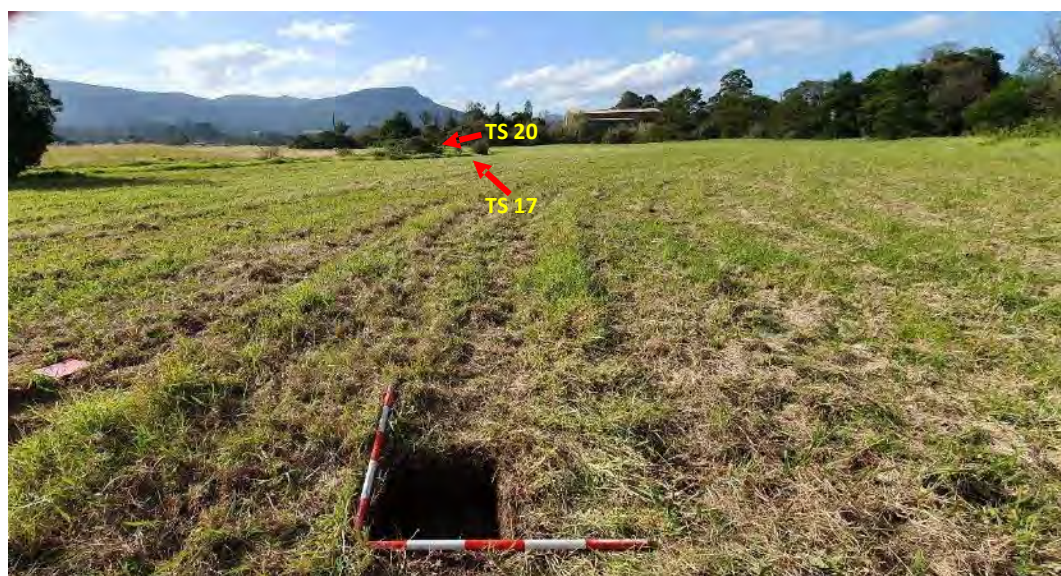
Plate 10. Terrace between [REDACTED] and its anabranch, facing south, excavated TS 18 in the foreground, with flagged TS 17 in the background and excavation in progress at TS 20 in the distance.

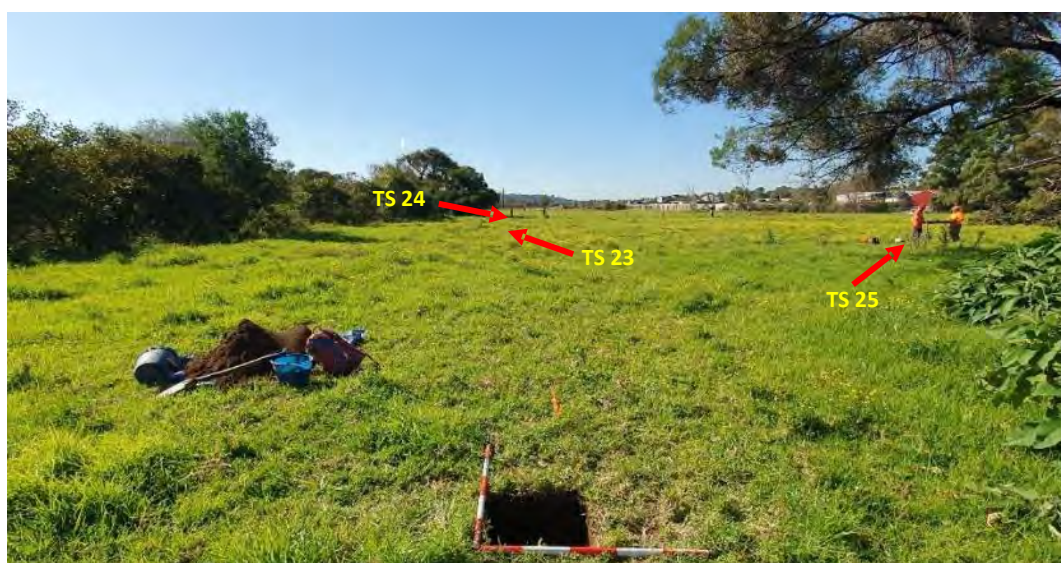
Plate 11. Terrace on the eastern bank of [REDACTED] facing north, excavated TS 22 in the foreground, with excavation in progress at TS 25 to the right and flagged TS 23 and 24 in the background.

The southernmost terrace was bordered by a residential area to the south and a small drainage line to the north (Plate 11). It was covered in short pasture grass with a few regrowth trees scattered and denser cover located around the creek banks. Visible disturbance included an existing sewer alignment and a fenceline, both running west-east. A total of seven test squares (TS 22-28) across two transects were placed on a 20 to 40 metre interval. All transects were oriented south-west – north-east following the proposed alignment orientation. Two transects 20 metres apart were placed south of the fenceline with a total of five test squares (TS 22 – 26), while one transect with two test squares 20 metres apart was placed north of the fenceline (Plate 11).

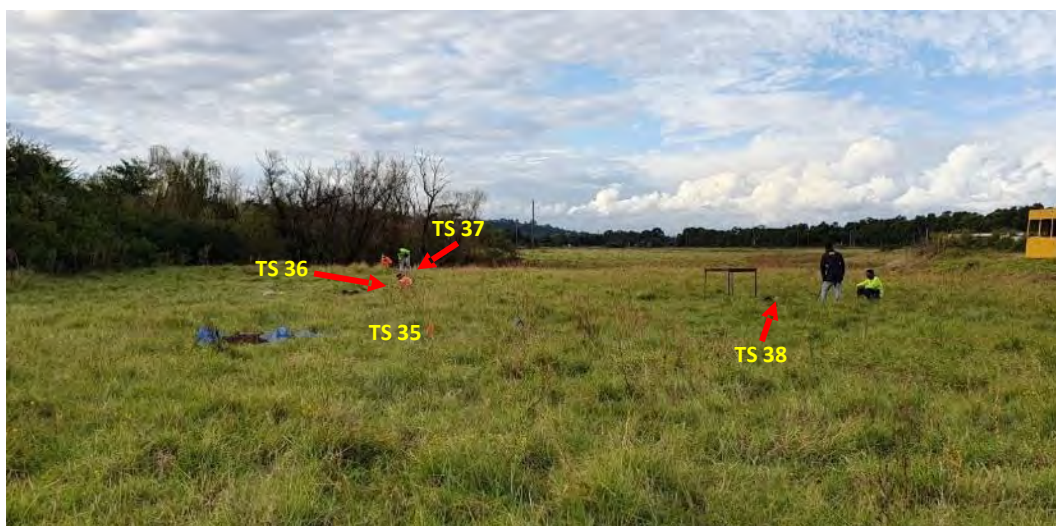
Plate 13. Terrace north of the artificial drainage, facing north; excavated TS 35 in the foreground, recording at TS 36 and excavation at TS 37 in the background, flagged TS 38 to the right.

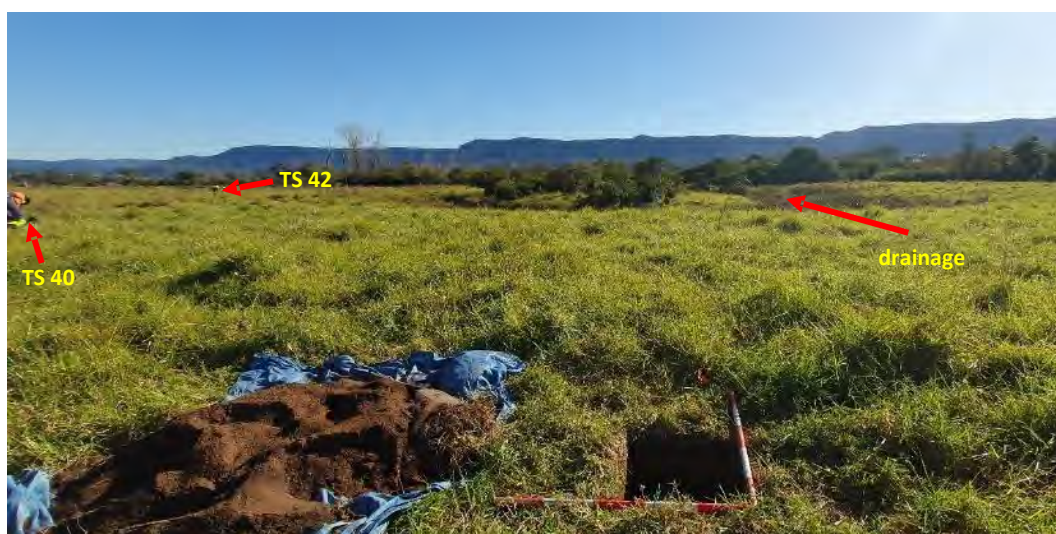
Plate 14. Terrace south of the [REDACTED] anabranch, facing south west, excavated TS 39 in the foreground, with excavation in progress at TS 40 in the background, and TS 42 in the distance.

The northernmost portion of the [REDACTED] AAS was located on a terrace approximately 160m long to the south of Darkes Road. The terrace is located adjacent to sections of small former anabranch channels off the main creek, which bend into almost oxbow formations and currently form low-lying swampy closed depressions. Review of historical aerials confirm these are natural drainage features and likely represent former creek channels; review of the Calderwood Parish map indicates this section of [REDACTED] may have migrated west (Plate 1). The drainage features had extensive erosion along their banks with the edges of the terrace also eroding. Another small drainage is located to the south of the terrace (Plate 6). A total of four test squares (Ts 39-42) were placed at both the eastern and western ends of the terrace. Two transects with two test squares each on a 20 metre interval were placed approximately 85 metres apart within the proposed impact area.

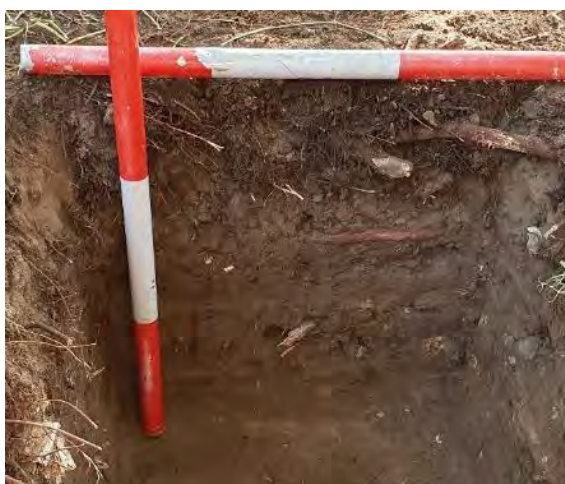
Figure 8. TS 3 west section and soil profile description

- I. 0-14cm: Grey sand. Loose. Humic, frequent root systems. Diffuse boundary to:
- II. 14-50cm: Mixed layer. Grey sandy silt with high sand content mixed with grey and yellow clay. High disturbed. Introduced fill material mottled with some natural soil. Abundant Fe/Mn, blue metal gravel, large rocks and gravel and decomposing sandstone fragments inclusions. Tree roots throughout. High compaction. Continuing to the base.

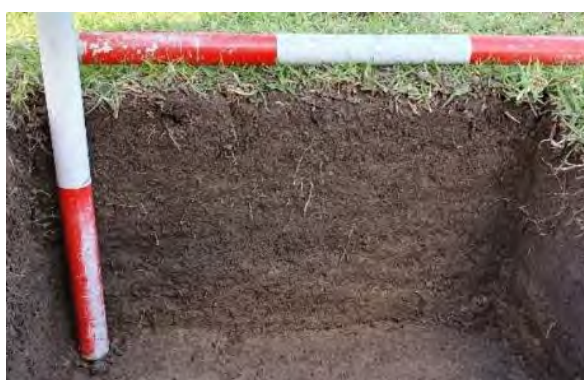
Figure 9. TS 4 east section and soil profile description

- I. 0-2cm: Humic layer, frequent fine root systems. Turf grass. Diffuse boundary to:
- II. 2-20cm: Dark red brown sandy loam. Low to moderate compaction. Green mesh included at 10cm depth covering the entire square. No other imported material at deeper layers. Infrequent small gravel inclusions. Diffuse boundary to:
- III. 20-30cm: Yellow orangy brown sandy clay. Fe/Mn nodules <2% inclusions. Diffuse boundary to:
- IV. Base: Yellow brown clay. Heavy. Plastic. High compaction.

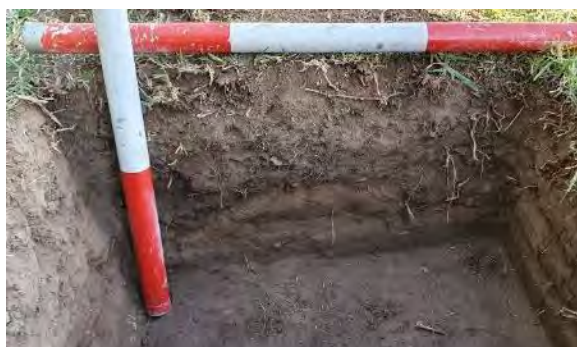
Figure 10. TS 5 south section and soil profile description

- I. 0-7cm: Humic layer, frequent fine root systems. Diffuse boundary to:
- II. 7-22cm: Dark greyish brown loam. Introduced fill with some mixing of natural soil. Small blue metal gravel inclusions. Moderate compaction. Clear boundary to:
- III. 22-26cm: Pale yellow sand. No gravel inclusions. Loose. Clear boundary to:
- IV. 26-30cm: Dark brown clay. Some loam content. Gravel and blue metal inclusions. Clear boundary to:
- V. Base: Dark brown clay. Plastic. High compaction.

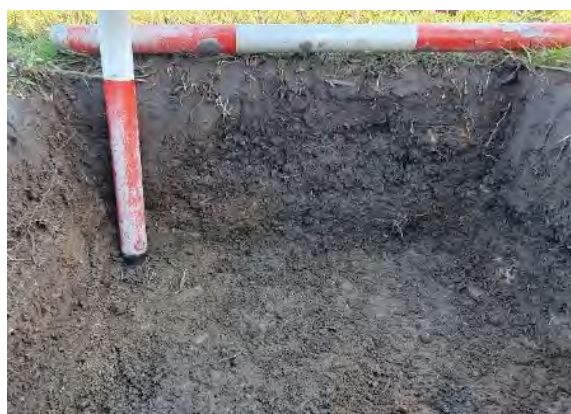
Figure 11. TS 8 west section and soil profile description

- I. 0-3cm: Humic layer, frequent fine root systems. Diffuse boundary to:
- II. 3-19cm: Greyish brown sandy loam. Low compaction. Infrequent nodules of ironstone/manganese <2cm ~1%. Clear boundary to:
- III. 19-34cm: Pale grey, almost bleached, sandy clay loam. Increased content of yellow brown clay. Size and frequency of ironstone/manganese nodules to ~50%. Diffuse boundary to:
- IV. Base: Yellow brown mottled clay. Scattered roots still visible, bioturbated.

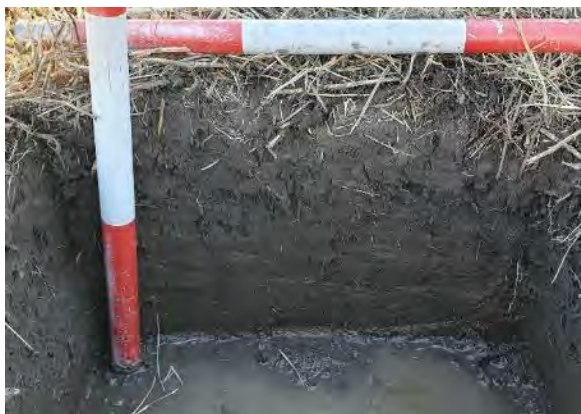
Figure 12. TS 11 west section and soil profile description

- I. 0-14cm: Dark brown clay loam. Humic, frequent root systems. Very greasy and moist. Diffuse boundary to:
- II. 14-30cm: Dark brown clay loamy silt. Increase in patches in yellow clay from 16cm depth. Very greasy and moist. High compaction. Diffuse boundary to:
- III. Base: Dark brown clay loamy silt. High clay content. Water seepage, highly saturated.

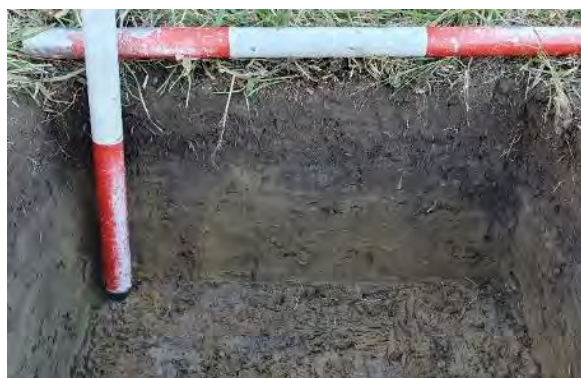
Figure 13. TS 13 north section and soil profile description

- I. 0-5cm: Dark grey sandy clay loam. Humic, frequent fine root systems. Moist. Diffuse boundary to:
- II. 5-14cm: Dark grey sandy clay loam. Moist. High clay content. Undulating. Diffuse boundary to:
- III. 14-28cm: Yellow clay. Plastic. Heavy. High compaction.

Soil profiles encountered across the alluvial flats and floodplain north of Bong Bong Road on the western side of [REDACTED] and its small anabranch were relatively homogenous and uniform. They were shallow and consisted of dark brown clay loams with higher moisture revealed within the floodplain (Figure 12). The alluvial flat, although on a slightly higher elevation than the floodplain, also had shallow moist clay loams with some gravel overlying basal clays at an average depth of 20cm (Figure 13-14).

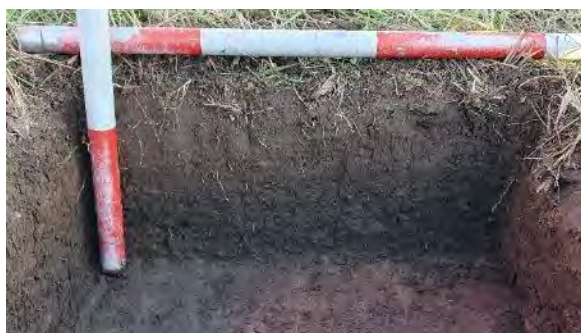
Figure 14. TS 14 south section and soil profile description

- I. 0-6cm: Humic layer, frequent fine root systems. Grey brown sandy clay loam. Diffuse boundary to:
- II. 6-10cm: Grey brown sandy clay loam. Low to moderate compaction. Infrequent small gravel inclusions <5%. Diffuse boundary to:
- III. 10-25cm: Grey sandy clay loam. High clay content and increasing with depth. Gravel increasing to <10%. Moist. Diffuse boundary to:
- IV. Base: Yellow orange clay. High compaction. Some gravel still inclusions.

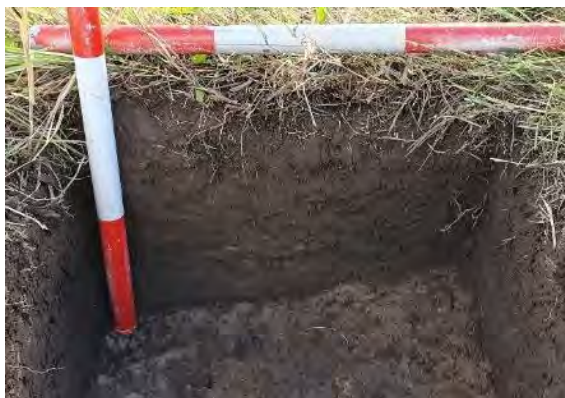
Figure 15. TS 18 west section and soil profile description

- I. 0-9cm: Humic layer, frequent fine root systems. Dark brown silty clay loam. Diffuse boundary to:
- II. 9-33cm: Homogenous dark brown clay loam. High clay content. Greasy, heavy clay at 16cm depth. High compaction. Diffuse boundary to:
- III. Base: Mottled orange and yellow clay. Plastic. Heavy. Moist.

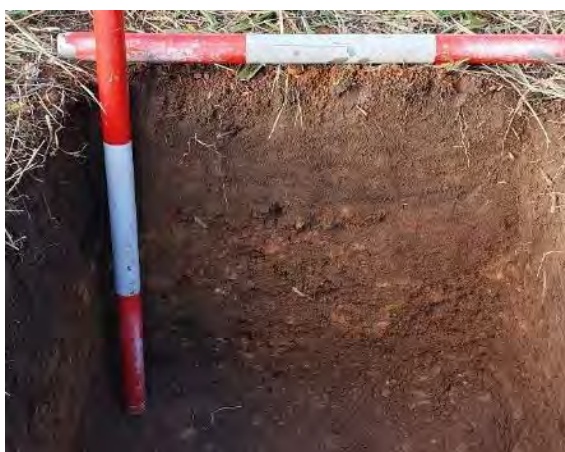
Figure 16. TS 19 north section and soil profile description

- I. 0-5cm: Humic layer, frequent fine root systems. Dark brown sandy clay loam. Diffuse boundary to:
- II. 5-18cm: Dark brown sandy clay loam. Moderate compaction. Gravel <20mm ~1%. Clear boundary to:
- III. 18-44cm: Reddish brown sandy clay loam. Abundant river gravel and pebbles <20mm ~70%, and increasing with depth. Diffuse boundary to:
- IV. Base: Red brown sandy clay. River gravel and pebbles inclusions. High clay content.

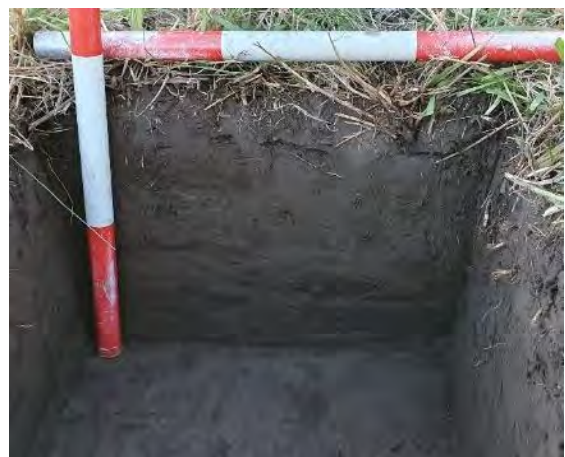
Figure 17. TS 20 north section and soil profile description

- I. 0-10cm: Dark brown silty clay loam. Very moist. Humic. Frequent fine root system. Diffuse boundary to:
- II. 10-38cm: Homogenous unit. Dark brown silty clay loam. Very moist. High clay content. High compaction, and increasing from 15cm depth. Towards the base increase in compaction. Diffuse boundary to:
- III. Base: Highly compacted, cemented dark brown silty clay.

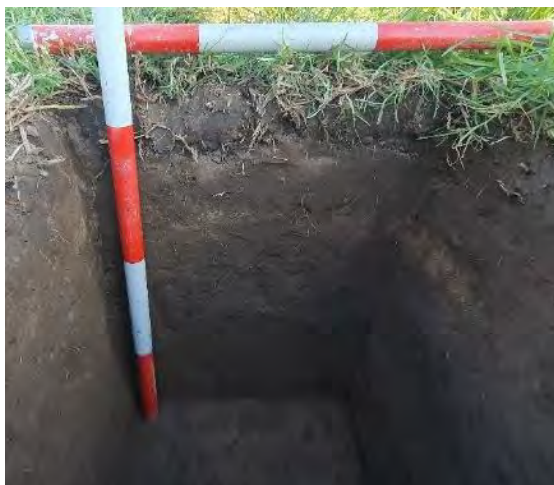
Figure 18. TS 22 south section and soil profile description

- I. 0-9cm: Dark brown silty loam. Humic, frequent root systems. Slightly moist. Diffuse boundary to:
- II. 9-40cm: Yellow brown (Munsell 7.5YR 4/4) sandy silt loam. Slightly moist. Low compaction. Diffuse boundary to:
- III. 40-60cm: Dark brown silty sand. Some clay content. Charcoal patches throughout, burnt tree root. Diffuse boundary to:
- IV. Base: Dark brown sandy clay. Moderate to high compaction.

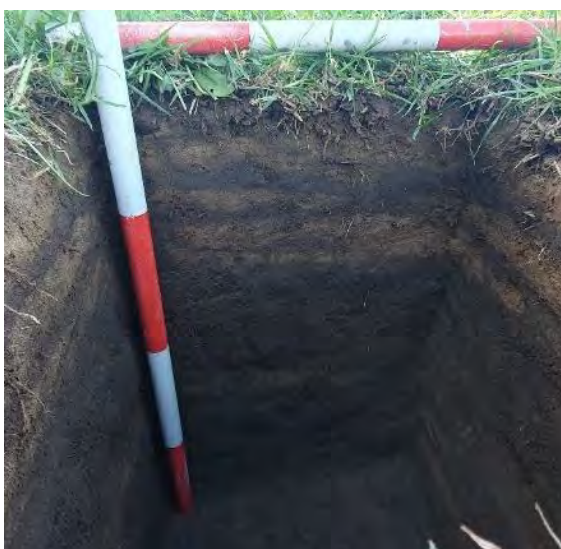
Figure 19. TS 24 north section and soil profile description

- I. 0-6cm: Pale brown sandy loam. Visible medium sand grains. Humic, frequent fine root systems. Loose. Diffuse boundary to:
- II. 6-8cm: Dark brown sandy clay loam. High clay content. Dry. Moderate compaction. Diffuse boundary to:
- III. 8-14cm: Dark brown sand. Some clay content. Moderate compaction. Clear boundary to:
- IV. 14-17cm: Dark brown sandy clay loam. Dry. High compaction. Diffuse boundary to:
- V. 17-40cm: Pale brown sandy clay loam. Diffuse boundary to:
- VI. 40-52cm: Dark brown sandy clay loam. Visible medium sand grains. Clear boundary to:
- VII. 52-60/62cm: Pale brown sandy clay loam. Clear boundary to:
- VIII. 60/62-65cm: Dark brown sandy clay loam. High compaction. Clear boundary to:
- IX. 65-70cm: Dark brown clay. Dry.

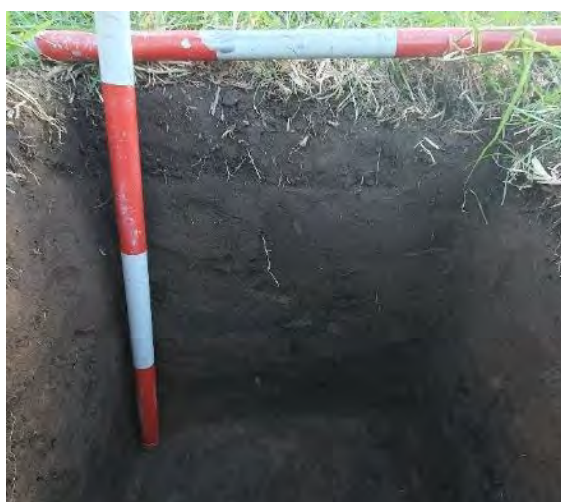
Figure 20. TS 25 west section and soil profile description

- I. 0-7cm: Dark brown sandy loam. Humic layer, frequent fine root systems. Diffuse boundary to:
- II. 7-35cm: Dark brown sandy clay loam. Abundant gravel inclusions. Some blue metal inclusions to 20cm depth. Low to moderate compaction. Diffuse boundary to:
- III. 35-60cm: Dark brown silty loam. High clay content and increasing with depth. Small patches of charcoal at the western wall. Diffuse boundary to:
- IV. Base: Yellow brown clay. Some sandy loam still included. High compaction.

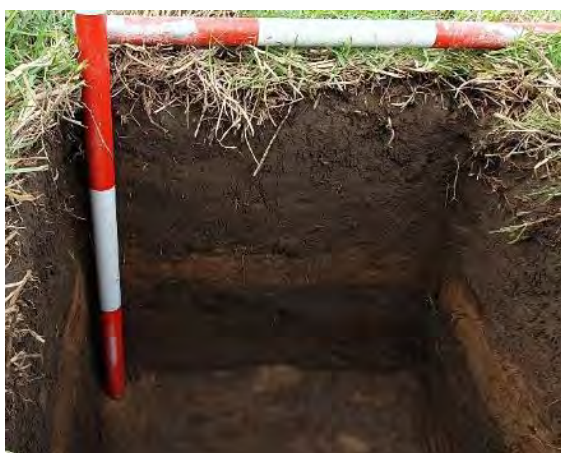
Figure 21. TS 28 east section and soil profile description

- I. 0-7cm: Humic layer, frequent fine root systems. Dark brown sandy clay loam. Moderate compaction. Diffuse boundary to:
- II. 7-21cm: Dark brown sandy clay loam. Visible sand grains. High clay content. Moderate compaction. Clear boundary to:
- III. 21-31cm: Yellow brown sand. Medium sand grains. Moist. Scattered gravel inclusions. Clear boundary to:
- IV. 31-37cm: Greyish brown sandy clay loam. Increase in clay content. Thick, plastic clay. Diffuse boundary to:
- V. 37-50cm: Dark brown sandy clay loam. Mottled with yellow brown sub-rounded gravel $\phi < 20\text{mm}$ increasing from 38cm depth. Clear boundary to:
- VI. Base: Mottled dark yellow brown sandy clay.

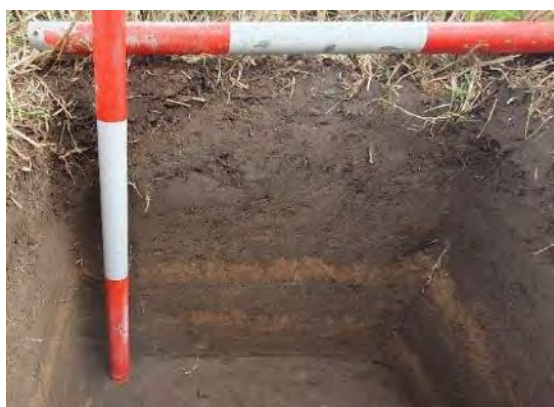
Figure 22. TS 29 west section and soil profile description

- I. 0-5cm: Humic layer, frequent fine root systems. Grey brown silty clay loam. Diffuse boundary to:
- II. 5-25cm: Dark brown sandy clay loam. Moderate compaction. Clear boundary to:
- III. 25-29cm: Yellow orange brown coarse sand. Low compaction. Clear boundary to:
- IV. 29-38cm: Mottling of dark brown sandy clay loam and yellow orange sand in bends. Moderate compaction. Diffuse boundary to:
- V. 38-40cm: Dark brown silty sandy clay. Diffuse boundary to:
- VI. Base: Dark brown clay. Some silt still included.

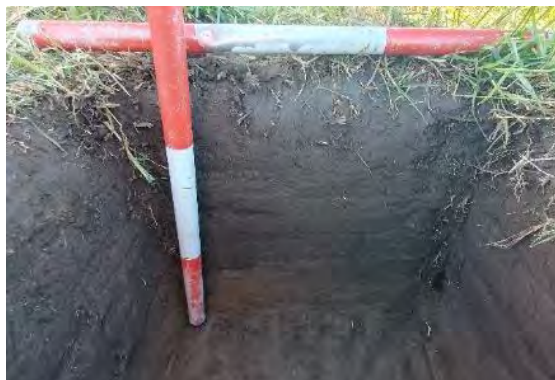
Figure 25. TS 39 north section and soil profile description

- I. 0-9cm: Dark brown silt loam. Humic, frequent root systems. Moderate compaction. Diffuse boundary to:
- II. 9-30cm: Dark brown silty loam. Some clay content. Moderate compaction. Fe/Mn nodules ~2%. Some charcoal flecking along the eastern section. Diffuse boundary to:
- III. 30-48cm: Orangy brown clay loam. Clay content increasing with depth. Moderate compaction. Diffuse boundary to:
- IV. Base: Orangy brown clay. High compaction.

Soils on the terrace adjacent to the anabranch drainage features at the northernmost extent of [REDACTED] AAS were uniform and moderately deep. They consisted of dark brown silty loams overlying orangy brown clay loams with high clay content above basal clay subsoils. Very small amounts of Fe/Mn nodules indicated some waterlogging, however, the profiles suggested relatively stable soils, apart from some bioturbation.

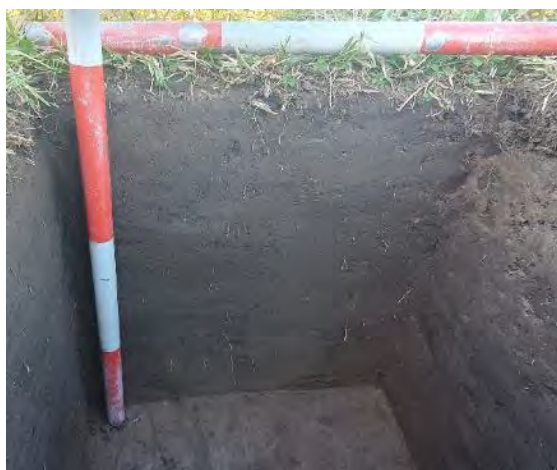
Figure 26. TS 40 east section and soil profile description

- I. 0-3cm: Greyish brown clay loam. Humic, frequent fine root systems. Diffuse boundary to:
- II. 3-40cm: Dark brown sandy clay loam. Visible sand grains. Dry. Moderate compaction. Fe/Mn $\phi < 20\text{mm}$ ~10% inclusions. Increase in sand from 37cm depth with low compaction. Diffuse boundary to:
- III. 40-60cm: Pale brown sandy clay loam. Visible sand grains increasing and loose compaction from 40 to 45cm depth. Increase in plastic red yellow patches. Increase in plastic red yellow clay at 51cm depth. Clear boundary to:
- IV. Base: Pale brown light sandy clay. Increase in red yellow clay patches. High compaction.

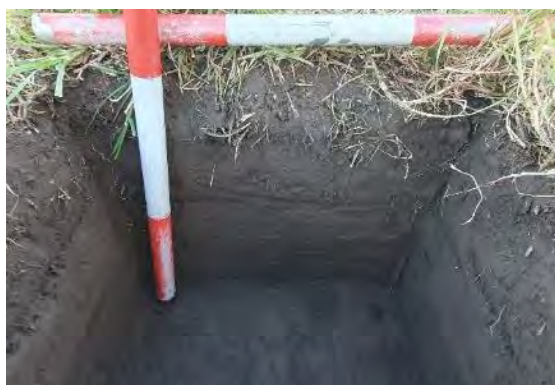
Figure 27. TS 42 west section and soil profile description

- I. 0-7cm: Dark brown clay loam. Humic layer, frequent fine root systems. Slightly moist due to recent rain. Diffuse boundary to:
- II. 7-40cm: Homogenous unit. Dark brown clay loam. Moderate compaction. Clay content increasing with depth. Bioturbated throughout. Diffuse boundary to:
- III. Base: Grey brown clay. Plastic. High compaction.

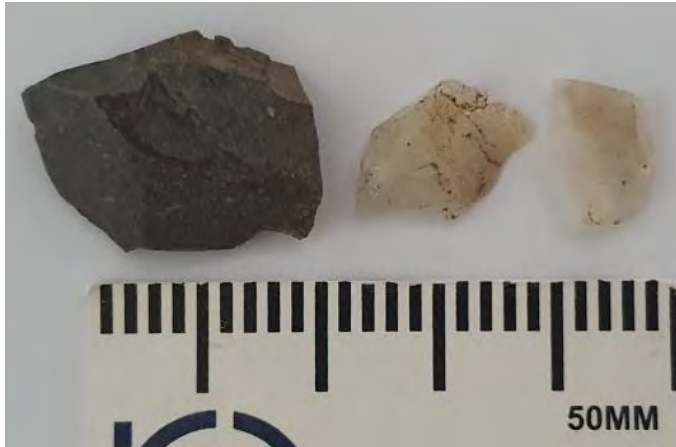
Plate 15. Silcrete flake and quartz artefacts with cortex from TS 4, spit 3 (20-30cm), ID# 1, 2 and 3.

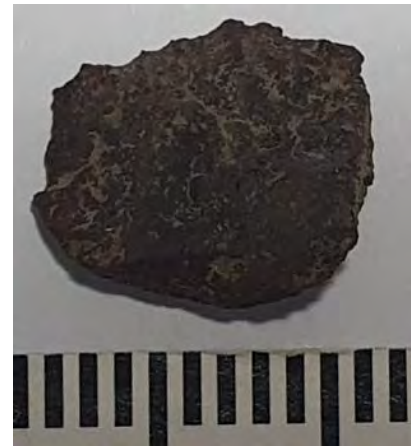
Plate 16. Chert artefact from TS 13, spit 3 (20-30cm), ID# 5.

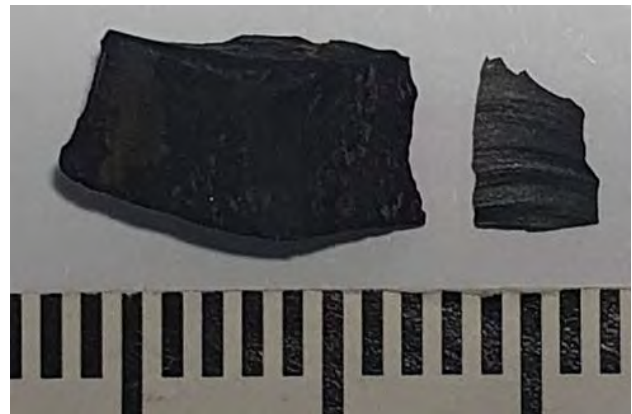
Plate 18. Petrified wood artefacts from TS 40, spit 3(20-30cm) and spit 5 (40-50cm), ID# 11 and 15.

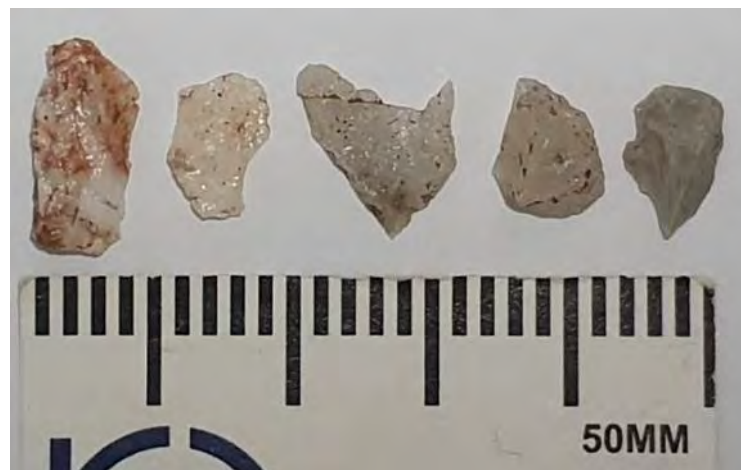
Plate 19. Quartz artefacts from TS 40, and silcrete flake from TS 39: ID# 13,14, 12, 9 and 8.

A relatively small percentage of artefacts retained cortex (n=5, 33.3%). The majority of the cortical artefacts displayed between 1 and 30% of remnant cortex (n=4, 80% of cortical artefacts), while the quartzite hammerstone fragment had more than 70% of cortex still remaining. Quartz had the most cortical raw material with three artefacts (Plate 15) while the single petrified wood core had 1-30% cortex remaining (Plate 20), indicating that earlier stage reduction of these raw material was taking place in the area. The sole core was recovered from TS 29, located on a small terrace adjacent to the eastern side of [REDACTED]. The core was retrieved from depths between 30 and 40cm from a silty to sandy clay layer overlying the basal clay. It was unifacially rotated and had a total of two negative flake scars (Plate 20).

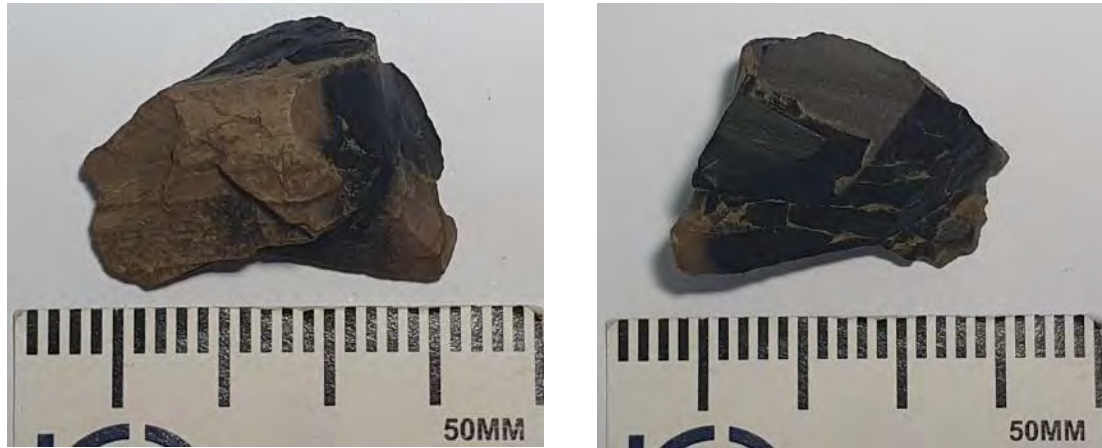
Plate 20. Petrified wood core with cortex, from TS 29, spit 5 (40-50cm): ID# 7.

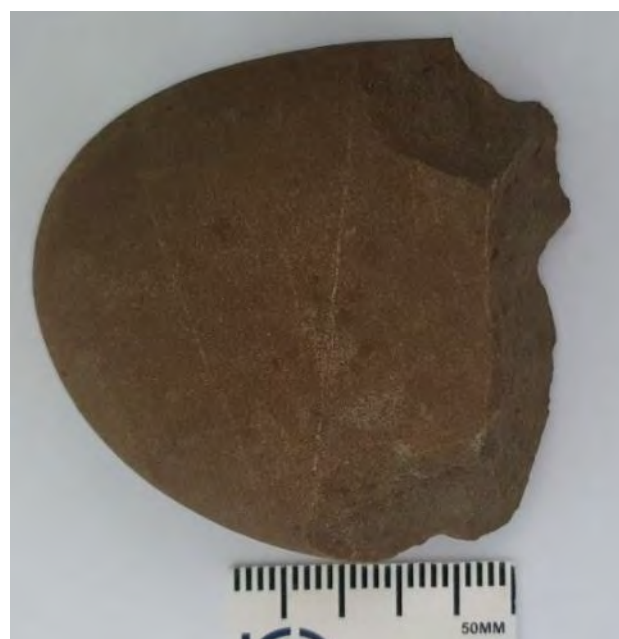
Plate 22. Quartzite hammerstone/grinding stone fragment, from TS 5: ID# 4.

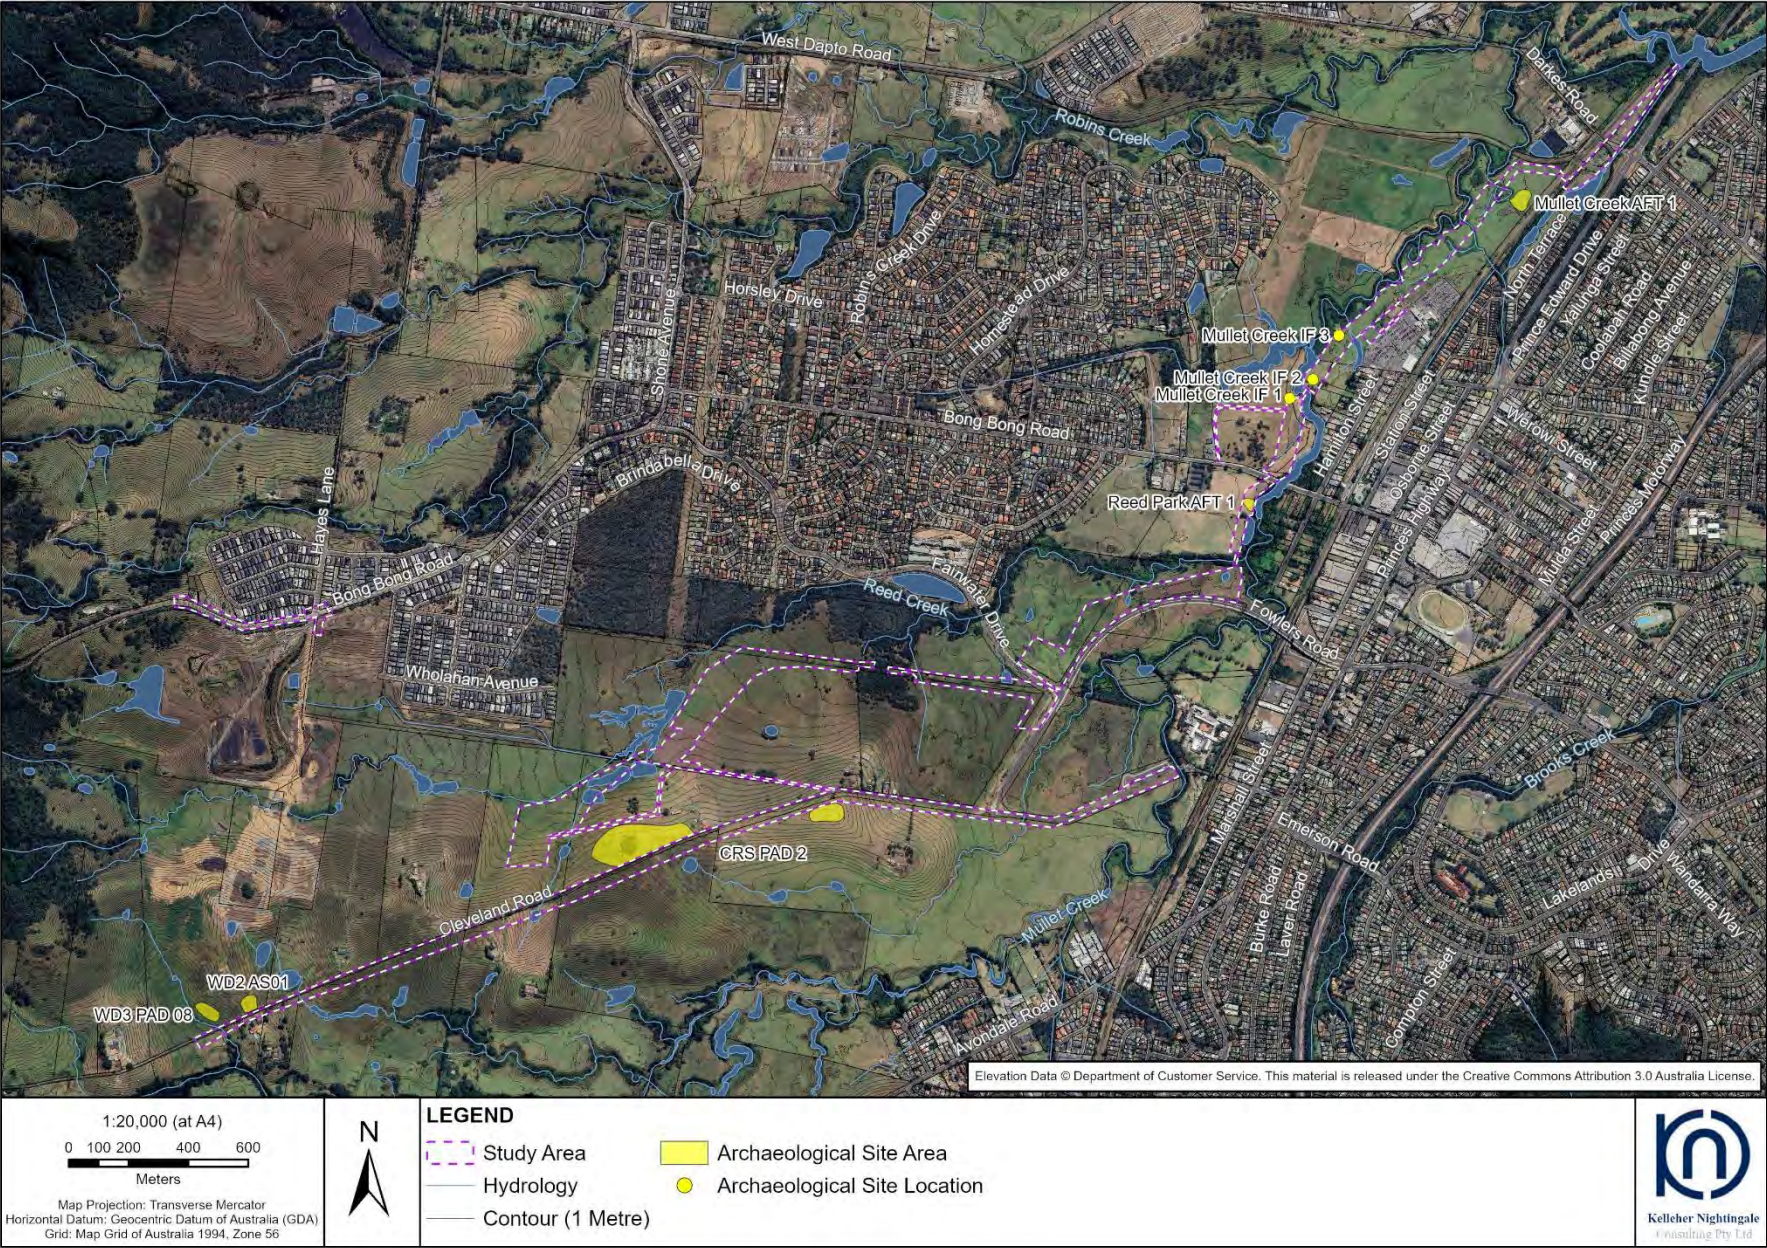
Figure 30. Identified archaeological sites within and near to WD3 Part 3A study area

Overall, it is considered that the recovered assemblage represents scattered cultural material from the area resulting from Aboriginal land use along the creek corridor; however archaeological integrity was generally found to be poor and the recorded objects have likely been dispersed and disturbed to some degree by flooding events, bioturbation and past land use activities. Due to the presence of positive test squares across a range of separate and distinct terraces and alluvial flats around [REDACTED], five separate Aboriginal sites have been recorded as a result of the test excavation. These comprise artefact scatter sites [REDACTED] AFT 1 (TS 4 and 5) and [REDACTED] AFT 1 (TS 39 and 40), and isolated find sites [REDACTED] IF 1 (TS 13), [REDACTED] IF 2 (TS 25) and [REDACTED] IF 3 (TS 29). Although [REDACTED] IF 2 and 3 are relatively close to one another, they are located on two distinct terraces, and therefore have been recorded as two separate sites. It is considered likely that similar low density and dispersed artefact occurrences exist within the study area and adjacent alluvial landforms bordering the creek corridor, generally forming part of the 'background scatter' of cultural materials across the landscape. Identified site locations in relation to the current WD3 Part 3A study area, and other identified nearby sites, are shown in Figure 30.

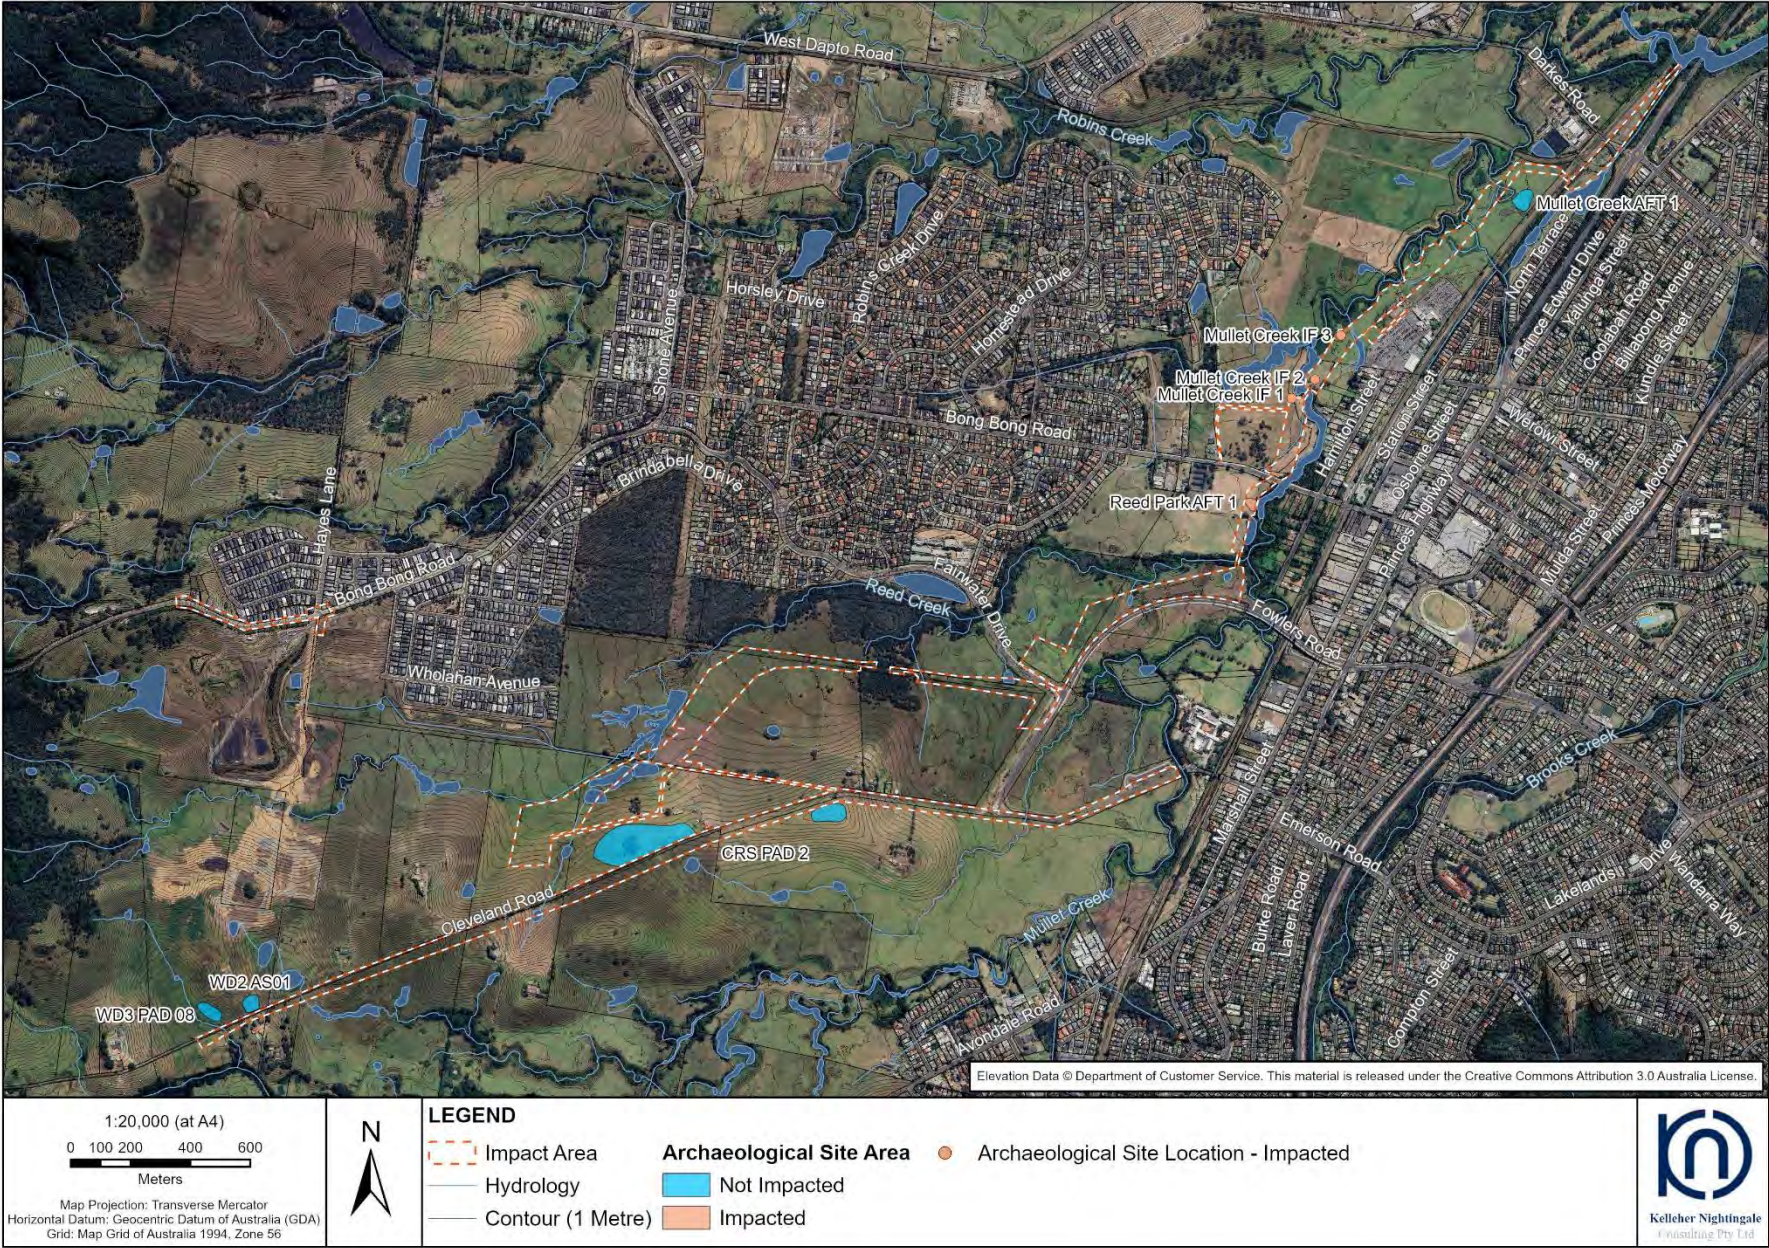
Figure 31. WD3 Part 3A impact area and identified Aboriginal archaeological sites

Based on impact assessment for the current WD3 Part 3A works corridor, four identified Aboriginal archaeological sites would be impacted (Table 6, Figure 31). The remainder of the identified sites/PADs adjacent to but outside of the study area and proposed works area would not be impacted by the proposal.

- Non-impacted Aboriginal archaeological sites in the vicinity (outside of study area boundary) as identified in Figure 31 should be marked on the CEMP prior to construction activities to ensure these sites and areas of archaeological sensitivity are avoided and not impacted by the proposed works. The sites/areas should be marked as environmentally sensitive “no-go zones”.
