Review of Environmental Factors

**Maroubra Reservoir (WS0067) Dam safety works
and condition assessment.**

Sydney
WATER

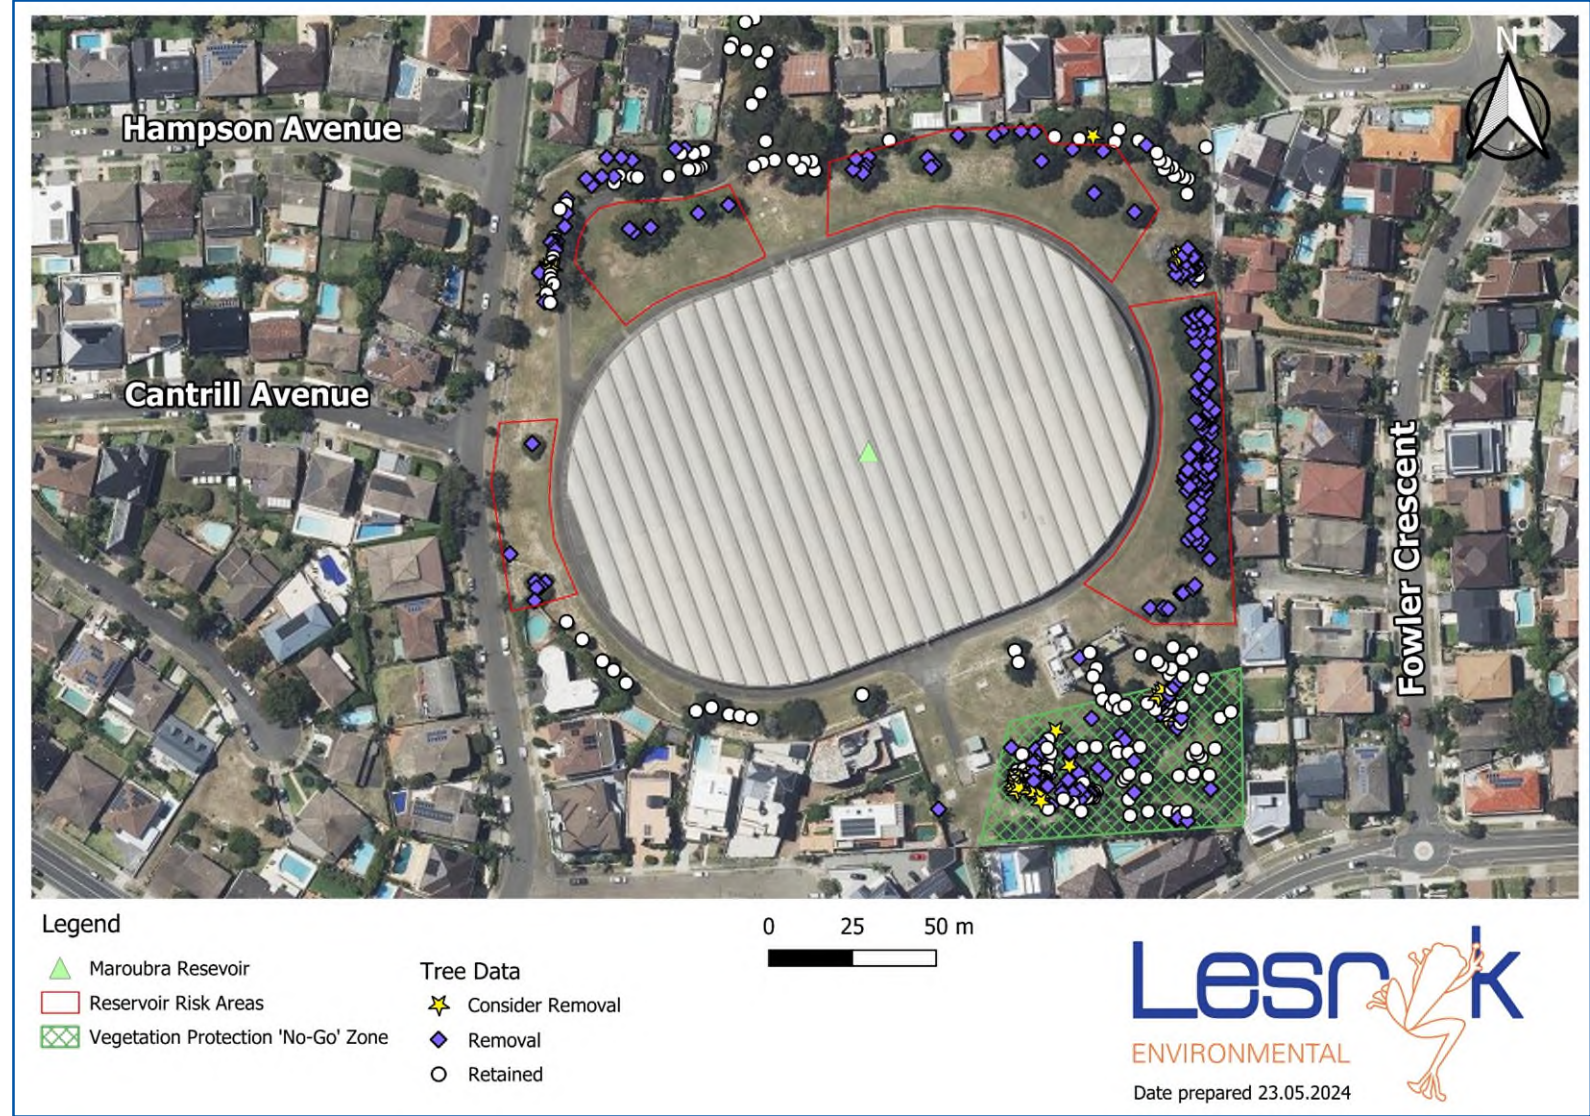
Figure 3-1 Location of proposal and key environmental constraints, illustrating the location of vegetation individuals required to be removed and individuals targeted and planned to be retained, as identified by Canopy Consulting 2024 (taken from Lesryk Environmental, 2024).

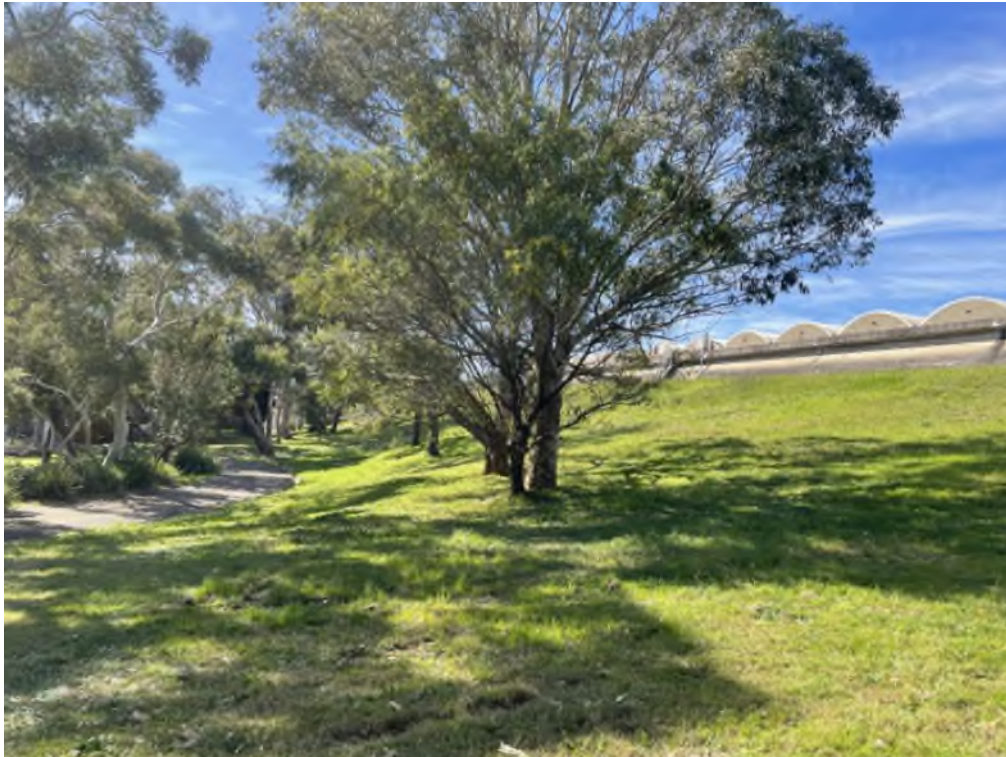
Figure A1: Maroubra Reservoir embankment along the eastern boundary, viewing north and showing vegetation on the embankment that requires removal. Residential properties shown are Fowler Crescent properties.

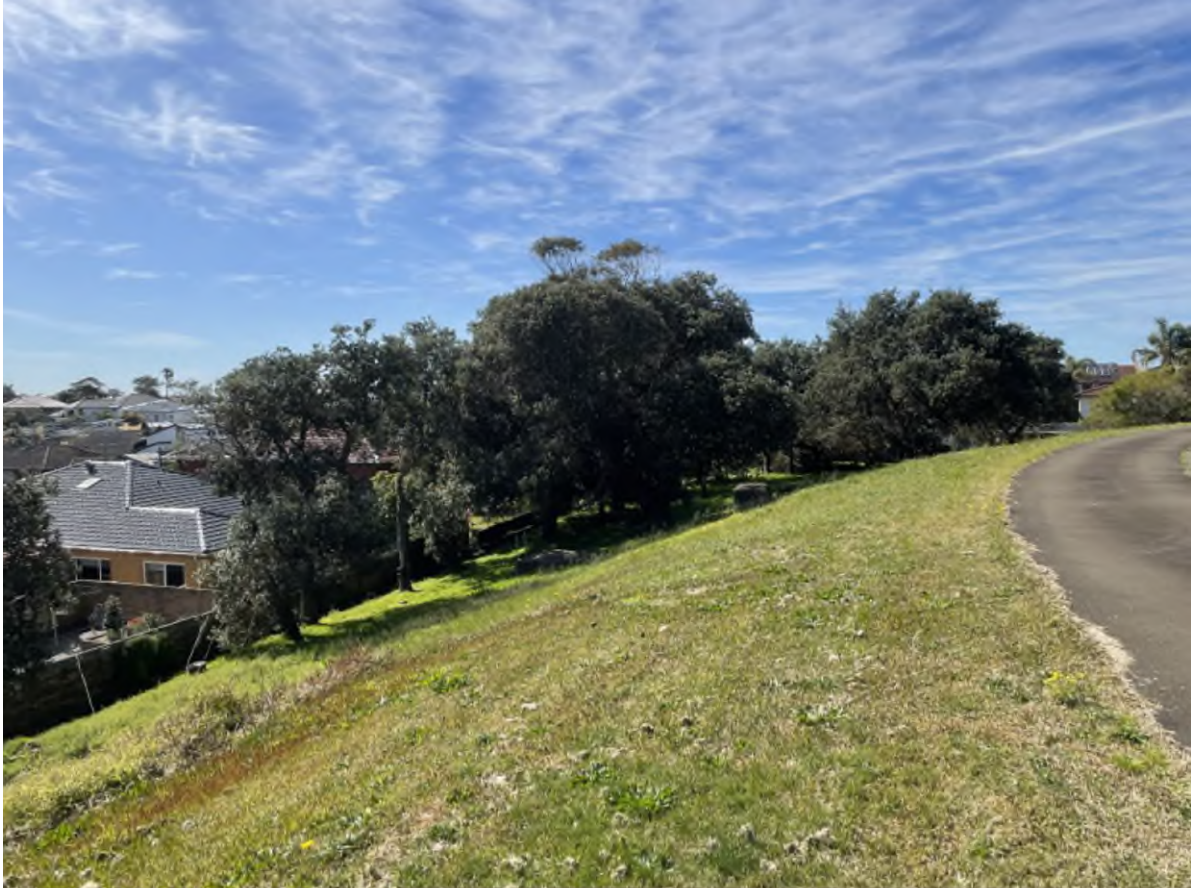
There is evidence of foxes (*Vulpes vulpes*) occupying the site and digging fox dens within and into the embankment. The fox is a *Priority Pest Animal* in accordance with the *Biosecurity Act 2015*. The biosecurity risks and impacts posed or likely to be posed by priority pest animal species are generally regulated under Part 3 of the *Biosecurity Act 2015* (NSW) and the general biosecurity duty requirements. The condition assessment is unlikely to have a specific, direct influence of foxes, however the implementation of any corrective actions identified from the condition assessment would be expected to support actions that discourage and inhibit foxes. It is expected that the condition assessment would identify the need for a corrective action regarding the existing fox den onsite, and it would likely be infilled in accordance with dam safety requirements.

Figure A3: Fox (*Vulpes vulpes*) den constructed into the Maroubra Reservoir embankment.

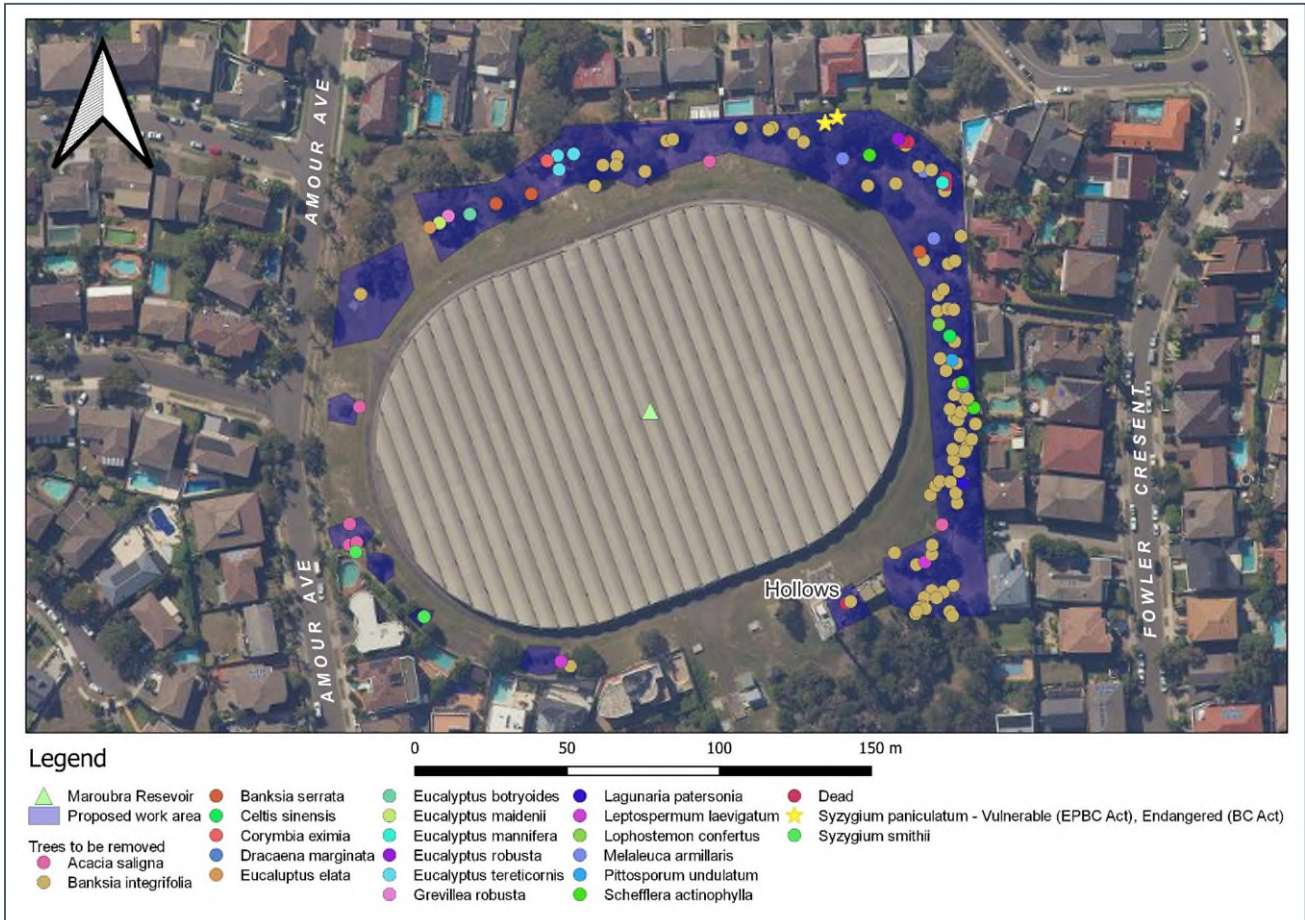
Figure 4. Tree species for removal

119 trees were located within the proposed clearing area, their locations being identified in Figure 4 with corresponding details provided in Table 2.

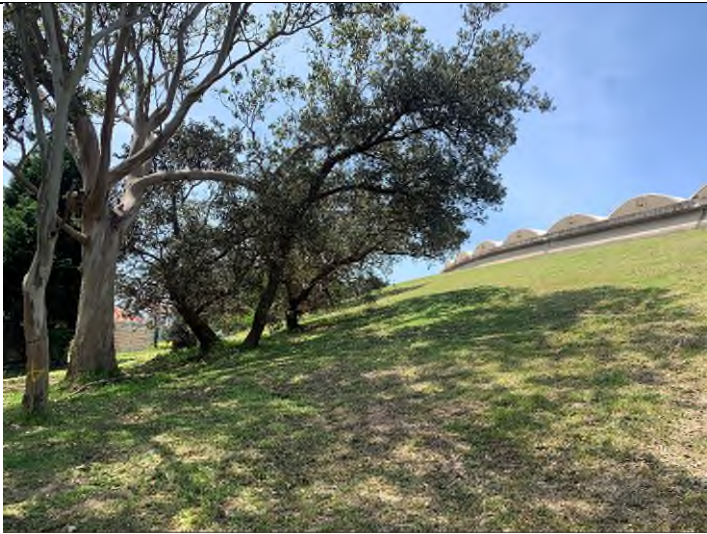
<p>Character of vegetation present at the site, including the reservoir walls in the background of the image.</p> <p>Select trees to be removed are marked in yellow, seen on the first tree in the left of the image. Photograph taken looking east through the site.</p>

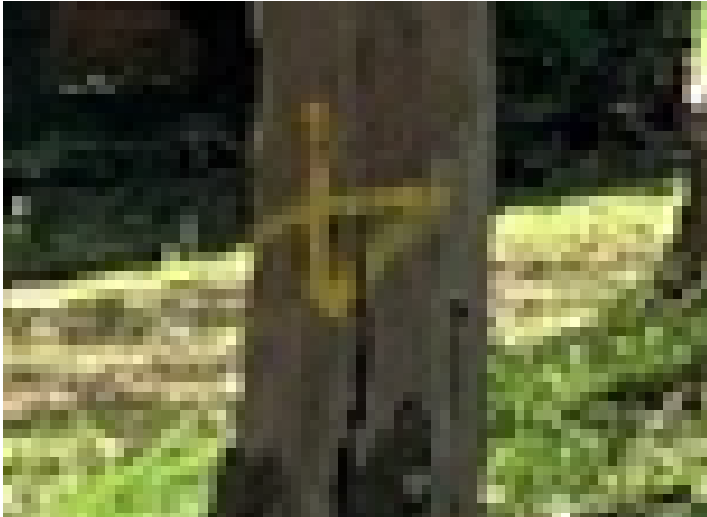
<p>Yellow markings identify the select trees to be removed.</p>

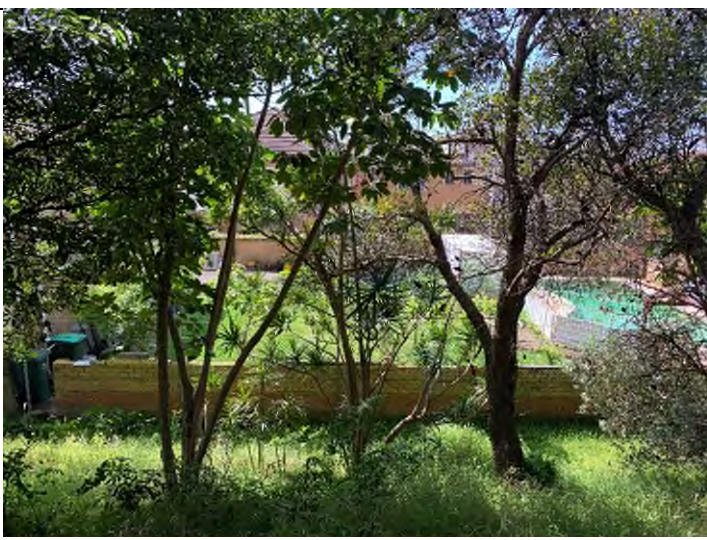
<p>Character of trees to be removed in proximity to adjacent residential properties. Photograph taken looking east through the site.</p>

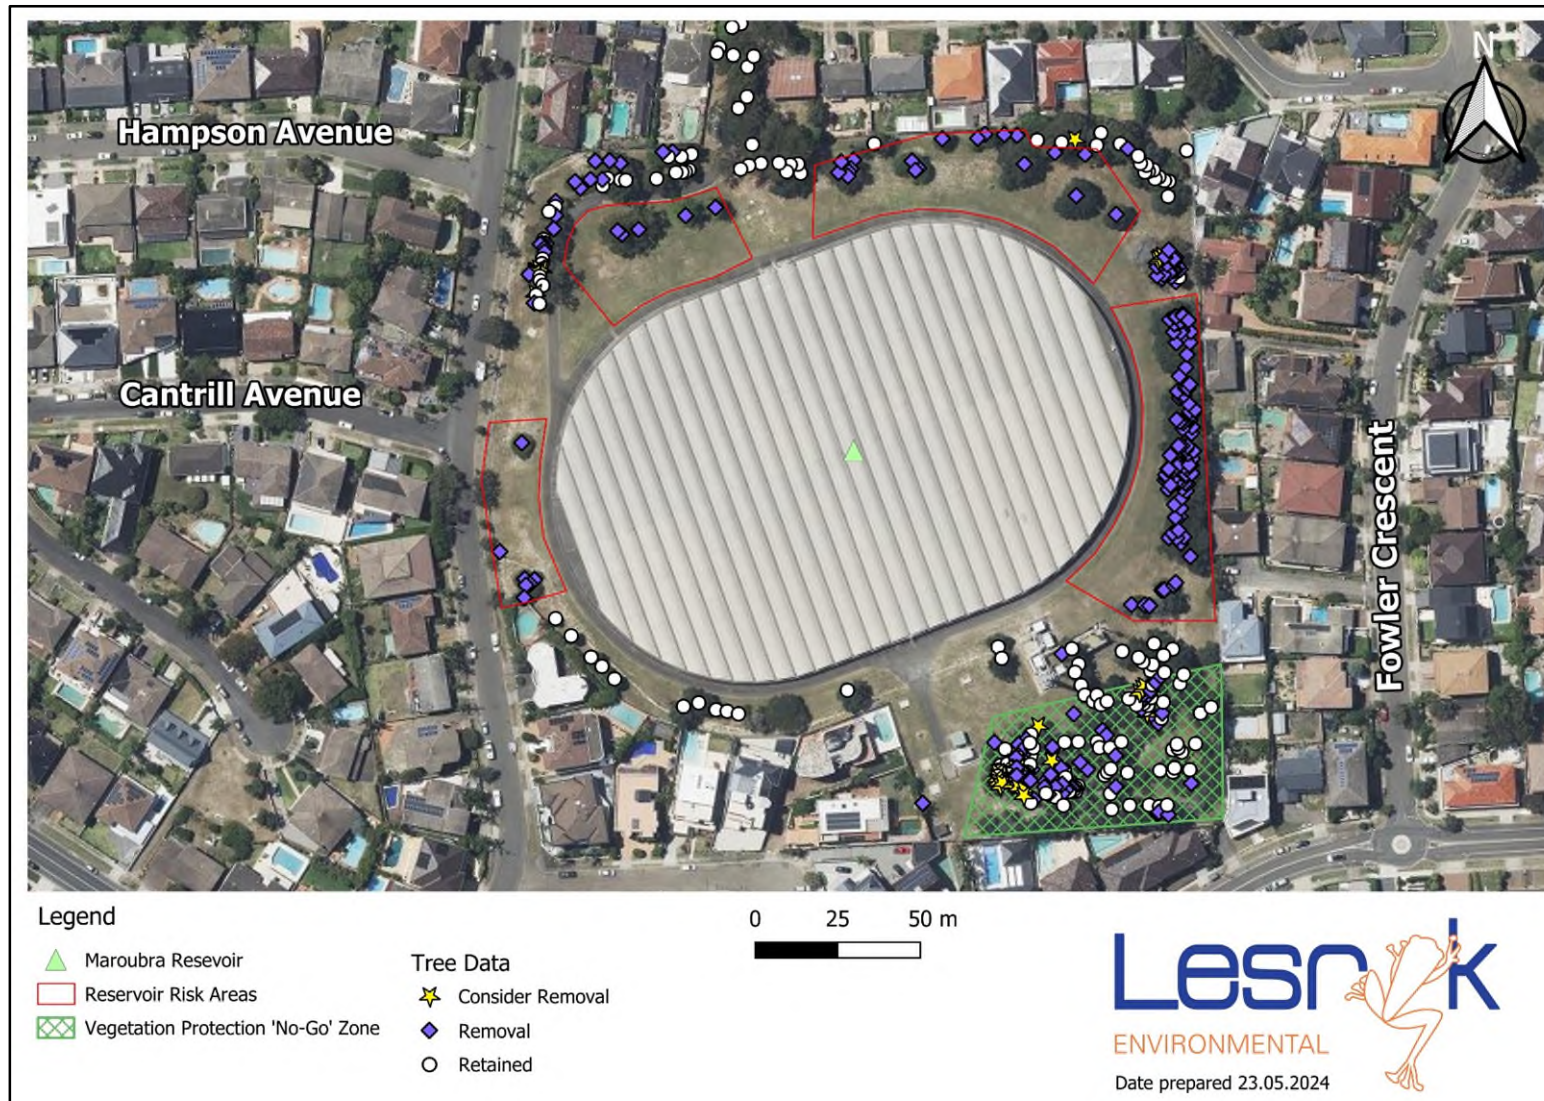
Figure 1. Location of those trees to be retained, and those requiring removal (per Canopy Consulting 2024)

For reference, based on the work of Canopy Consulting (2024), Figure 1 identifies the locations of those plants being retained and those being cleared.

Considering the revised scope of works, a total of 84 native plants, 7 exotic plants and one dead stag would require clearing to ensure compliance with the NSW *Dams Safety Act 2015* and Dams Safety Regulation 2019. The revised scope of works would result in a disturbance footprint of about 0.5 hectares (ha) as opposed to the original 0.69 ha that was considered.

Whilst retained, it is noted that several of the plants present, including the three Forest Red Gums, the Yellow Bloodwood and Lilly Pilly, will be trimmed.
