Pre-Construction Road Dilapidation Report for Dapto NSW 2530

Prepared for Geosurv Locating Pty Ltd

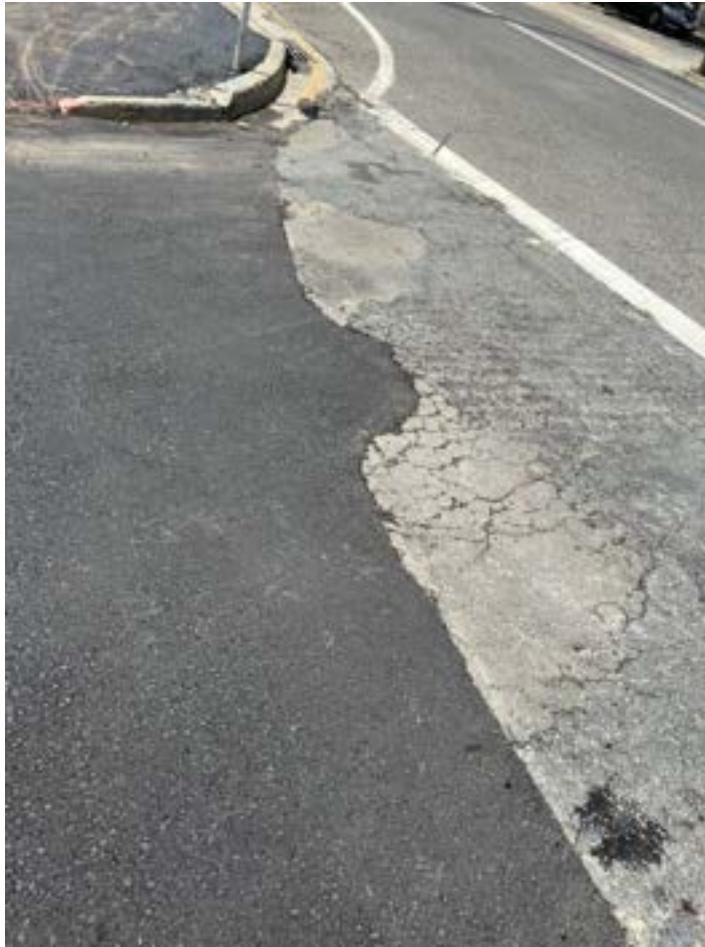
Photo 3

DEFECT/PHOTO NO.	LOCATION	LENGTH (mm)	WIDTH (max, mm)	COMMENTS
1	 	V	10 -15	Crocodile Cracks in Asphalt Concrete (AC) road surface
2		V	10 -15	Crocodile Cracks in AC road surface and evidence of guard rail damage
3		V	10 -15	Crocodile Cracks near previously repaired section of AC road surface
4		V	10 -15	Crocodile Cracks near patching
5		V	10 -15	Extensive crocodile cracks throughout AC road surface and kerb & gutter
6		V	10 -15	Extensive crocodile cracks throughout AC road surface
7		V	10 -15	Crocodile Cracks near previously repaired section of AC road surface
8		V	10 -15	Crocodile Cracks near patching
9		V	10 -15	Extensive crocodile cracks throughout AC road surface, evidence of kerb damage and ponding
10		3000	1500	Pothole
11		V	10 -15	Various cracks near intersection of unsealed road and AC road
12		V	V	Various potholes in unsealed road
13		V	V	Various potholes in unsealed road
14		V	10 -15	Various cracks in AC road surface

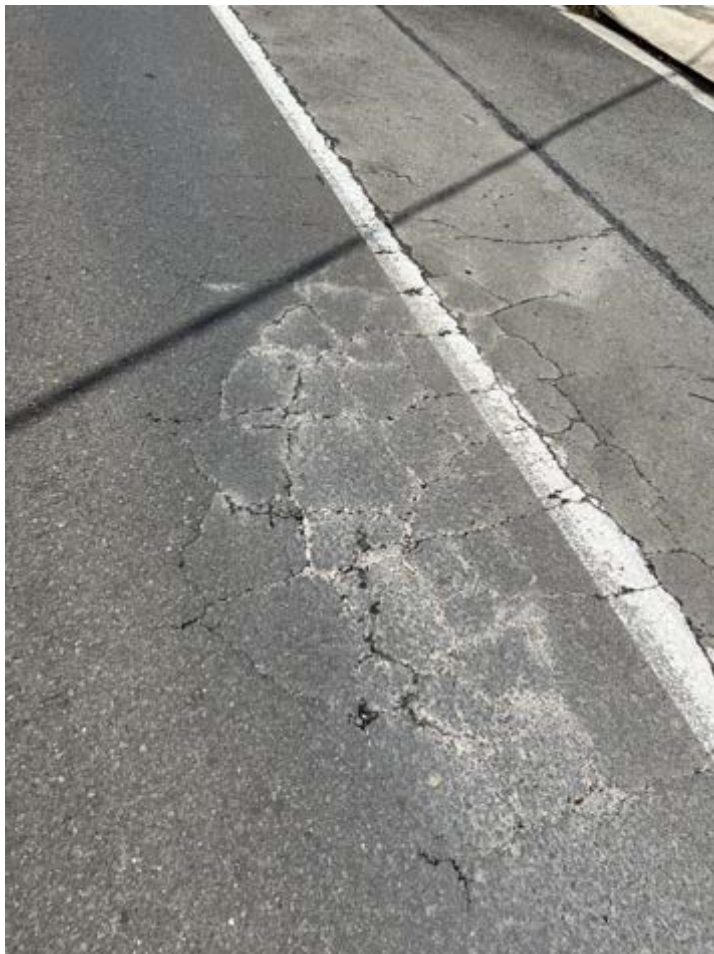
Photo 18

15		V	10 -15	Various cracks in AC road surface
16		V	V	Various Potholes
17		V	V	Extensive crocodile cracks throughout AC road surface and evidence of kerb damage
18		V	10 -15	Crocodile Cracks in AC road surface
19		V	5 -10	Crocodile Cracks near previously repaired section of AC road surface
20		V	5 -15	Extensive crocodile cracks throughout AC road surface
21		2000	1500	Pothole
22		V	10 -15	Various cracks near patching
23		V	10 -15	Linear and transverse cracks throughout AC road surface
24		V	10 -15	Various cracks in AC road surface
25		V	10 -15	Various cracks in AC road surface
26		V	V	Extensive crocodile cracks throughout AC road surface and evidence of patching

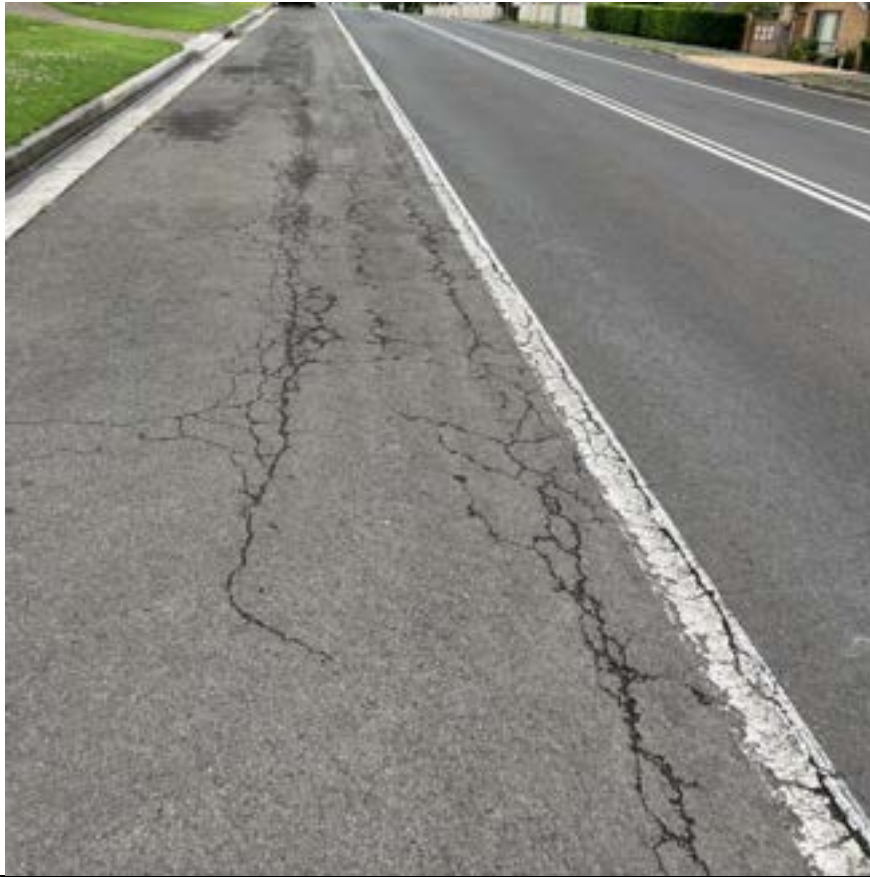
Photo 27

DEFECT/PHOTO NO.	LOCATION	LENGTH (mm)	WIDTH (max, mm)	COMMENTS
27		V	10 -15	Extensive cracks throughout AC road surface parking lane
28		V	10 -15	Extensive crocodile cracks near delamination of AC road surface
29		V	10 -15	Various cracks in AC road surface parking lane
30		V	5 -10	Various cracks in AC road surface
31		V	5 -10	Extensive crocodile cracks throughout AC road surface parking lane
32		V	10 -15	Various cracks and evidence of delamination in AC road surface
33		V	10 -15	Linear and transverse cracks in AC road surface
34		6000	10 -15	Transverse crack in AC road surface
35		2500	10 -15	Transverse crack in AC road surface
36		3000	10 -15	Transverse crack in AC road surface
37		5000	10 -15	Linear crack in AC road surface and evidence of ponding/seepage
38		V	10 -15	Various cracks in AC road surface
39		V	5 -10	Crocodile cracks in AC road surface
40		V	5 -15	Crocodile cracks in AC road surface
41		V	10 -15	Crocodile cracks in AC road surface and evidence of delamination

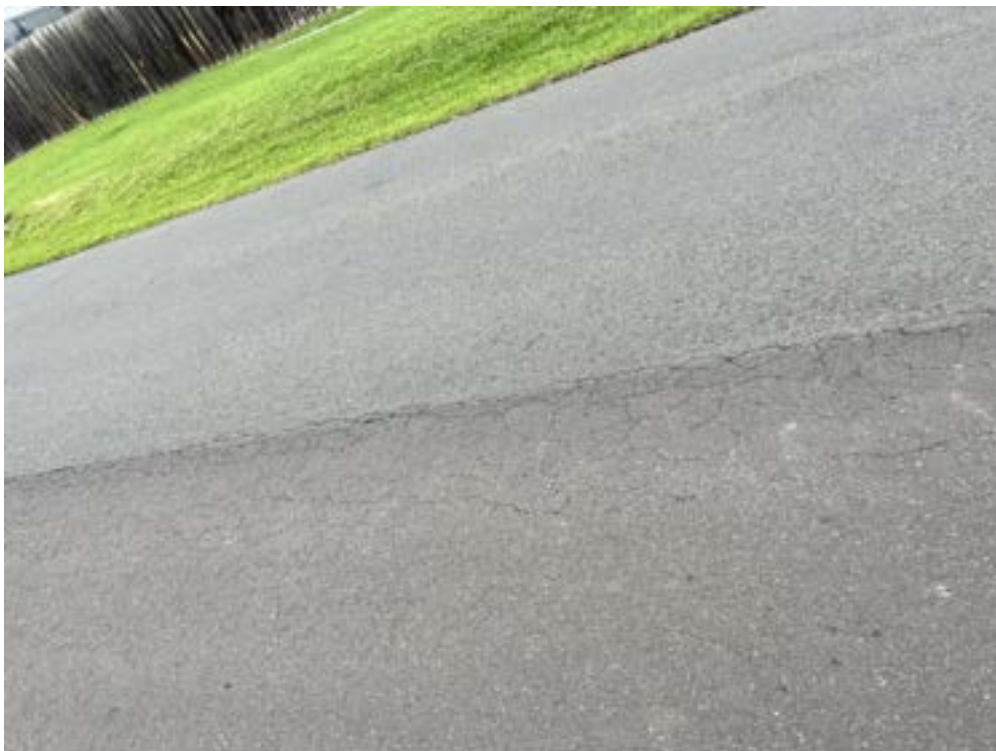
Photo 42

42		V	5 -10	Extensive crocodile cracks throughout AC road surface
43		V	5 -10	Various cracks in AC road surface
44		V	10 -15	Various cracks in AC road surface along previous repaired length against gutter
45		V	5 -10	Crocodile cracks in AC road surface and ponding along edge of pavement
46		V	5 -10	Crocodile cracks and evidence of delamination in AC road surface
47		6000	10 -15	Linear crack in AC road surface
48		V	10 -15	Various transverse cracks in AC road surface
49		6000	5 -15	Various transverse cracks in AC road surface
50		6000	10 -15	Linear crack in AC road surface
51		V	10 -15	Various cracks in AC road surface
52		V	10 - 20	Various cracks in AC road surface
53		V	10 -15	Various cracks in AC road surface
54		V	10 -15	Linear cracks and crocodile cracks in AC road surface
55		V	5 -10	Various cracks in AC road surface
56		V	5 -10	Various cracks in AC road surface

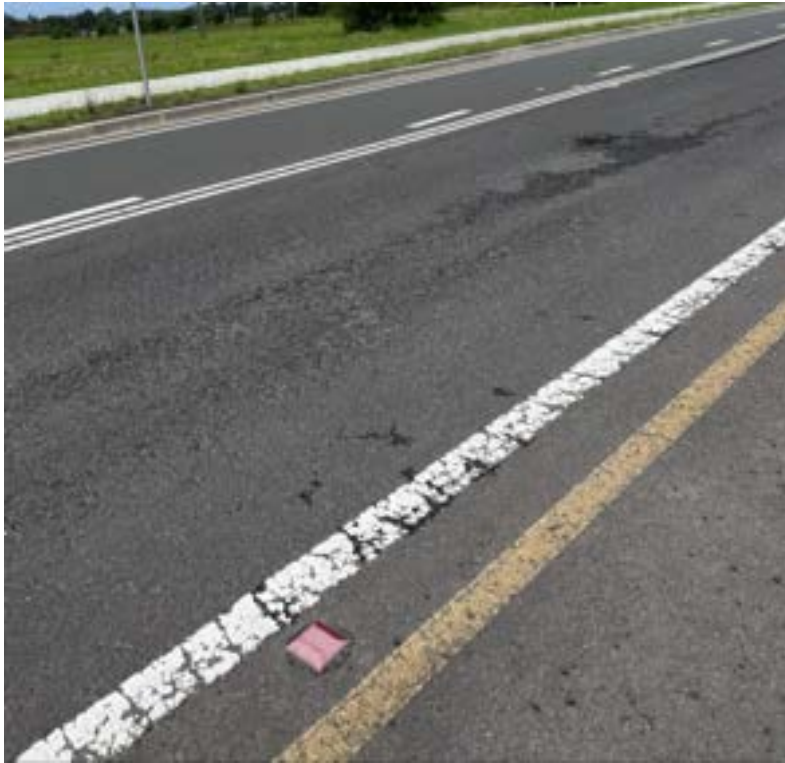
Photo 61

V	5 -15	Various cracks in AC road surface
58		V	10 -15	Extensive crocodile cracks throughout AC road surface
59		V	10 -15	Extensive crocodile cracks throughout AC road surface
60		V	10 -15	Extensive crocodile cracks throughout AC road surface
61		-	-	Raveling in AC road surface
62		1500	1500	Pothole and crocodile cracks throughout AC road surface
63		V	10 -15	Extensive crocodile cracks throughout AC road surface
64		V	10 -15	Extensive crocodile cracks throughout AC road surface
65		3000	5 -15	Transverse cracks in AC road surface
66		V	5 -15	Various extensive cracks in AC road surface
67		V	5 -10	Various cracks in AC road surface
68		300	150	Delamination with crocodile crack in AC road surface
69		150	100	Pothole with crocodile crack in AC road surface
70		V	150	Various cracks near patching and evidence of raveling
71		V	10 -15	Extensive crocodile cracks throughout AC road surface and near patching

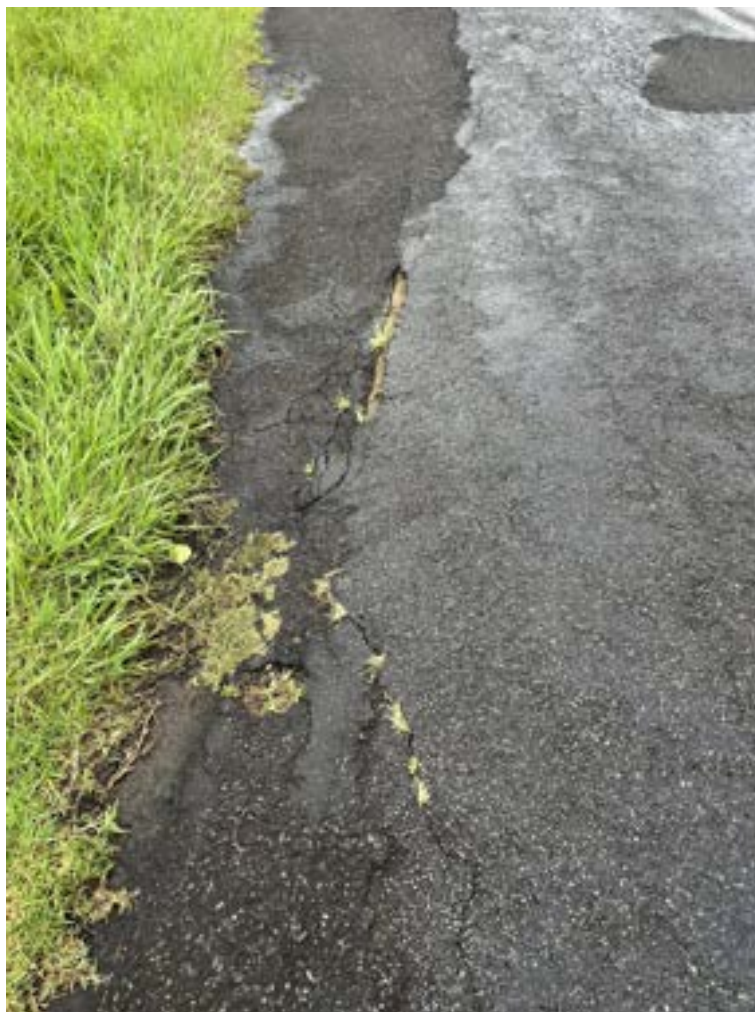
Photo 72

72		V	V	Various potholes with crocodile crack in AC road surface
73		V	5 -15	Extensive crocodile cracks throughout AC road surface and near patching
74		V	5 -15	Extensive crocodile cracks throughout AC road surface and near patching
75		V	5 -15	Extensive crocodile cracks throughout AC road surface and near previously repaired section of AC road surface
76		V	5 -20	Extensive crocodile cracks throughout AC road surface and near patching
77		200	150	Delamination with small pothole in AC road surface
78		-	-	Evidence of weathering
79		200	150	Delamination of AC road surface
80		800	5 -15	Various cracks in AC road surface adjacent previous repairs
81		1000	5 -10	Meandering cracks in AC road surface
82		100	80	Small Pothole
83		5000	5 -10	Linear crack in AC road surface
84		7000	5 -15	Extensive block cracking in AC road surface
85		V	5 -15	Various extensive cracks in AC road surface
86		V	5 -10	Various extensive cracks in AC road surface
