Mill Stream Environment Management Plan (EMP) Annual Compliance Report

Report Number 1

Period 7 June 2024 to 17 January 2025

In Compliance with Authorisation Number 01/2024

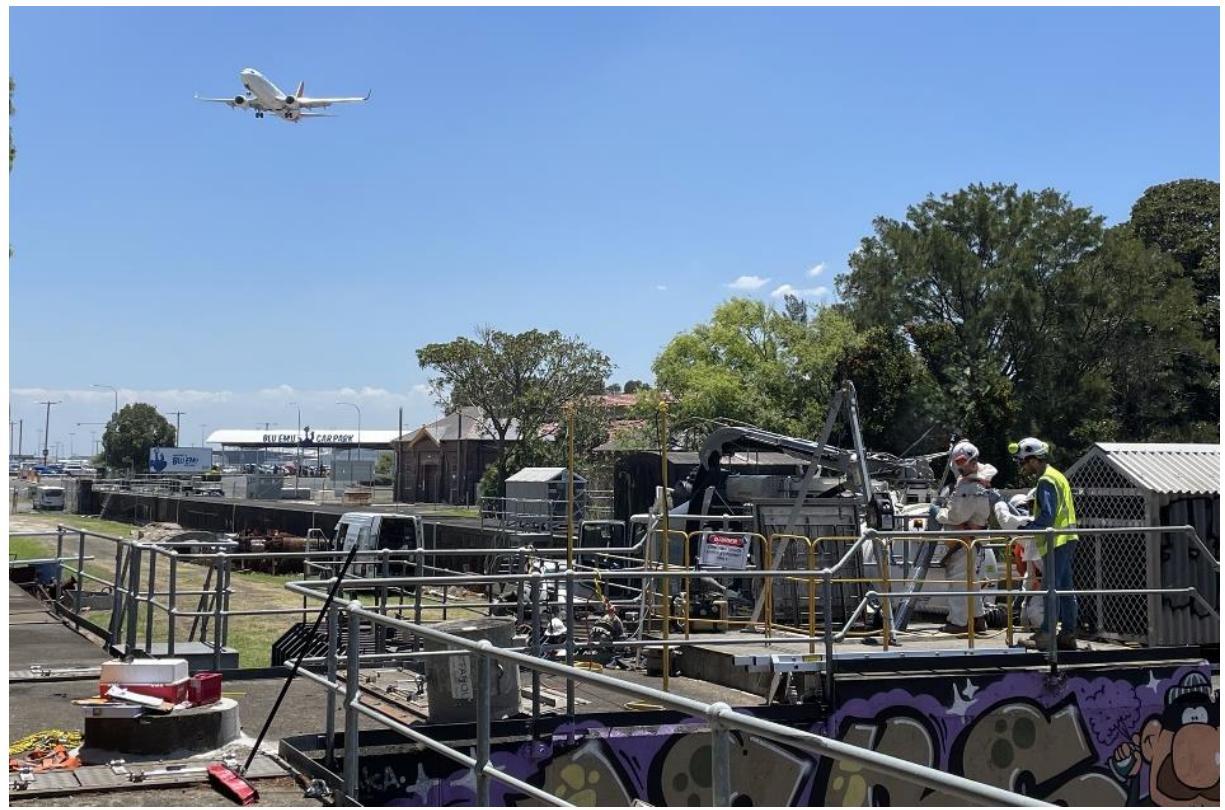
Figure 3-1: Desilting SWSOOS2 Package A1

Sydney Water has started planning works on package A2, which will include the desilting, and inspection works in the South Barrel. Package A2 also includes structural repair works of both the barrels between Cross Connection, 2 near the SP0038 building, and Hale Street, Botany. Once Package A2 is approved, Sydney Water will start background works on Package A3 to continue a rolling program of works.

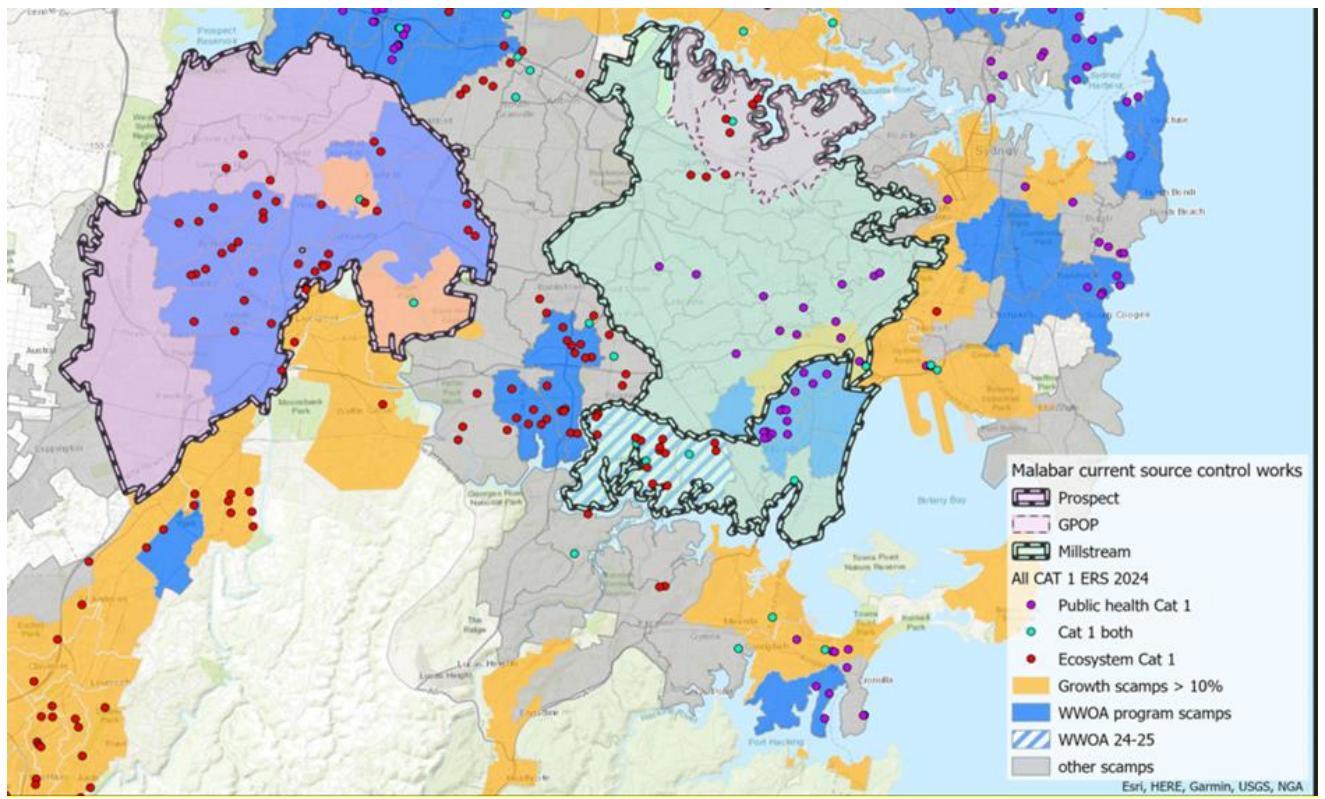
Figure 3-4: Source control catchments in the Malabar system

Source control works seek to reduce stormwater inflow and infiltration into the wastewater system, resulting in a reduction of the volume and frequency of wet weather overflows at ERSs. Source control works are broken into three stages, each representing different types of work which are defined in Table 3-1. The different stages can be implemented concurrently, and not all stages are implemented in every catchment or work program.

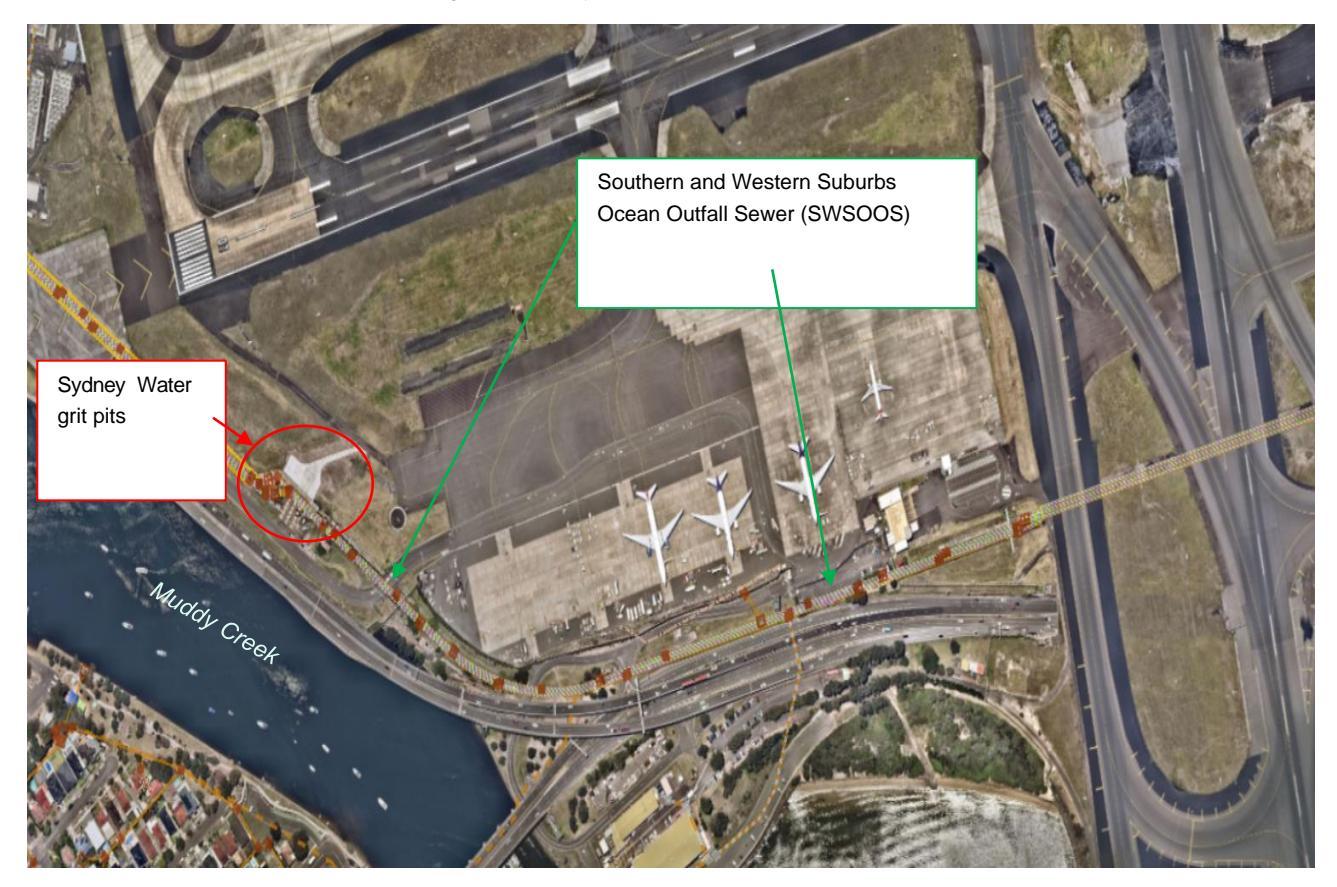
Figure 3-8: SWSOOS Sydney Airport grit pit location

Construction of a concrete hardstand adjacent to the grit pits to enable safe and all-weather access for cleaning was completed in late October 2024 (Figure 3-8, Figure 3-10, and Figure 3-11). Sydney Water has negotiated an approval with Sydney Airport to carry out cleaning activities during daylight hours. However, Sydney Water has achieved only partial compliance with the requirement to complete 10 cleaning shifts of approximately 4 week cycle. This shortfall is attributed to the prioritisation of airport operations over cleaning activities, resulting in the cancellation of planned cleaning tasks by Sydney Airport. The number of completed cleaning shifts per cycle is detailed in Table 3-2.

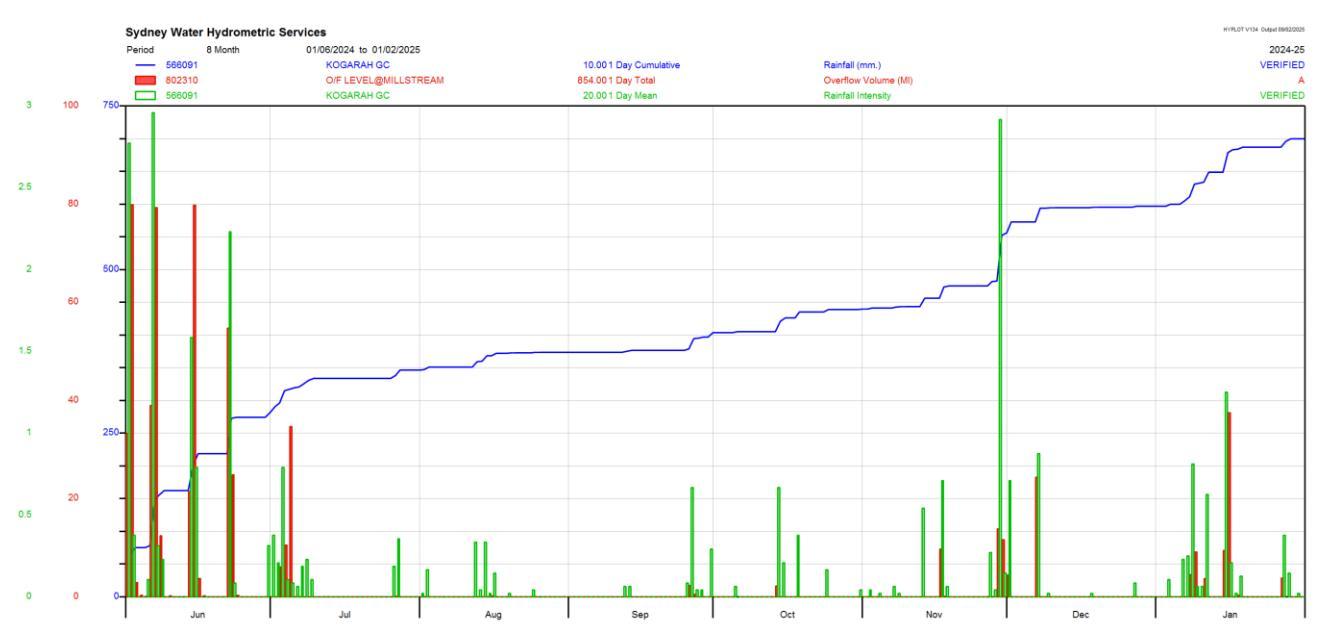
Figure 3-12: Cumulative rainfall (mm) and intensity at permanent rain gauge (Gauge Number: 566091) located at Kogarah Golf Course compared with discharge from overflow gauge number 802310 for the reporting period.

The cumulative total discharge for this period was 1,061 ML across 15 events and 36 days (see Figure 3-12 for details). Details of the date, volume and duration of the individual discharges from 7 June 2024 to 17 January 2025 are provided in Appendix 1.

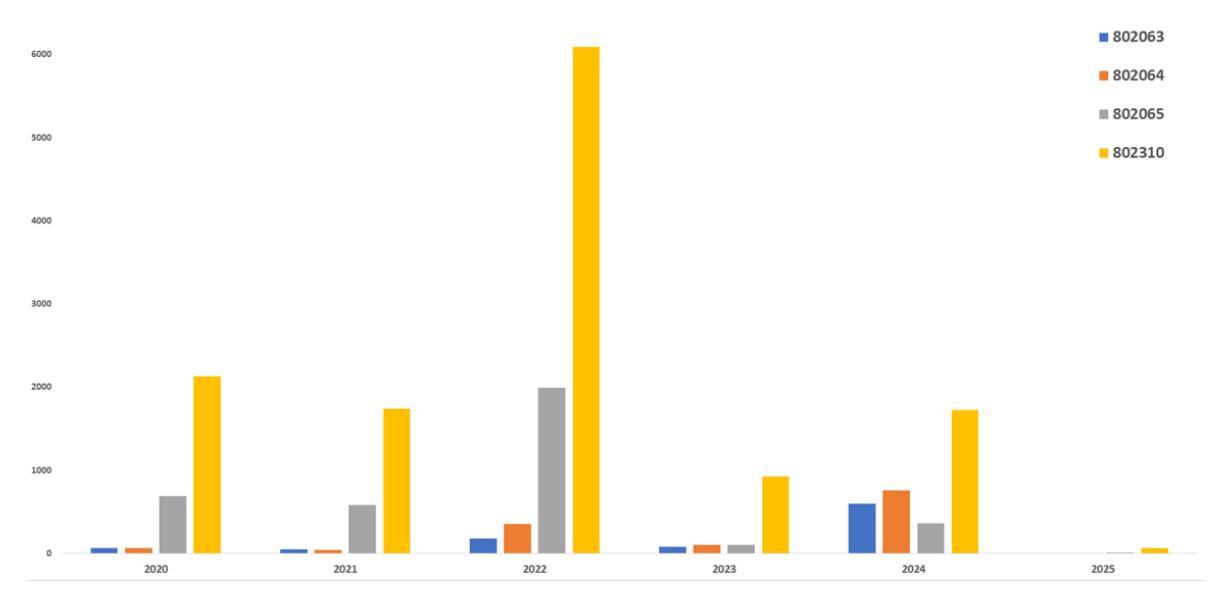
Figure 3-18: Annual Total Discharge (ML) per ERS Gauge

Sydney Water has provided annual total discharges per ERS gauge at the Mill Stream for the period 2020 until 2025 (Figure 3-18). Prior to June 2024 the reporting methodology for the Mill Stream overflow gauge at SG0035 (802310) was overstating the discharge volume leaving the sewer network. This was due to all positive overflow events being classified as siphonic hydraulic conditions. With the addition of new monitoring equipment being installed since June 2024, we have evidence to support the calculated discharge to be a more accurate representation of actual volume discharge.

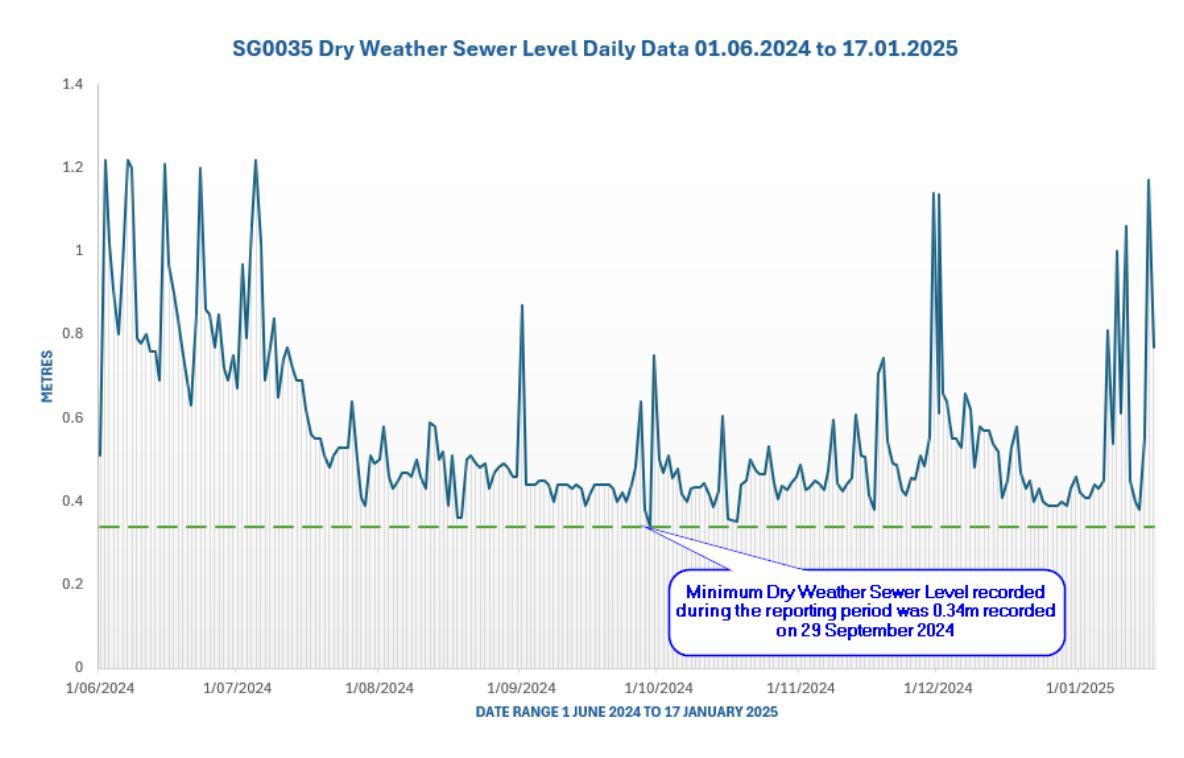
Figure 3-19: SG0035 dry weather sewer level daily data 01.06.2024 to 17.01.2025

The metric used is the minimum wastewater level below 0.45m over a rolling six-month period. The minimum wastewater level is utilized because it is not affected by fluctuations in wastewater depths due to wet weather, and a rolling six-month period ensures that the measured period is not entirely influenced by wet weather conditions. Desilting and grit removal activities increase capacity and reduce the wastewater level.

The minimum dry weather sewer level recorded during this reporting period was 0.34m, recorded on 29 September 2024 (Figure 3-19). Raw data is available (0). Minimum dry weather sewer level of 0.34m was implemented to facilitate safe maintenance activities in upstream sewer mains.

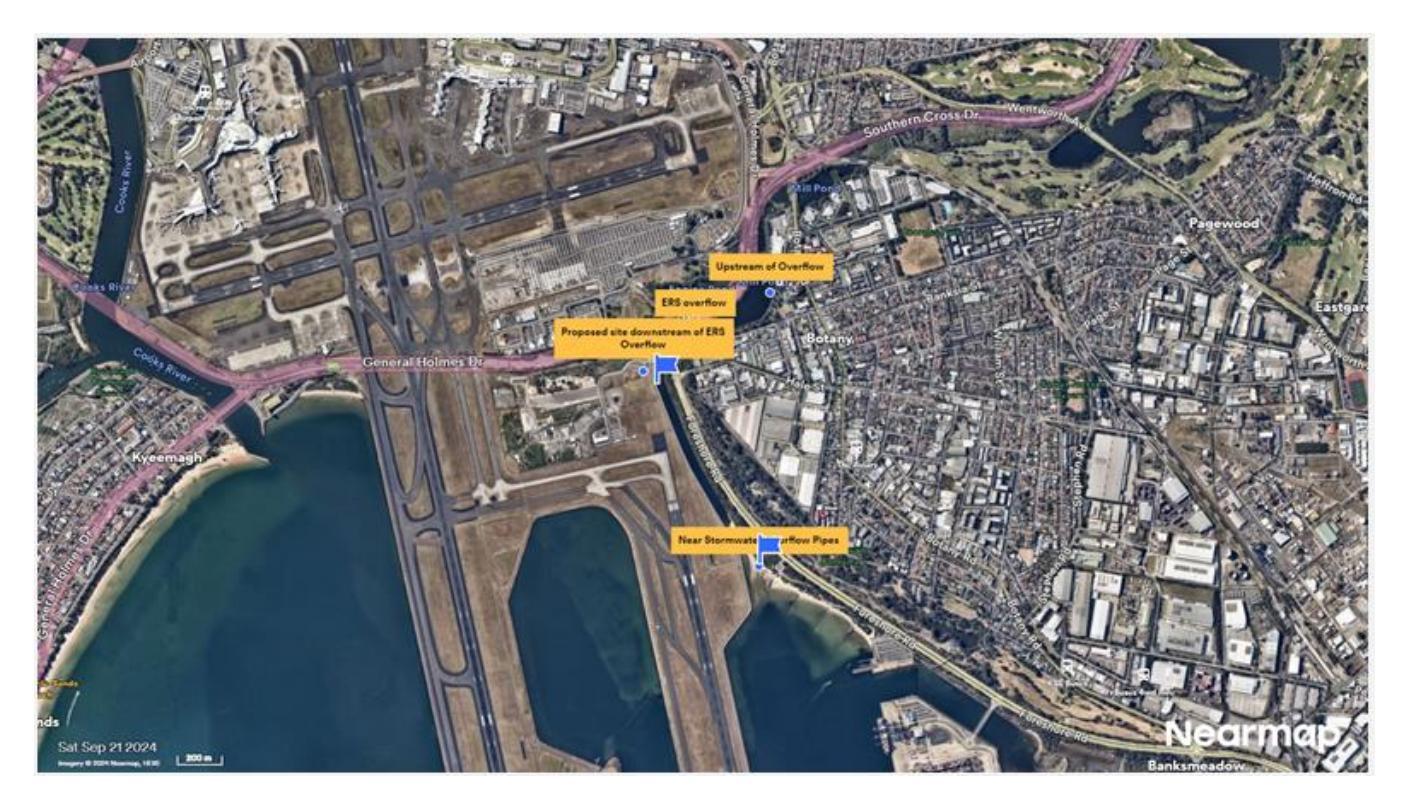
Figure 3-20: Sewer overflow odour monitoring location

Monitors were installed on 18 September 2024, upstream of overflows near Botany Public School, at the Mill Stream overflows, and near the Botany container terminal along Foreshore Drive (Figure 3-20). These monitors will be in place for 12 months. An additional monitor at the airport fence will be installed when an approval from Sydney Airport has been granted.

During the monitoring period from 18 September 2024 to 17 January 2025, no levels of Hydrogen Sulfide (H2S) were detectable by the human nose from the Mill Stream Overflows. However, on 7 January 2025, a reading of 0.4ppm (parts per million) was detected near the council stormwater overflow pipes for a brief duration of less than an hour. While this level is considered detectable by the human nose, it was very low and posed no danger to human health.

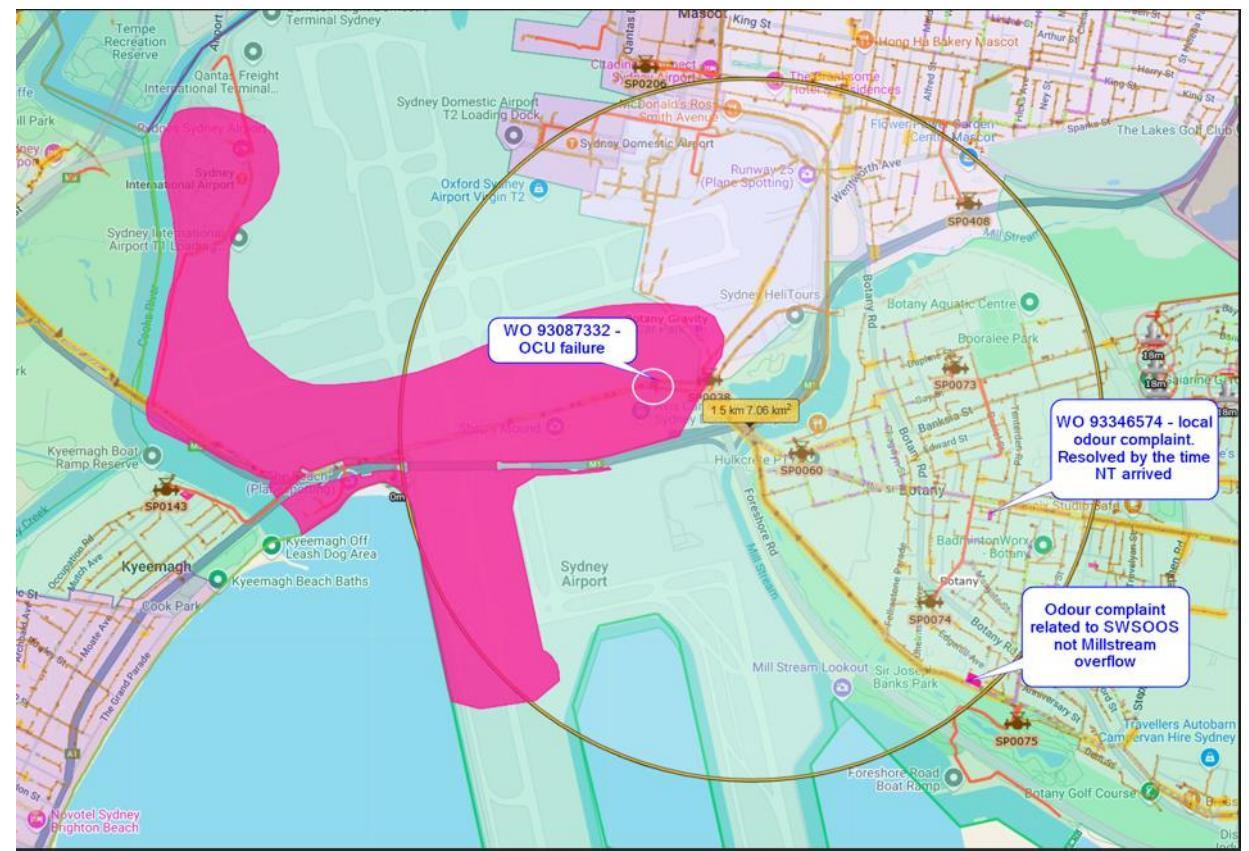
Figure 3-21: Odour complaints around Mill Stream from 7 June 2024 to 17 January 2025

Between 7 June 2024 to the 17 January 2025 the were no noise or water complaints. However, there were two complaints related to Mill Stream overflow and one complaint concerning a failure of the Airport OCU (SY0041). The Mill Stream complaints originated from the Botany area, located to the south-east of the Mill Stream overflows (Figure 3-21). Details of these complaints are provided in Table 3-8

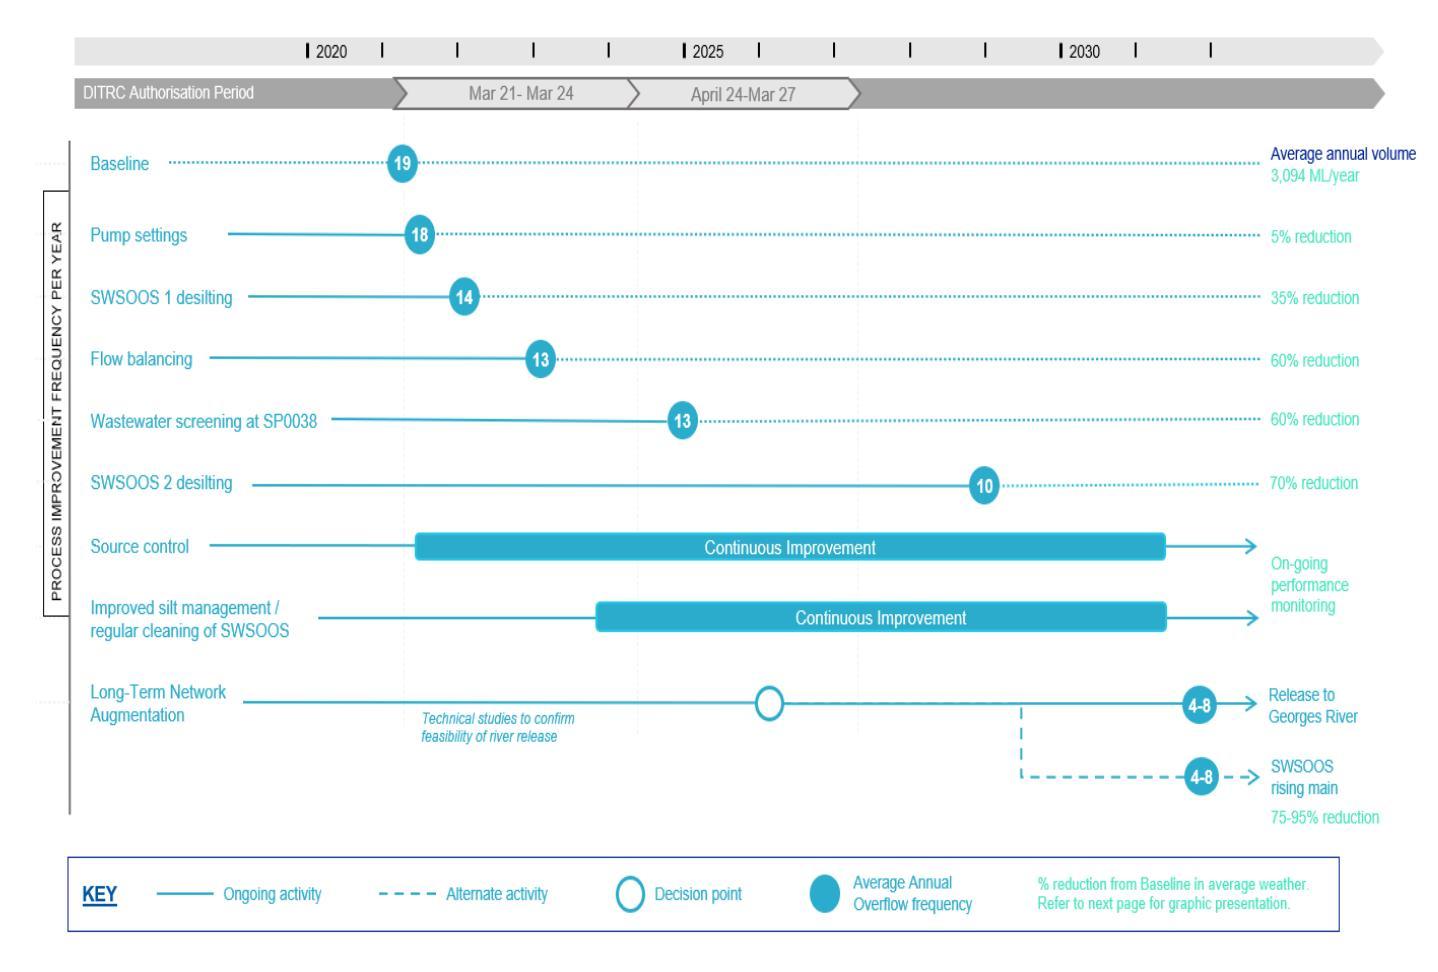
Figure 2 Millstream plan on a page (1), indicating overflow performance from asset works *Please note: performance beyond 2023 is an estimate based on assumed benefit from future works*

The modelled overflow performance is an average, calculated against an existing time series of rainfall that represents a range of weather conditions (10 years, 1985 – 1994). This time series is used by Sydney Water to provide a consistent and comparable assessment of the wastewater system performance as the system is changed through maintenance activities, upgrades, and ongoing development/population growth. The model is also calibrated with data sourced from flow gauges, level and pressure sensors, that continually monitor the network. This method is consistent with the process Sydney Water uses for reporting compliance with our Environment Protection Licences regulated and assessed by the NSW EPA. However, it is an averaged metric and cannot be used to compare to overflow activity observed during smaller weather periods, particularly more extreme periods such as flooding or drought. To address that Figure 1-3, represents how that average performance sits within the seasonal variability accounted for in the modelled time series, and as could be directly observed year to year at Mill Stream.
