Vaucluse Diamond Bay Ocean Discharges

Pollution Study Report (PRP 305)

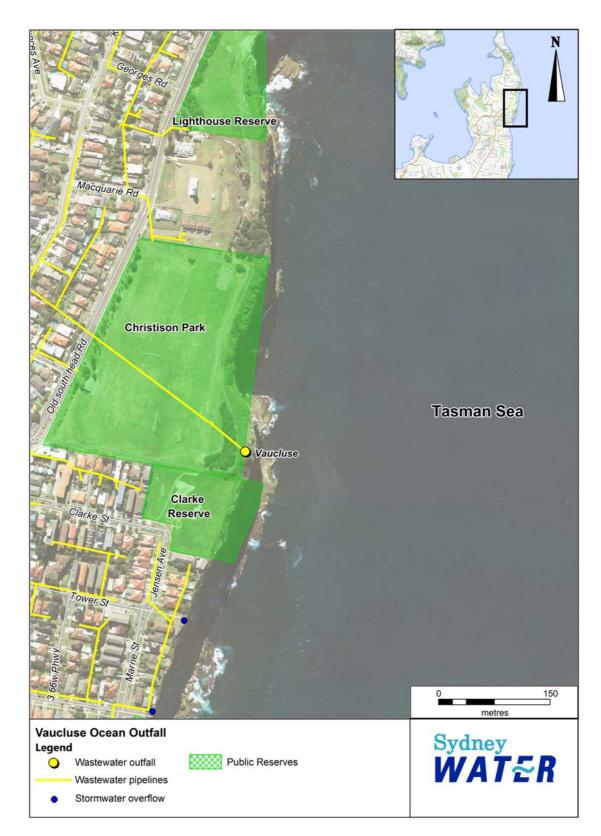
Figure 5-1 Location map of Vaucluse outfall

The VC system services a catchment extending from South Head to Clairvaux Road, an area of about 290 ha comprising the suburbs of Watsons Bay and parts of Vaucluse. The length of this system is about 3 km. Wastewater flows gravitate westward towards Sydney Harbour, and are pumped by five small pumping stations to two major branch pipelines. The two pipelines converge at Parsley Bay Reserve, where wastewater then travels east to the VC outfall via the Vaucluse Ocean Outfall Sewer (VOOS). The VOOS comprises a 990 mm by 600 mm ovoid pipe, which discharges sub-tidally, about 6 m below sea level. The system has been in operation for just over 100 years, being commissioned in 1916. A map of the VC discharge point is shown in **Figure 5-1**.

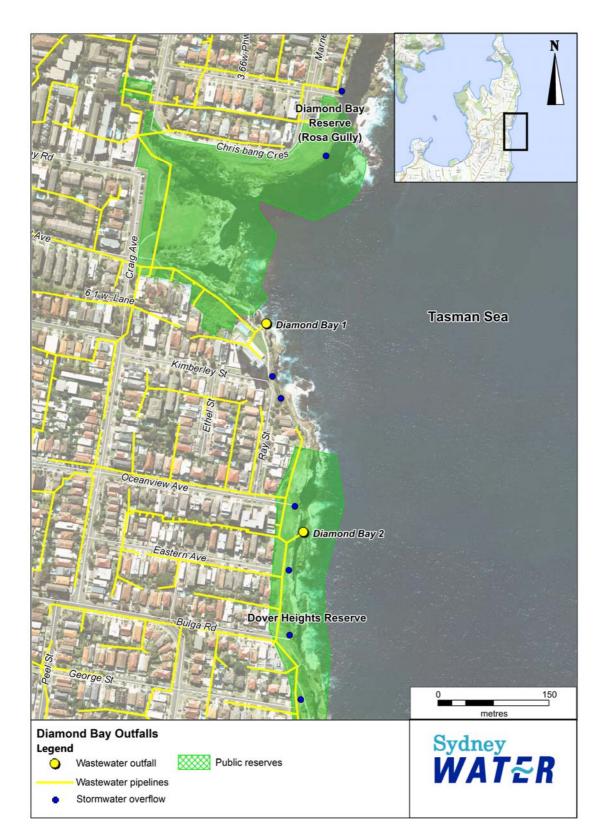
Figure 5-2 Location map of Diamond Bay outfalls

The two Diamond Bay ocean outfall systems (DB1 and DB2) service much smaller catchments than the VC system. They were the last systems in the Sydney Water network to be built without treatment facilities. The location of the DB1 and DB2 outfall points is shown in **Figure 5-2**.

The DB1 outfall services an area of about 39 ha, comprising parts of Vaucluse and Dover Heights. The outfall is a 225 mm diameter wastewater pipe built in 1932. It is located at the base of a 25-30 m high cliff and discharges at sea level. Wastewater flows by gravity towards the coast, eventually connecting at vertical sewer shafts, then discharging via a tunnel to the ocean. There are no wastewater pumping stations within the catchment.

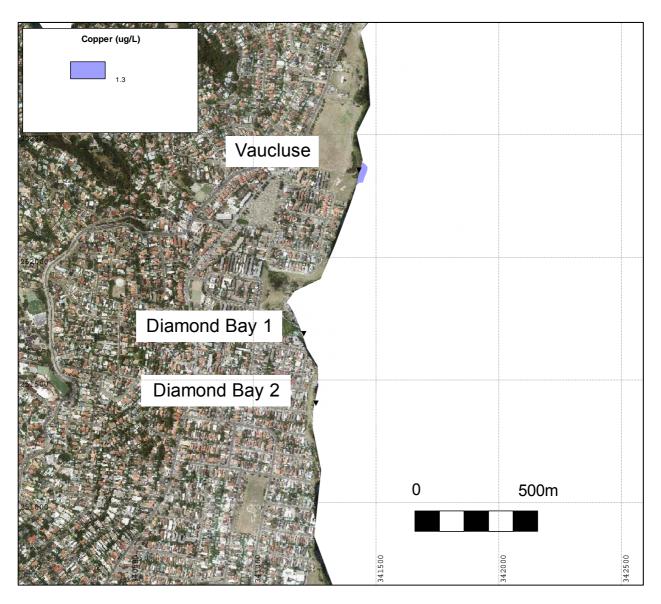
Figure 5-4 and **Figure 5-5** represent the estimated maximum possible extents using a conservative tracer (Copper or TN) simulated over a period from July 2015 to June 2016. The modelling work has not been verified by monitoring. The cliff face outfalls discharge at the surface zone where hydraulic conditions are very complex and difficult to be modelled. A nearfield mixing zone was assumed to be 20x20x1m at the discharge location to reflect the breaking wave effect. This assumption may overestimate the nearfield mixing, but these impact zones are much smaller than the faecal contamination zone presented in the next section.

Figure 5-4 Concentration contour for copper to achieve concentration below ANZECC 2000 trigger value for toxicants.

The nutrient concentrations in outfall discharges present a potential stressor for bio-stimulation of the receiving waters. Nutrient dilution rates of about 400 times would be required to meet the ANZECC trigger values for nutrient stressors (nitrogen slightly more than phosphorous). Pilot modelling is only able to provide an indicative extent of these dilutions. Pilot modelling indicated that this represents an area extending about 60 m offshore and 240 m alongshore at Vaucluse; 15 m offshore and 70 m alongshore at DB1; and 30 m offshore and 110 m alongshore at DB2 (**Figure 5-5**).

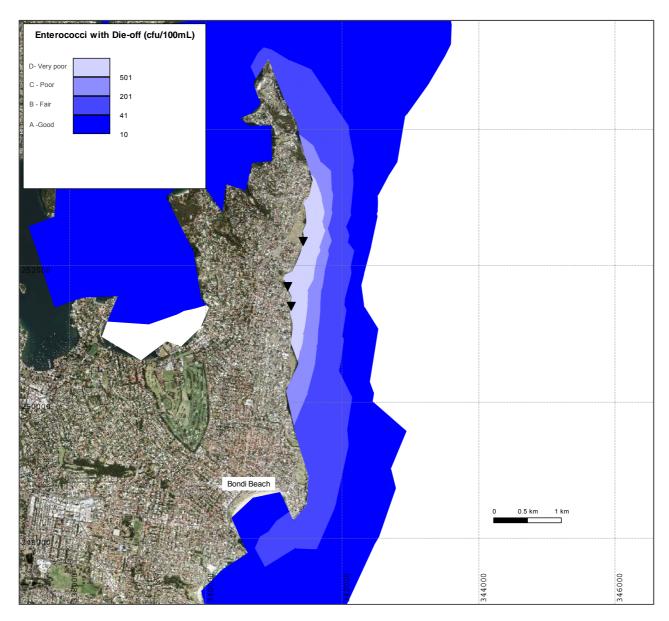
Figure 5-6 shows the pilot modelling results for enterococci levels through dispersion at the 95th %ile, in line with the NHMRC 2008 guidelines. The enterococci limits mapped correlate with the microbial assessment categories (MAC) defined in the NHMRC guidelines and used for Beachwatch classification (**Table 5-6**). The four categories (A to D) relate to levels of risk of illness, determined from key epidemiological studies, whereby the greatest risk off illness occurs in the areas mapped as Category D, and decreases further offshore. Category A represents the lowest risk of illness for those conducting primary contact recreation. Importantly, nearby swimming beaches, such as Bondi, are unaffected (which is supported by Beachwatch data, see section 3.3.5).

Figure 5-6 Enterococci statistics for combined impact of the three VDB discharges (95th percentile)

In addition to the pilot modelling, a visual assessment and estimation of the visible plume was conducted using aerial imagery in Nearmap. Historic aerial photos of the study area were used to make a qualitative assessment of the visible plumes emanating from each outfall, and their dispersion behaviour. Visual assessment of 47 Nearmap aerial images from 2009 to 2016 revealed the wastewater plumes are visible around 75% of the time. The extent of the visible plume observed in historic aerials was confined to the area mapped as Category D in **Figure 5-6**, above.

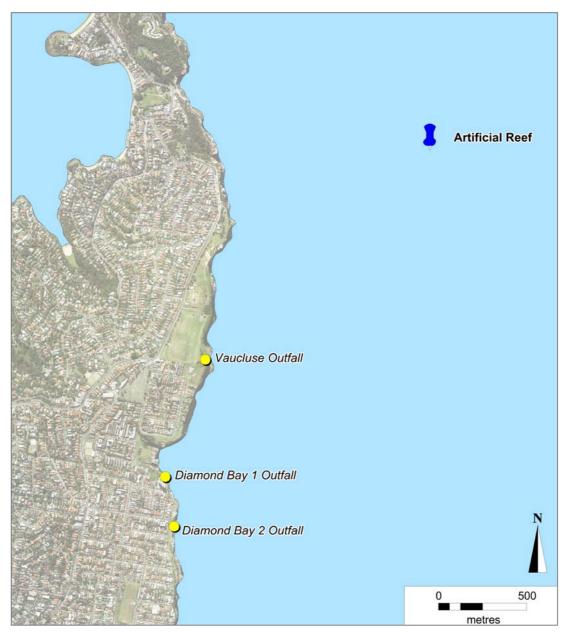
Sydney's first artificial reef was deployed off the coast of Vaucluse on 12 October 2011 by the NSW Department of Primary Industries (DPI). The project was funded by the NSW Recreational Fishing Trust. It is located about 1.2 km off the coast from The Gap at 38 m depth (see **Figure 5-8**).

Figure 5-8 Location of Vaucluse artificial reef (deployed by DPI Fisheries), in relation to the VDB outfalls.

The nearest VDB outfall to the reef is Vaucluse, located about 1.8 km southeast. At this distance, it is considered unlikely that the discharges from the outfall would adversely affect the water quality or ecosystem at the artificial reef site. The location of the reef is outside of the Category B, C, and D areas modelled in the pilot modelling (see section 5.4.3).
