## Upper South Creek

# Advanced Water Recycling Centre and Pipelines

Environmental Protection License – Environmental Monitoring Data  
Report

September 2023 to September 2025

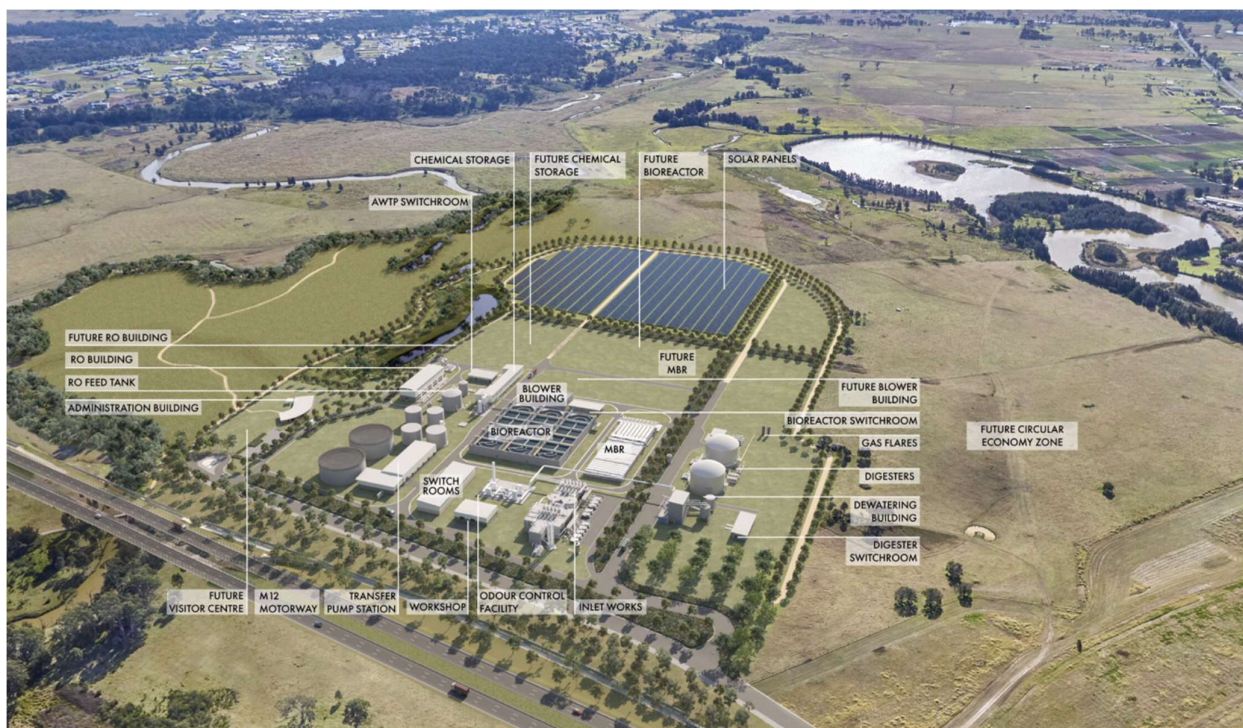
Figure 1-1 – Indicative AWRC site arrangement

The project comprises of the following components which are also detailed in Figure 1-1, Figure 1-2 and Figure 1-3.

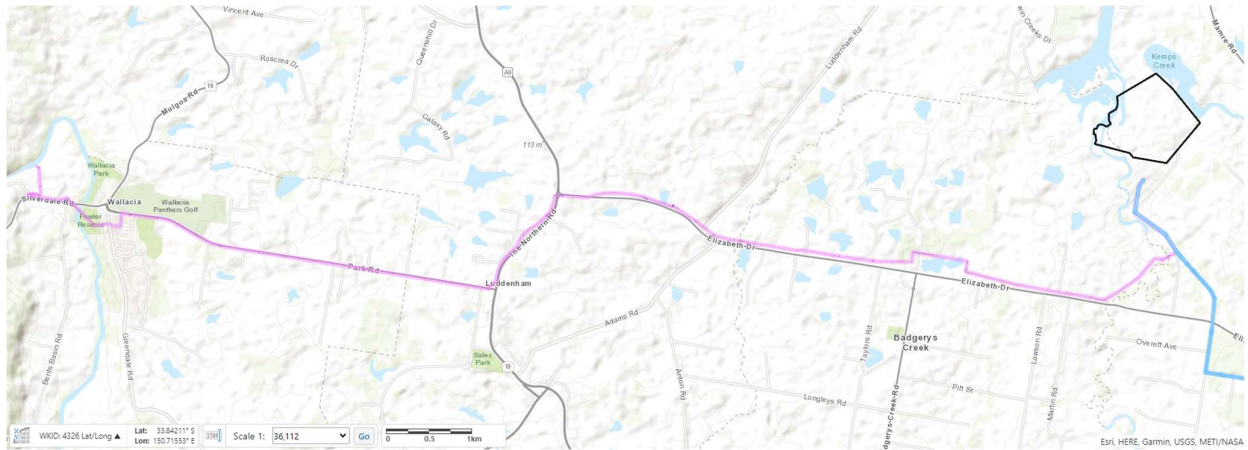
Figure 1-2 – Overview of the AWRC site and the treated water pipeline

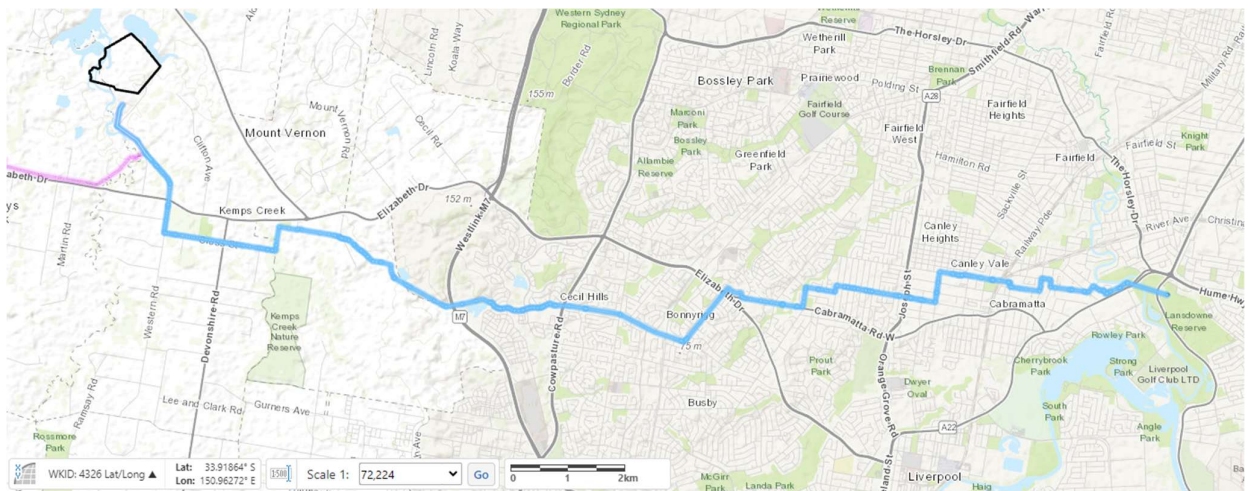
Figure 1-3 – Overview of the AWRC site and the brine pipeline
